## ACCENT HOUSING - HEALTH & SAFETY ASSESSMENT

<b>Region :</b>	<b>East</b>
<b>Scheme Name :</b>	<b>St Edmunds Walk</b>
<b>Scheme Address :</b>	<b>Hampton Hargate Peterborough PE7 8GQ</b>
<b>Date of Assessment:</b>	<b>29/03/2022</b>
<b>Date of Next Assessment:</b>	<b>28/03/2025</b>
<b>H&amp;S Frequency:</b>	<b>3 Yearly</b>
<b>Fire &amp; Safety Assessor</b>	<b>Lynn Betteridge</b>

Photographs - Health & Safety

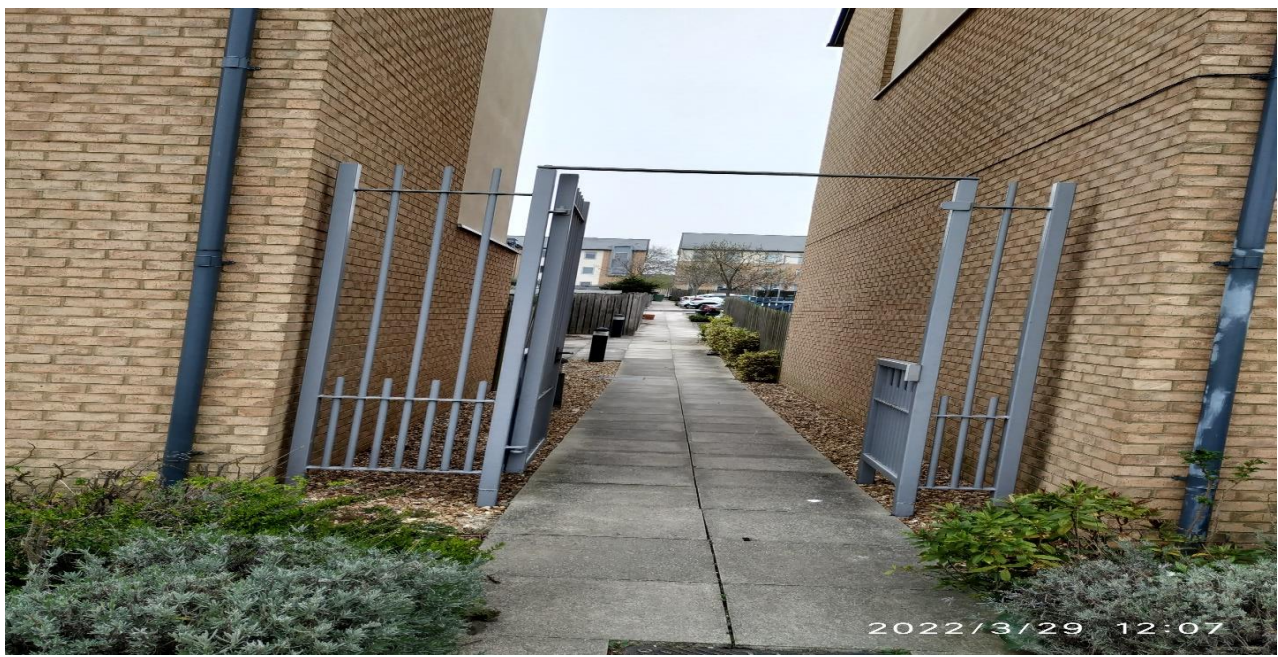
Photo No. 1

5.7	Satisfactory condition/safety of boundary walls/fences	Yes	Note: Fencing to Rear Garden area.	.		
5.8	Artificial lighting (suitable/sufficient/working)	Yes	Note: External area's sufficient lighting and records show on Active "H" maintained daylight inspection deemed acceptable.Side alley way has waist high illumination to rear car park.	.

Note: Passage to carpark with low level lighting.
