Asset ID: 9590 1-40 Shepherdson Court Block 1-40 Shepherdson Court, Middlesbrough

Date of Fire Risk Assessment Date of Next Fire Risk Assessment FRA Frequency (Months) Purpose of Fire Risk Assessment Type of Fire Risk Assessment Fire & Safety Assessor 03 Apr 2025 03 Apr 2026 12 Annual Re-Assessment Type 1 (Common Parts Only - Non Destructive) Kevin Jones GIFireE.Tech IOSH

MIS-AMS ActiveH - Fire Risk Assessment Report

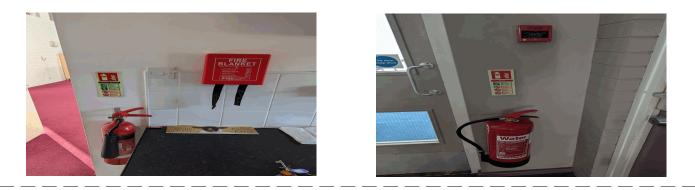
Correcly positioned and signed extinguisher equipment
