## ACCENT HOUSING - FIRE RISK ASSESSMENT

| <b>Scheme Name :</b> | <b>133-139 Black Prince Avenue.</b> |
| <b>Scheme Address :</b> | <b>Market Deeping<br/>#REF!<br/>PE6 8LR</b> |
| <b>Date of Assessment:</b> | <b>30/06/2026</b> |

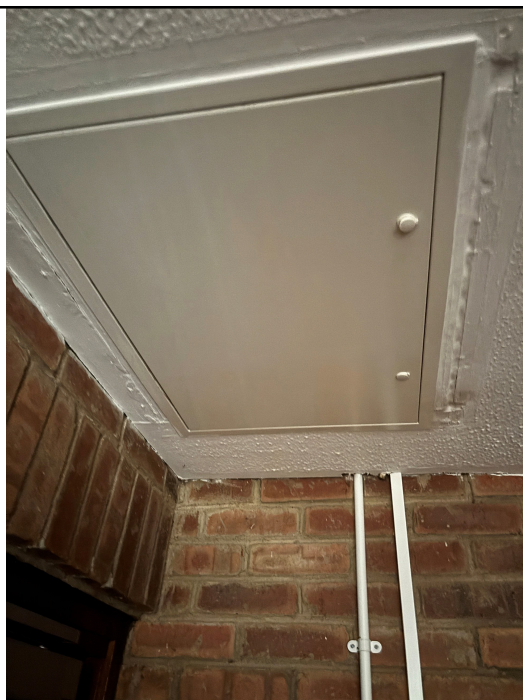
Photo No. 3

Lofy hatch requires updating to conform to the latest standards.

| 11.5 | Loft hatches fire resisting? | Yes | | . | | |

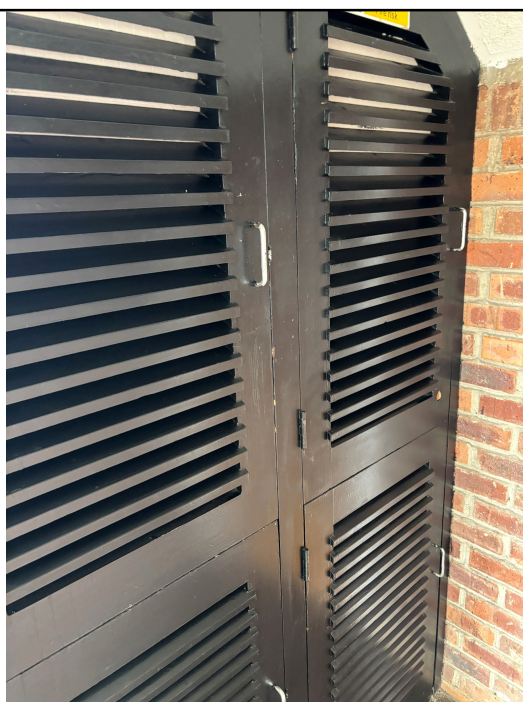
Photo No. 4

Compartmentation survey required in the service cupboard. Job raised

| 7.2 | Are all electrical/intake/service cupboards secure and free from general waste, contractors waste and residents personal items. | No | Personal items were found being stored in the service cupboard. These should be removed to keep the area clear. The cupboard also requires fire stopping. A job has been raised for a survey, with any required remedial works to follow. Job no 1387996 | . | | |

| 11.1 | Is it considered that the compartmentation is of a reasonable standard? | No | See note 7.2 | . | | |

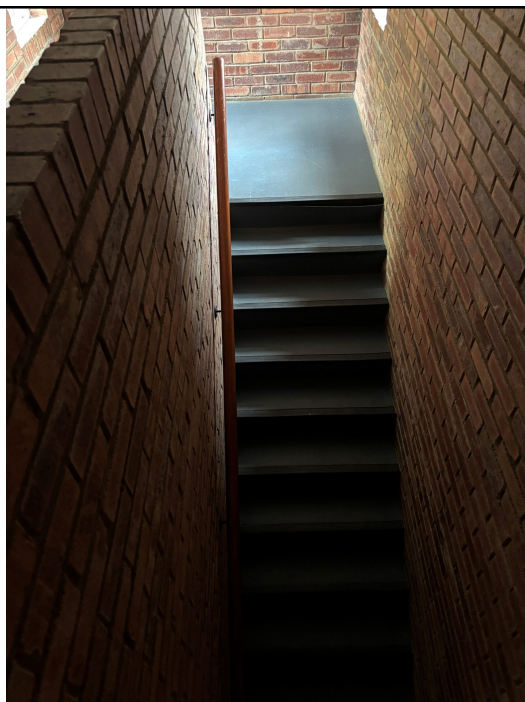
Photo No. 5

All areas were clear at the time of the audit.

| 10.2 | Escape routes unobstructed and safe to use? | Yes | There were no obstructions on the means of escape at the time of inspection. | . | | |

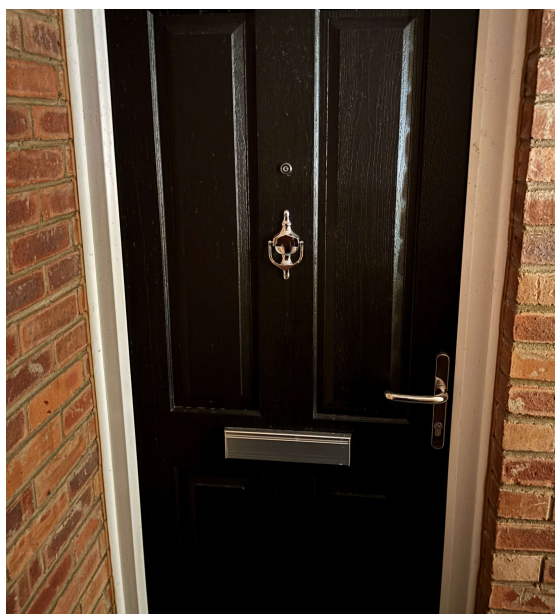
Photo No. 6

All front flat doors were new and in good condition.
