## ACCENT HOUSING - FIRE RISK ASSESSMENT

| <b>Scheme Name :</b> | <b>Maple Croft</b> |
| <b>Scheme Address :</b> | <b>2 - 10 Maple Croft<br/>Leeds<br/>LS17 6AN</b> |
| <b>Date of Assessment:</b> | <b>09/06/2026</b> |

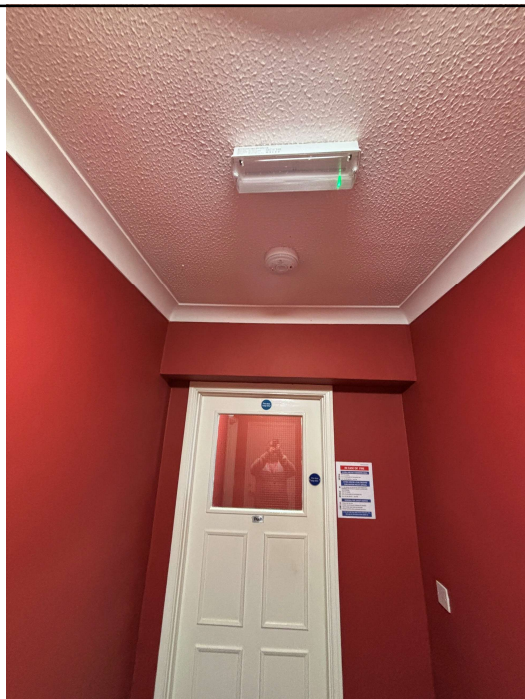
Photo No. 1

| 15.2 | Are all emergency lighting units in good condition and securely fixed to walls/ceilings | Yes | All in good condition at the time of inspection. | . | | |

Emergency lighting and detector

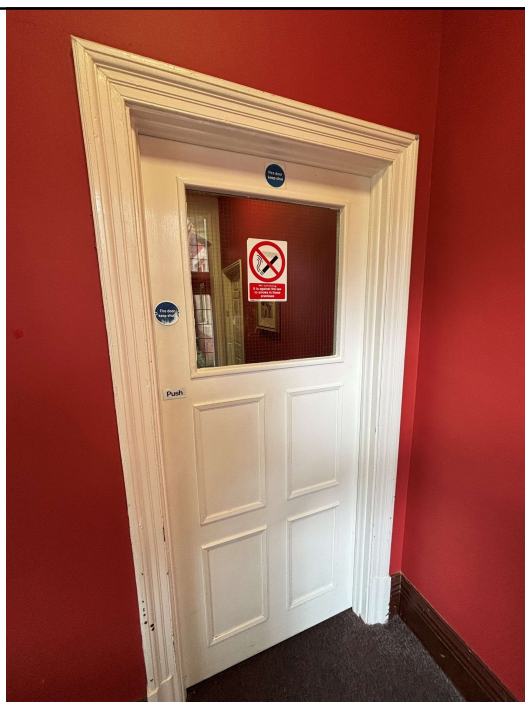
Photo No. 2

| Significant Findings - Fire | | | | | | |
|---|---|---|---|---|---|---|
| 2.1 | Are there any risks associated with smoking in the building? | No | Smoking is not allowed within the communal areas. Smoking is only permitted within flats. There are smoking signs present within the communal areas. | . | | |

No Smoking.

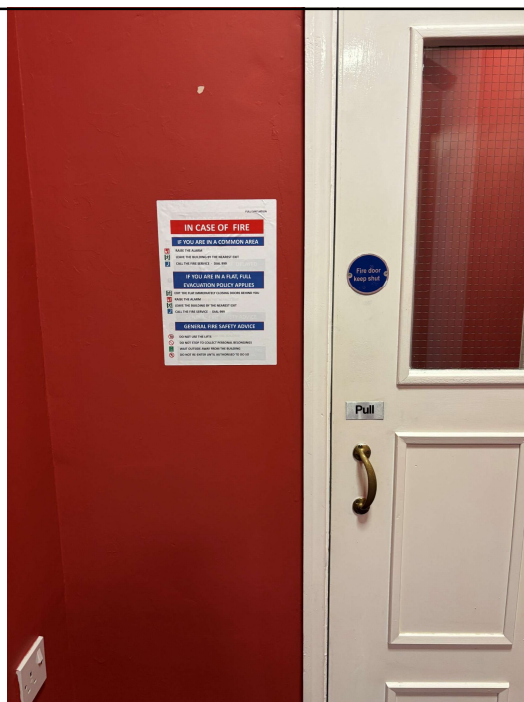
Photo No. 3

| 16.1 | Are the correct Fire Action/Advice notices displayed in prominent locations within the common areas? | Yes | The correct Notices are displayed throughout the scheme. | . | | |

Evacuation notices.

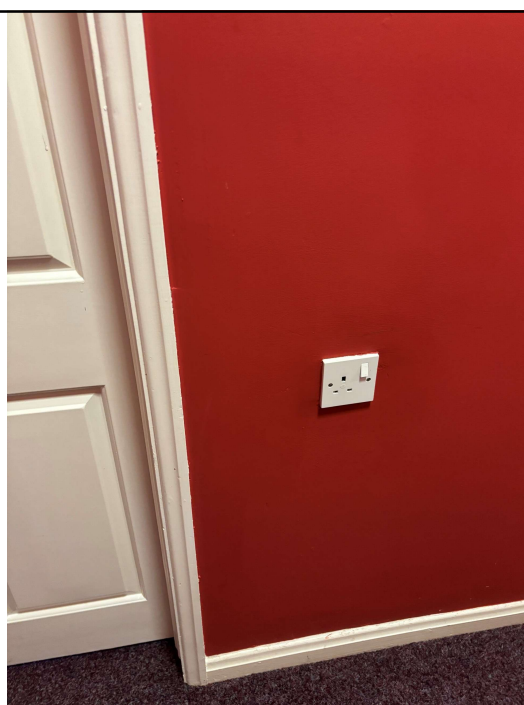
Photo No. 4

| Significant Findings - Fire | | | | | | |
|---|---|---|---|---|---|---|
| 1.1 | Electrical Installation within common areas (Fixed Wiring, sockets, switches, light fittings) in good condition and no obvious damage | Yes | All common area sockets and fittings in a satisfactory condition at the time of inspection | . | | |

Electrical sockets.

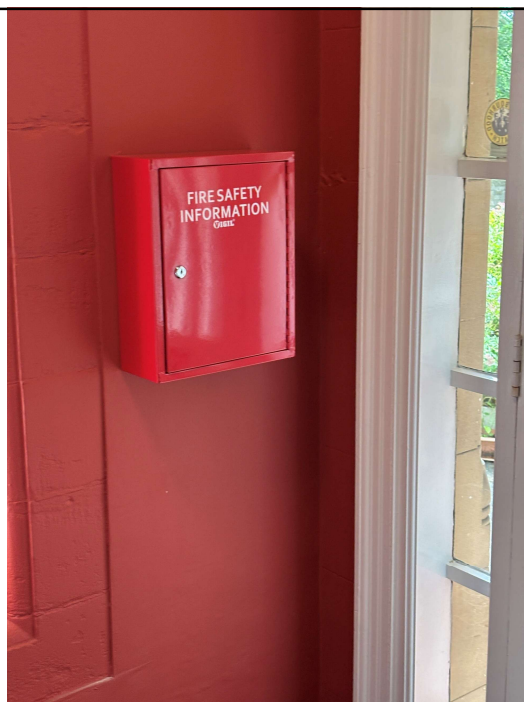
Photo No. 5

Fire information box.

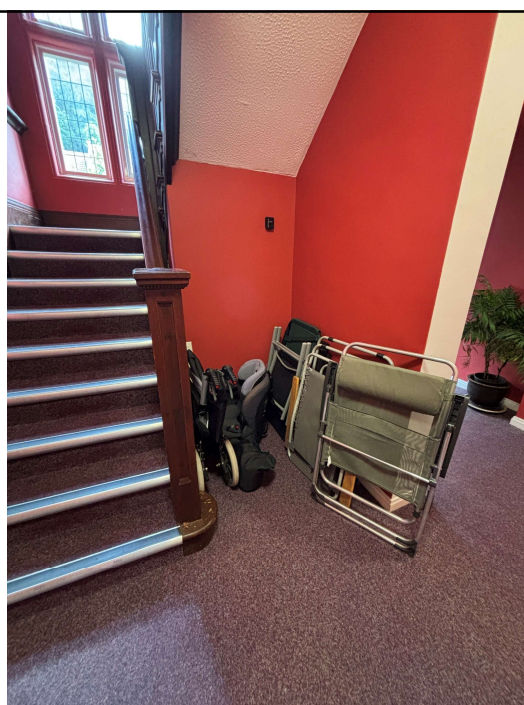
Photo No. 6

| 7.1 | Is the standard of housekeeping adequate? | No | Items were found at the foot of the stairs, Housing Partner informed and dealing. | Low | 25/6/26 | Housing Partner |

| 10.2 | Escape routes unobstructed and safe to use? | No | Some items were found within the escape route. See 7.1 | . | | |

Items in the stairs to be removed.

| Action Plan - Fire | | | | | |
|---|---|---|---|---|---|
| Is the standard of housekeeping adequate? | Items were found at the foot of the stairs, Housing Partner informed and dealing. | Low | 25/06/26 | Housing Partner | |

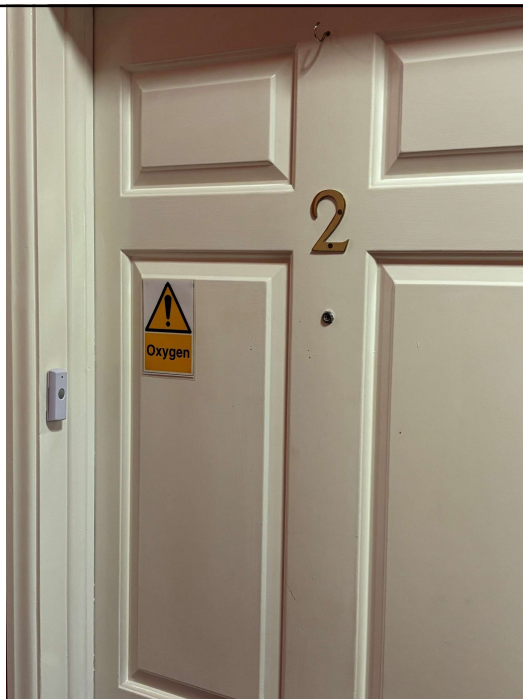
Photo No. 7

| 7.5 | Are hazardous materials stored appropriately (i.e. oxygen cylinders, flammable materials, explosive products, oxidising products, aerosols) | Other | Flat 2 Has Oxygen signage to alert medical Oxygen is in use. | . | | |

oxygen in flat 2

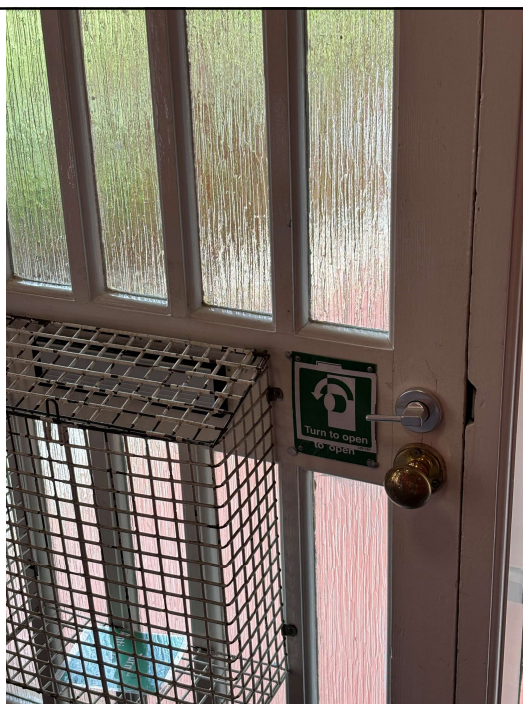
Photo No. 8

| 16.3 | Directional fire escape signage in place and adequate? | Yes | | . | | |

Exit signage.
