# FIRE RISK ASSESSMENT

CJA Property Management Ltd

Burnside House

# Fire Risk Assessment

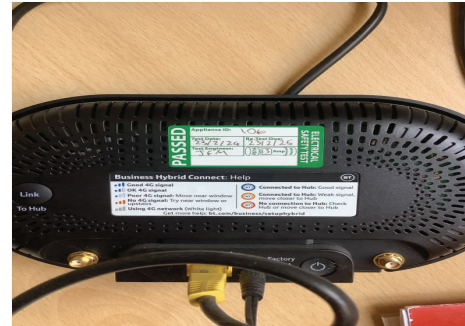
PAT testing Label / Certificate

Portable Appliance Comments: PAT is overdue on all relevant items within communal areas of the premises.

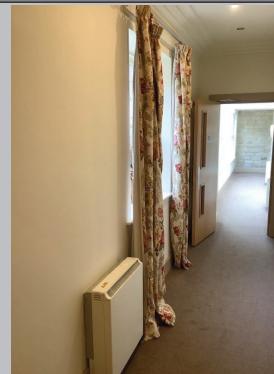
Housekeeping throughout the premises is of a high standard with limited fuel sources throughout the majority of areas. There are curtains hung on all windows along the 1st floor escape corridors. These curtains must meet BS 5867-2:2008 category B standards for flame retardant curtains. There is an area used as a library at the base of the single stairwell, directly outside flat 34. within this area is a large amount of books and a number of chairs and sofa. These items create a large amount of fire loading on the escape route, comprising the stairs and flat 34 ability to exit their apartment. These items must be removed from this area to allow safe use of the stairwell, the ground floor exit route and allow apartment 34 to safely exit their apartment.

| 12 | Curtains are in place on windows along exit corridors throughout the building. Any curtains used along exit corridors must meet BS5867-2:2008 combustibility standards.<br>If curtains do not meet these standards they are to be replaced with compliant curtains to reduce the potential for fire spread in this area. | MEDIUM | 28 Feb 2026 | LOW | |

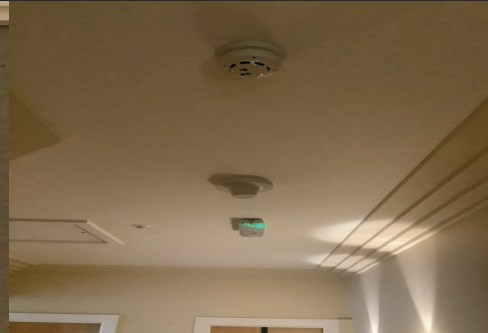
2.Emergency lighting and detection within communal areas of the corridors

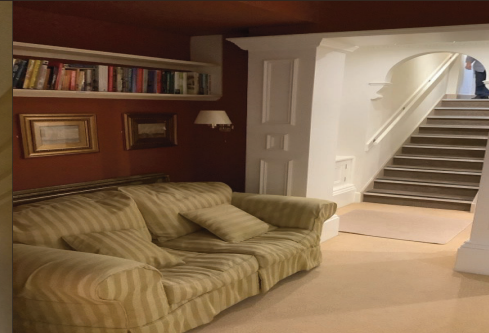
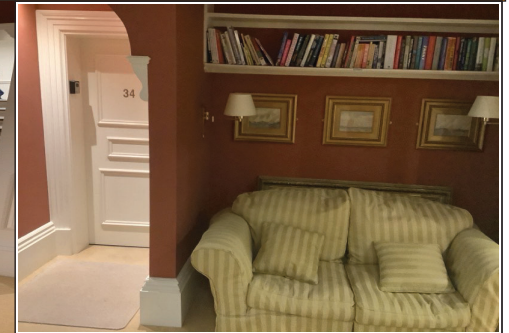
There is an area used as a library at the base of the single stairwell, directly outside flat 34. within this area is a large amount of books and a number of chairs and sofa. These items create a large amount of fire loading on the escape route, comprising the stairs and flat 34 residents ability to exit their apartment.

3.combustible items stored at base of stairwell and outside apartment 34

4.combustible items stored at base of stairwell and outside apartment 34

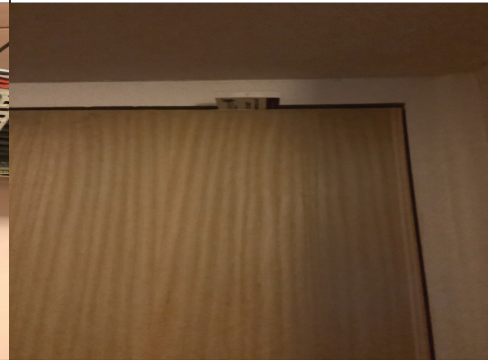
6.Flat26 has excessive gap at top of door. Reduce to 3mm

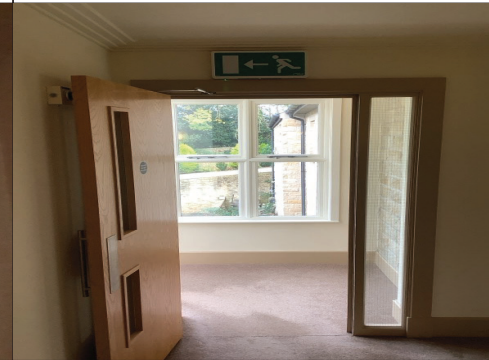
7.Direction exit sign pointing away from closest fire exit point on 1st floor

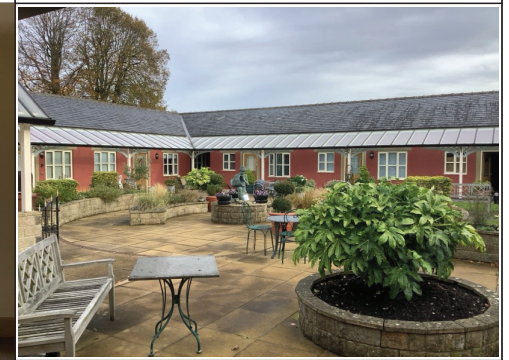
8.Outdoor courtyard from 1st floor exit. 2 exit points from courtyard available

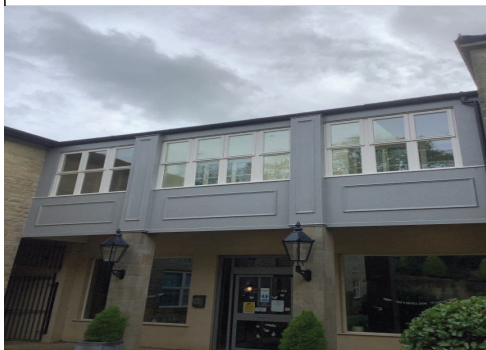
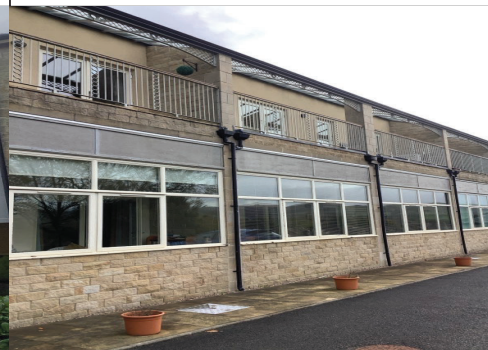
9.Unconfirmed cladding requires investigation to combustibility

10.Unconfirmed cladding requires investigation to combustibility

| # | Action to be completed | Risk Rating | Target Completion Date | Residual Risk After Completion | Comments | |
|---|---|---|---|---|---|--|
| 2 | There are unconfirmed cladding materials on a number of external walls. These materials and how they are fixed to the building require an external wall survey to assess their combustibility and the potential for their replacement if required.<br>The survey should be carried out by a qualified and competent person. | HIGH | 31/012/2025 | LOW | | |

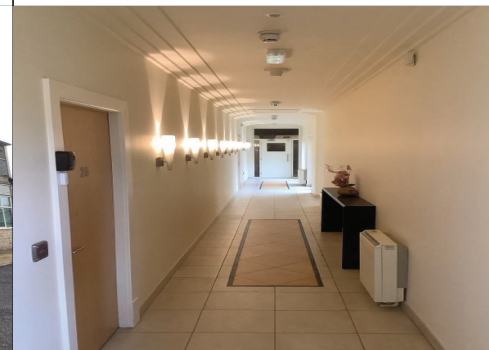
11.Direction exit signage required on corridor at Apt 26

| Is the fire safety signage adequate and compliant with BS ISO 7010 & BS5499 standards ? | No (see comments) | Comments: Directional exit signage is required on the ground floor exit corridor near to apt 26.<br>Directional exit Signage on the 1st floor corridor requires changing to point evacuation persons towards the 1st floor final exit door. It currently directs persons back towards the exit stairwell, increasing travel distances considerably. The 1st floor final exit is roughly 5 metres from the sign.<br>There is emergency lighting along all exit routes, at final exits and externally where required. There are large amounts of natural lighting throughout the premises. |

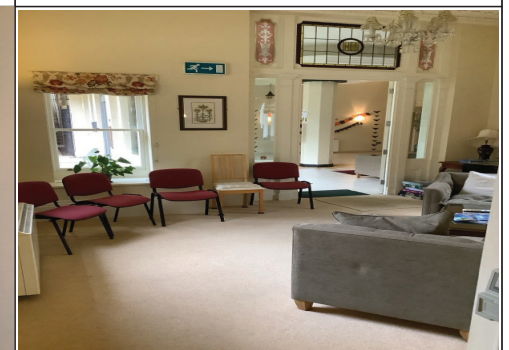
12.Ground floor communal lounge. Low risk room and clearly signed exit point with exit route kept clear
