## **ACCENT HOUSING - FIRE RISK ASSESSMENT**

| <b>Scheme Name :</b> | <b>Stafford House</b> |
| <b>Scheme Address :</b> | <b>1-50 Station Road<br/>Aldershot. Hampshire.<br/>GU11 1BA</b> |
| <b>Date of Assessment:</b> | <b>05/12/2025</b> |

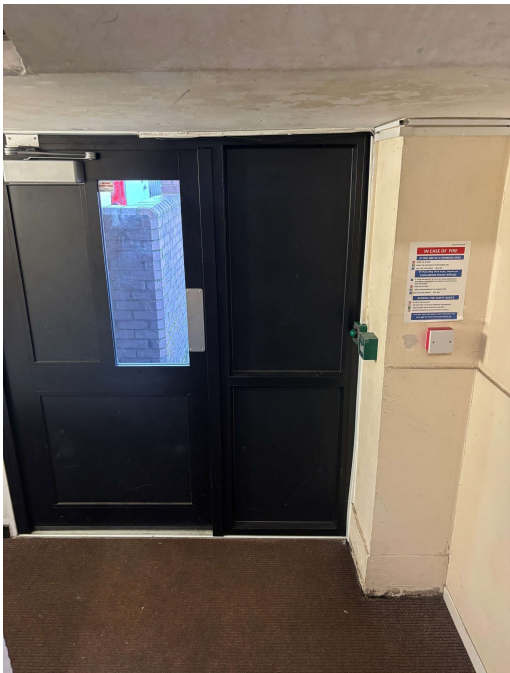
Photo No. 1

Evacuation Policy Posted throughout the building.

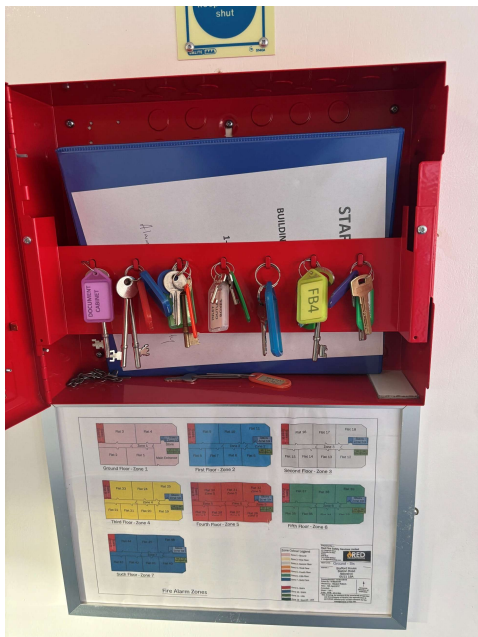
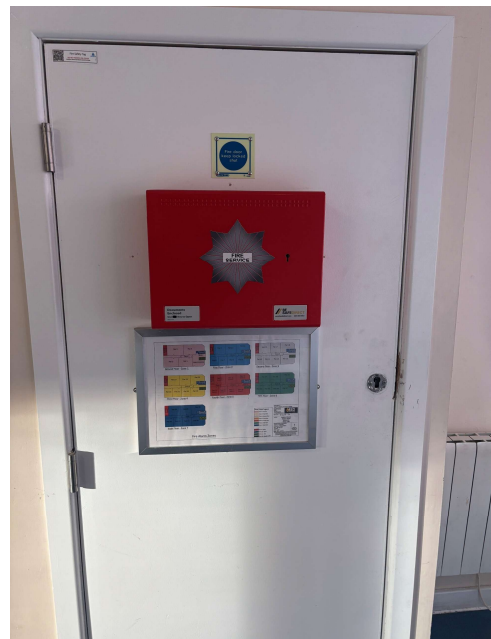
Photo No. 2

Fire Information box containing Plans and keys for the building.

| 12.1 | Communal fire doors to FD30s standard and in a serviceable condition, | Yes | However the PIB and Zone plan should not have been screwed into the fire door to the fire panel. This door is due to be replaced under programmed works in 2026. All Communal fire doors are subject to a Quartey check. These have QR codes fitted for information | . | | |

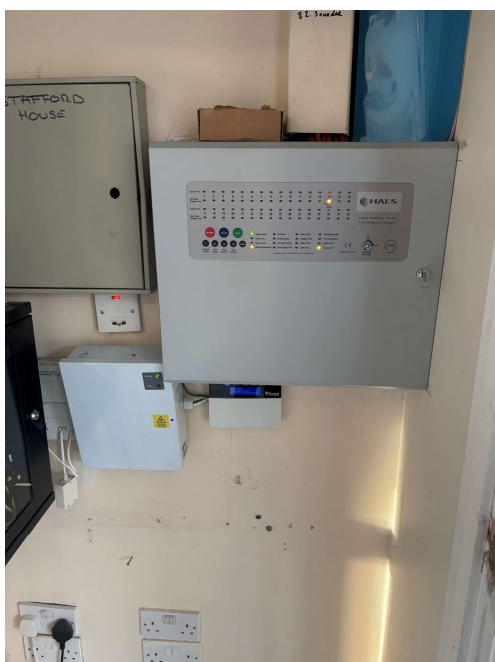
Photo No. 3

Fire alarm tested weekly and logged by the Tunstall engineer.

| 17.3 | Is the fire detection and warning system maintained/tested and all certificates saved on file. (BS 5839-1:2017) | Yes | Weekly test by Tunstall engineers. There is a fault showing on zone 14 the engineer informs us that this is due to a dead end into the fire panel and <u>does not form any part of the fire alarm system</u> . | . | | |

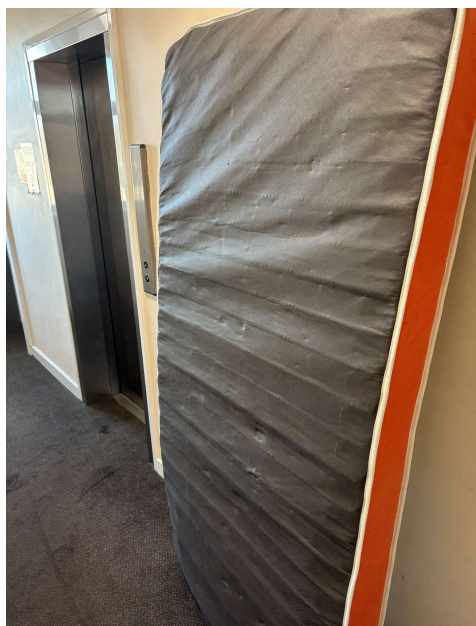
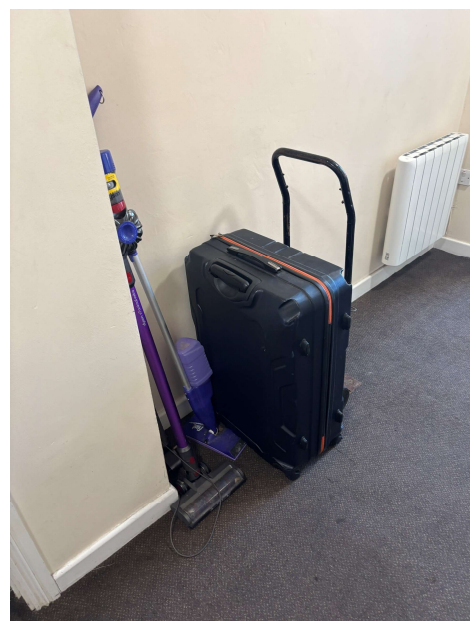
Photo No. 4

| 7.1 | Is the standard of housekeeping adequate? | No | Some fly tipping on the 2nd and 4th floors a job had already been raised for clearance by the HP. | . | |
| 7.3 | Are combustible materials separated from ignition sources and stored appropriately? | No | Fly tipping was found on Floors 2 and 4 in addition items were left on the fire alarm panel. | . | |

| 10.2 | Escape routes unobstructed and safe to use? | No | Some fly tipping on the 2nd and 4th floors a job had already been raised for clearance by the HP. | . | | |

Fly tipping on Floor 4 This was removed at the time of the audit.HP Dealin

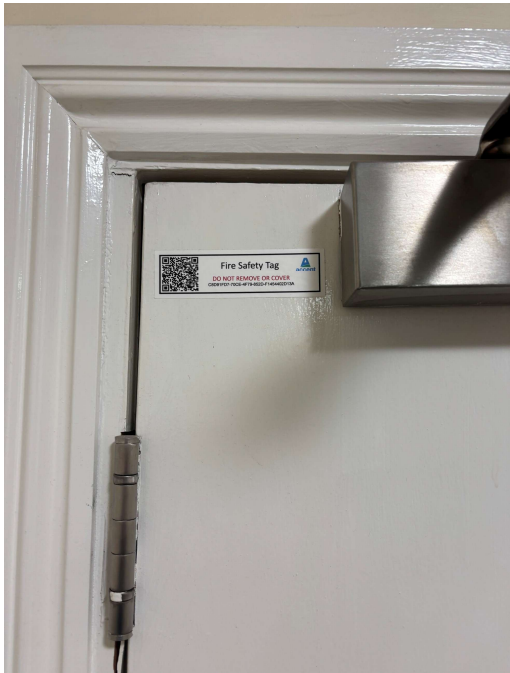
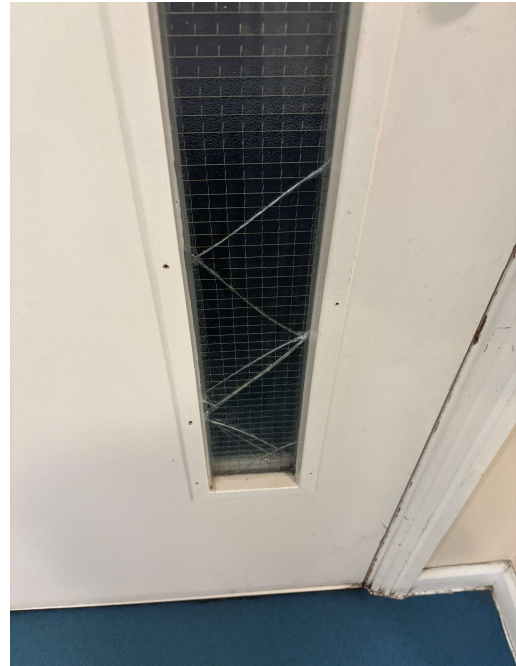
Photo No. 5

All communal fire doors are tested quarterly and have a QR details. Any findings are raised to the contractor.

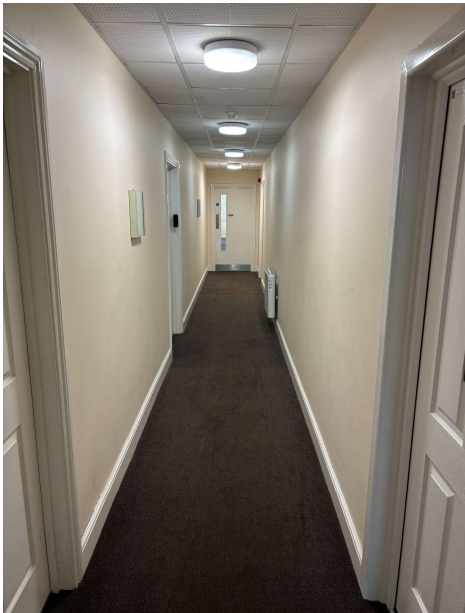
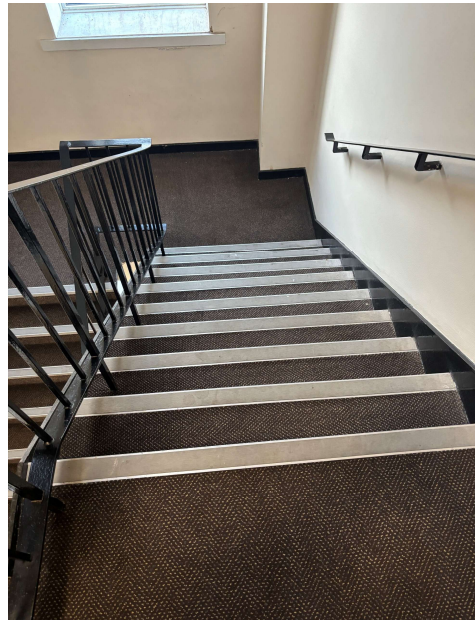
Photo No. 6

All areas were clear at the time of the audit.

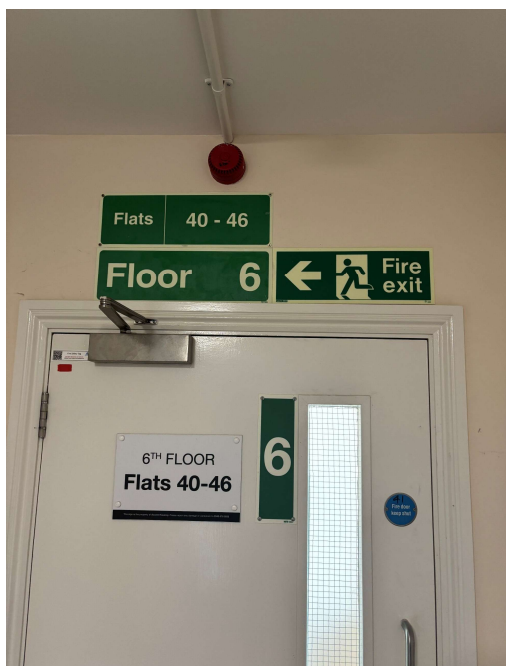
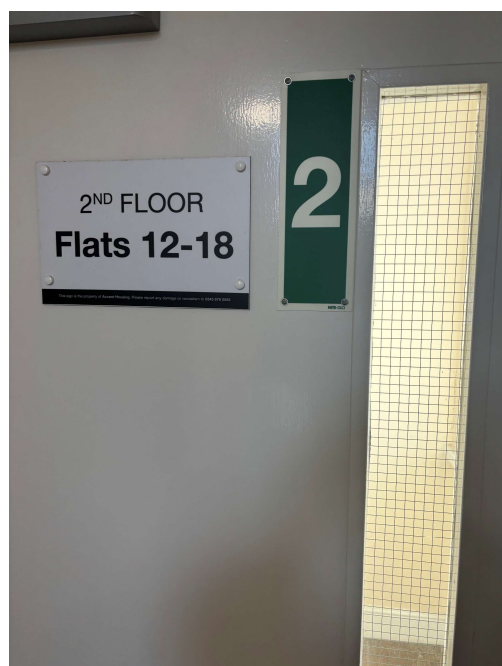
Photo No. 7

Satisfactory singage throughout the building.

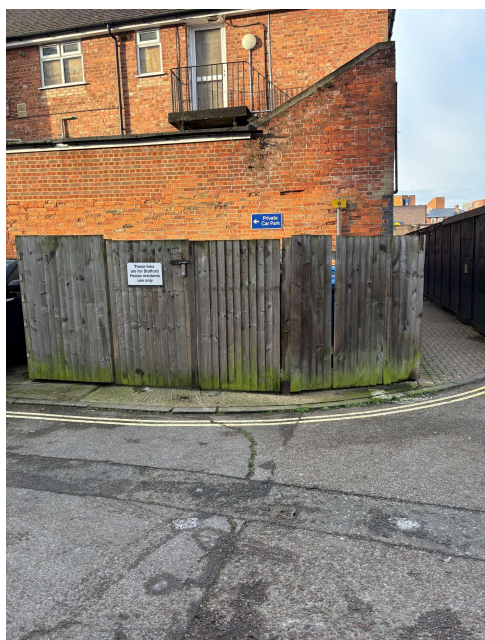
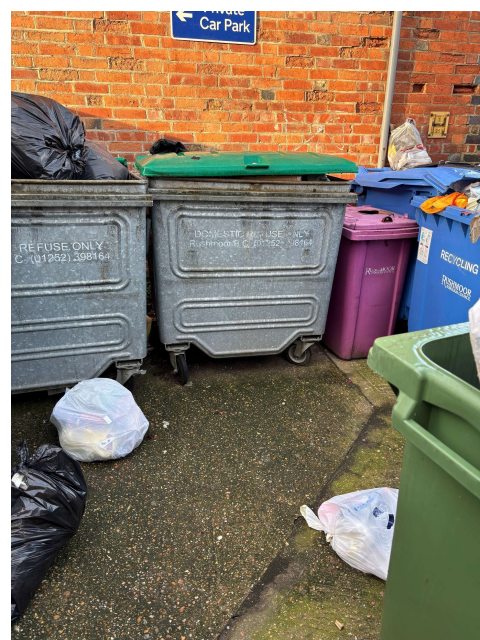
Photo No. 8

| 7.4 | Are unnecessary accumulations of combustible materials or waste avoided? | Yes | However a new location needs to be considered for the bin store as it is close to a means of escape to the building at the rear of the address. This building is no longer in use and is | . | |

A new location is required for the bin store as it is close to a means of esc

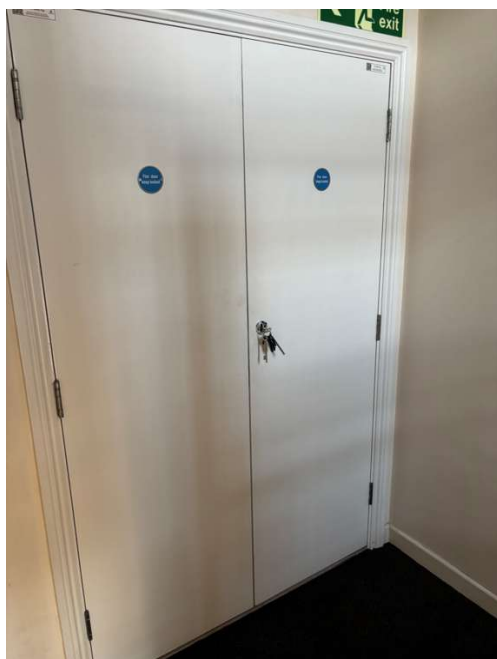
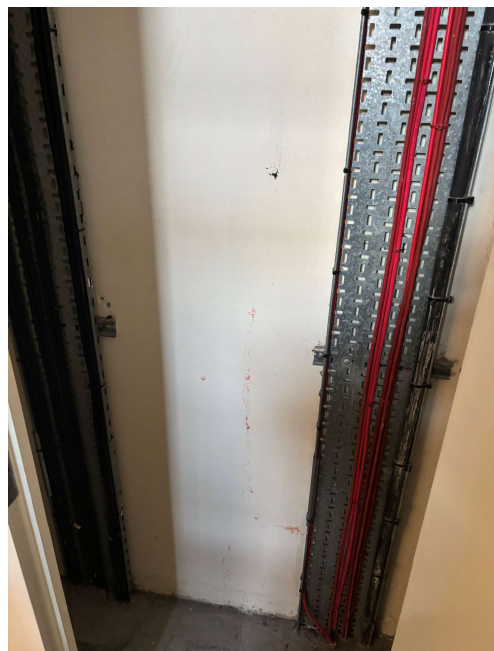
Photo No. 9

| 7.2 | Are all electrical/intake/service cupboards secure and free from general waste, contractors waste and residents personal items. | No | Some equipment was found being stored in the main entrance electrical cupboard. These were removed during the audit. | | |

All electrical cupboards were clear at the time of the audit.

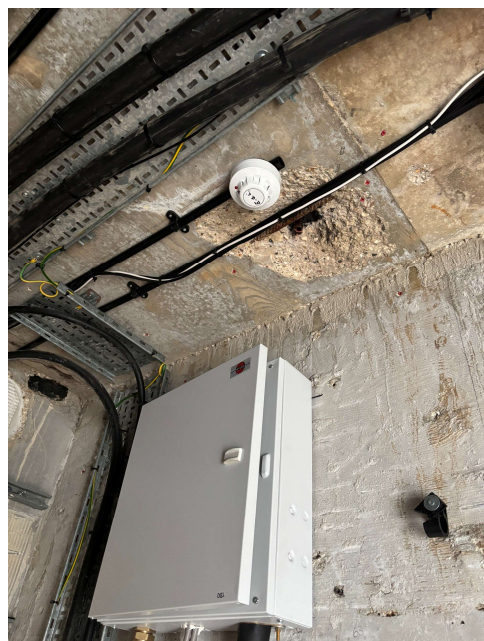
Photo No. 10

Compartmentation work recently been carried out throughout the
