Fire Risk Assessment Report

Asset ID: 5965 **Hunt Court Flanshaw Lane, Wakefield**

Date of Fire Risk Assessment	08 Apr 2025
Date of Next Fire Risk Assessment	08 Apr 2026
FRA Frequency (Months)	12
Purpose of Fire Risk Assessment	Annual Re-Assessment
Type of Fire Risk Assessment	Type 1 (Common Parts Only - Non Destructive)
Fire & Safety Assessor	Steven Manners Tech IOSH MIFSM MFPA, Steven Manners

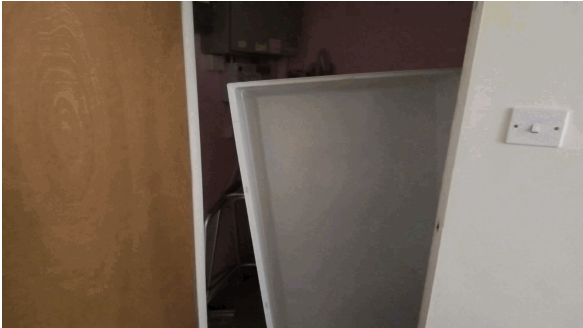
Observation	Priority	Referred To	Required By:	Task ID
Combustible items in cleaner store first floor next to visitors flat	Internal - Low	Independent Living Coordinator	01/07/2025	1960825

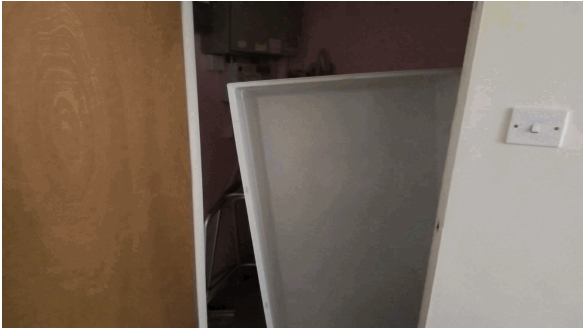
Observation	Priority	Referred To	Required By:	Task ID
Combustible items in cleaner store first floor next to visitors flat	Internal - Low	Independent Living Coordinator	29/04/2025	1960825

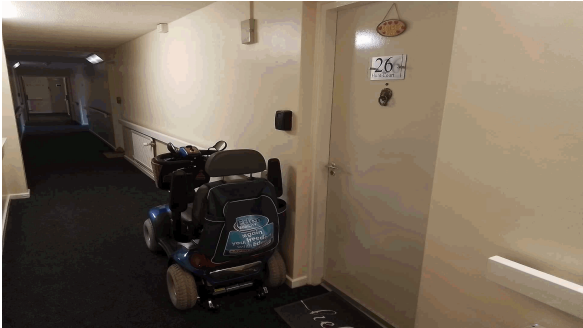
Comment	2 mobility scooters were found in the corridors outside flats, see observations. SHP informed and dealing.
Is there a purpose built mobility scooter store/charging area?	No
Comment	Residents are informed they must keep the scooters in their flats at all times.
Does the building have a lightning protection system?	No

Observation	Priority	Referred To	Required By:	Task ID
Mobility scooter in corridor outside flat No 6 needs to be stored in flat	Internal - High	Independent Living Coordinator

2 mobility scooters were found in the corridors, SHP deasing.

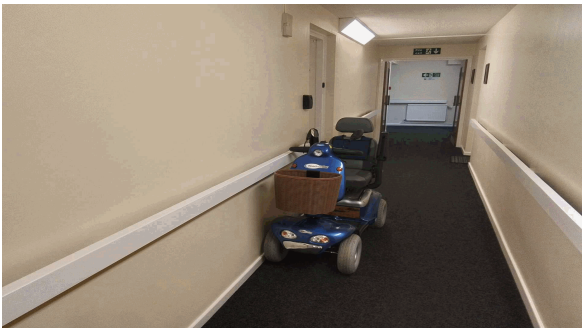
Observation	Priority	Referred To	Required By:	Task ID
mobility scooter outside flat 26	Internal - High	Independent Living Coordinator

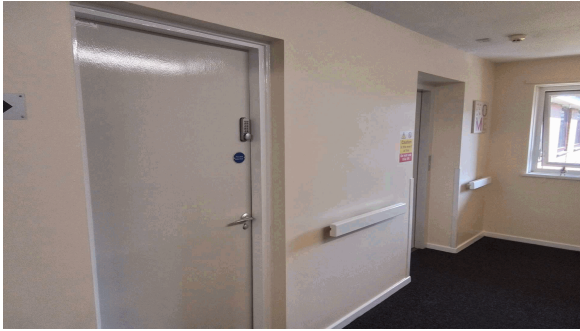
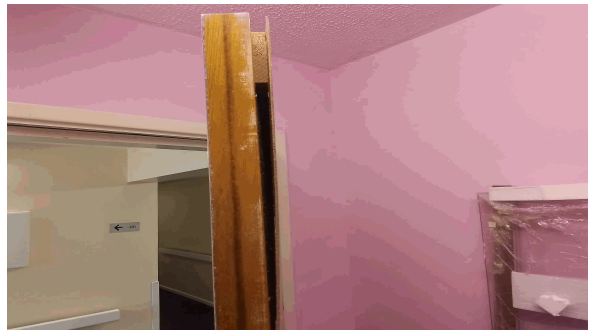
Observation	Priority	Referred To	Required By:	Task ID
Door to store adjacent to lift on first floor needs replacing with FD30 including digital lock code 1985 WO 1273126	Repair - Non Emergency	Project Manager (Building Safety)	01/07/2025	1960825

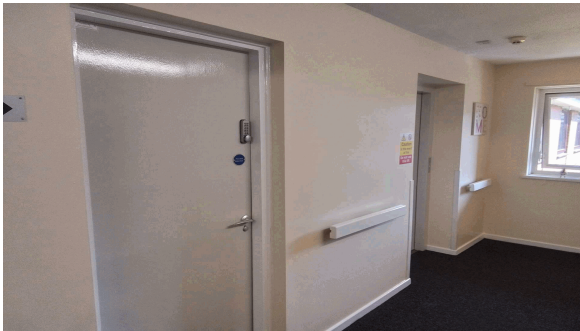
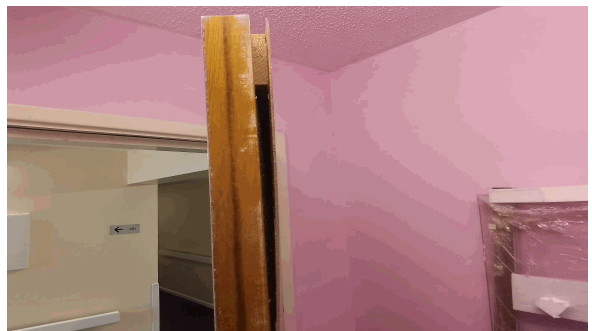
Observation	Priority	Referred To	Required By:	Task ID
Door to store adjacent to lift on first floor needs replacing with FD30 including digital lock code 1985 WO 1273126	Repair - Non Emergency	Project Manager (Building Safety)	29/04/2025	1960825

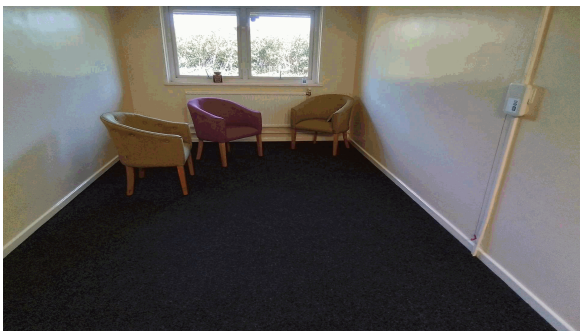
Observation	Priority	Referred To	Required By:	Task ID
Furniture in the communal area on first floor. Question fire retardant. No labels.	Internal - Low

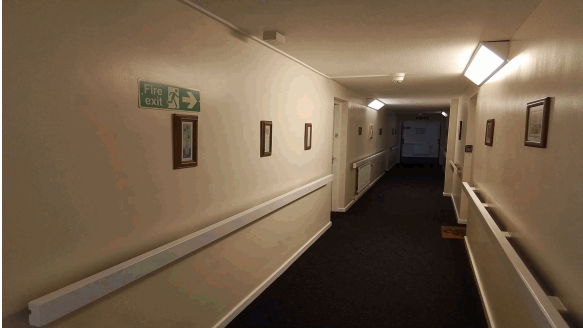
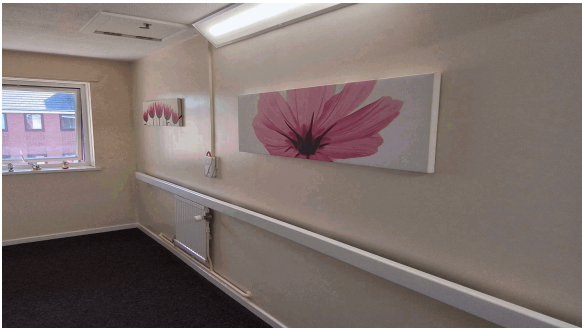
Several pictures were present on the escape route, some were canvas, the SHP has been informed. the pictures are held with a velcro pad. if pictures are to be displayed they need to be screwed to the wall. Canvas pictures are not allowed.

Observation	Priority	Referred To	Required By:	Task ID
Pictures on the walls flats 8 to 15 need to be screwed to walls, the ones not behind glass need removing.	Internal - Medium	Independent Living Coordinator

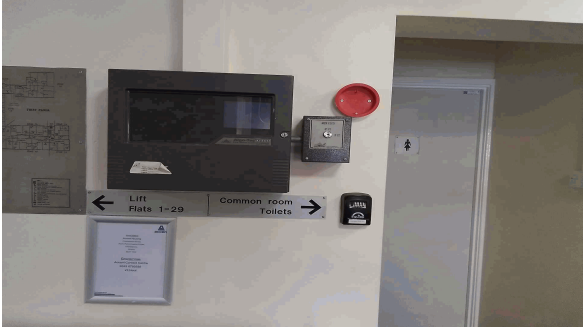
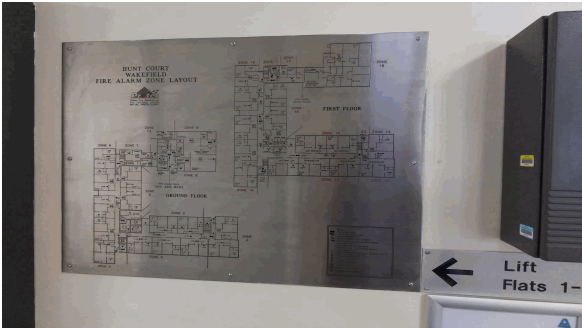
Observation	Priority	Referred To	Required By:	Task ID
fire panel and z9ne ppan

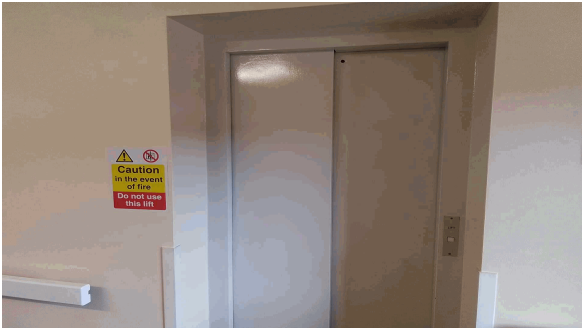
Observation	Priority	Referred To	Required By:	Task ID
lift notice.
