## **ACCENT HOUSING - FIRE RISK ASSESSMENT**

| <b>Scheme Name :</b> | <b>Nelson Street</b> |
| <b>Scheme Address :</b> | <b>4 Nelson Street<br/>Dewsbury<br/>WF13 1NA</b> |
| <b>Date of Assessment:</b> | <b>01/06/2026</b> |

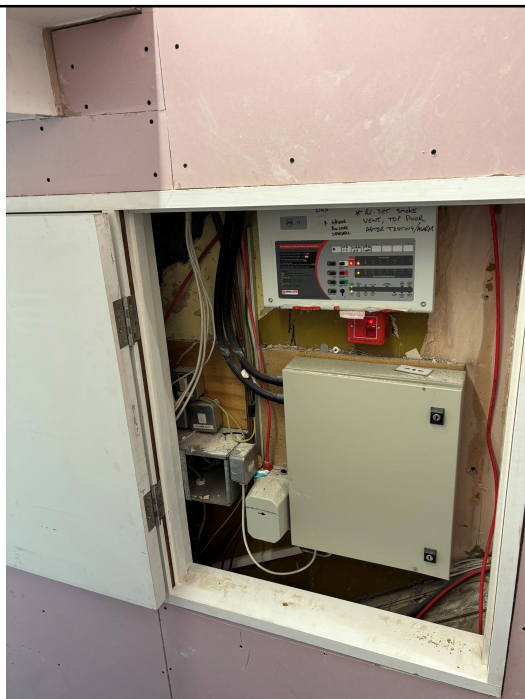
Photo No. 1

Fire panel within new 1 hour fire doors, missing seals to be fitted with door furniture this week. boarding also required to be taped and skimmed across joints to ensure it provides an adequate fire barrier

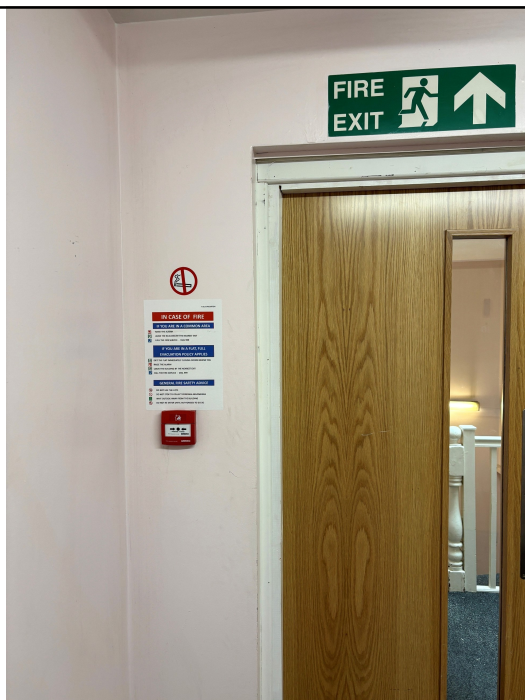
Photo No. 2

Fire Call point, evacuation notices. No Smoking and fire exit Signage.

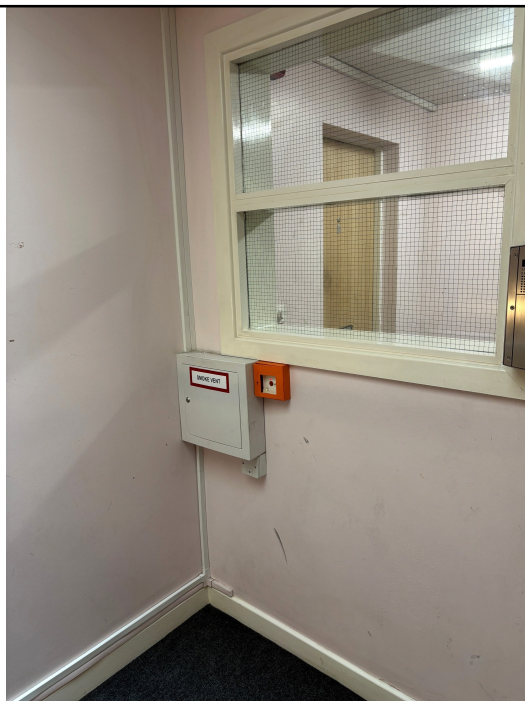
Photo No. 3

AOV Control panel on third floor

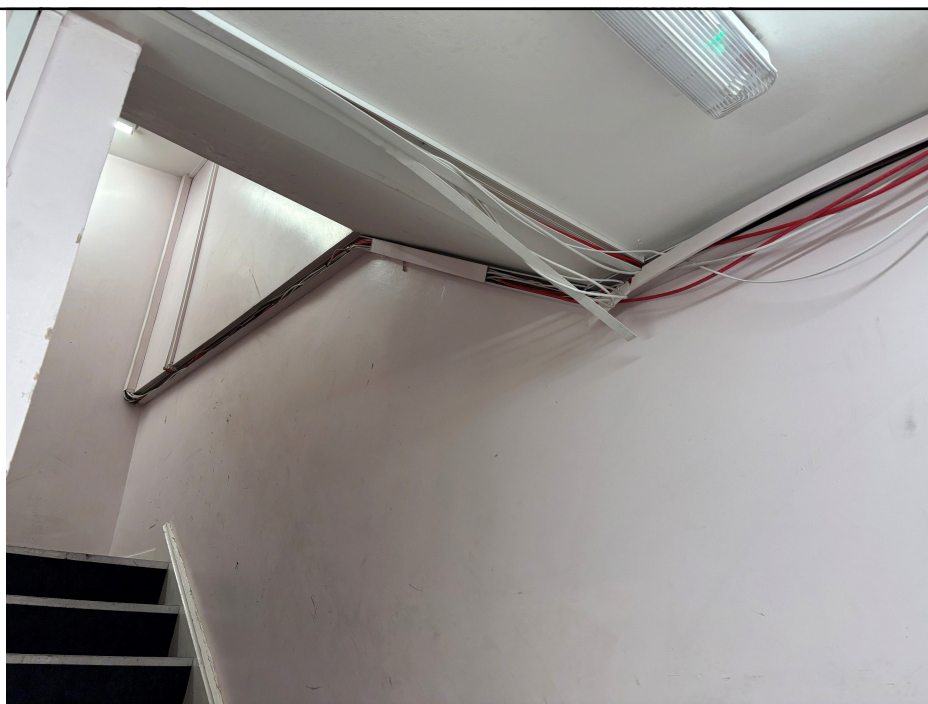
Photo No. 4

| Significant Findings - Fire | | | | | | |
|---|---|---|---|---|---|---|
| 1.1 | Electrical Installation within common areas (Fixed Wiring, sockets, switches, light fittings) in good condition and no obvious damage | No | cables hanging down from ceiling due to missing and damaged conduit. Replace conduit and fasten cable with metal fixings. Awaiting quote. | Med | 31/7/26 | Building Safety Project manager |

| 10.2 | Escape routes unobstructed and safe to use? | No | Conduit lids were missing throughout the building and some cables had come out and were hanging loose which could be dangerous within a fire situation. Cables are required to be fastened with metal fixings. Awaiting quote. | Med | 31/7/26 | Building Safety Project manager |

Cables hanging from ceiling trunking. To be fastened with metal fixings.

| Action Plan - Fire | | | | | |
|---|---|---|---|---|---|
| Electrical Installation within common areas (Fixed Wiring, sockets, switches, light fittings) - any signs of obvious damage | cables hanging down from ceiling due to missing and damaged conduit. Replace conduit and fasten cable with metal fixings. Awaiting quote. | Med | 31/07/26 | Building Safety Project manager | |

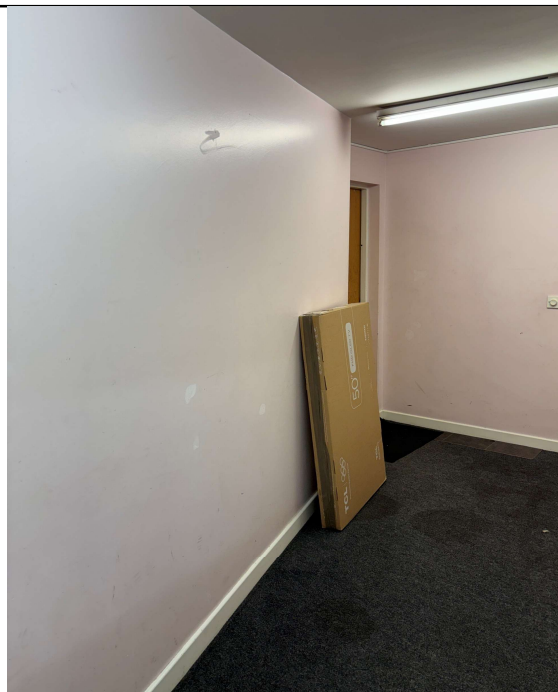
| 7.1 | Is the standard of housekeeping adequate? | No | Ther were items within the lobby area on the first floor and items within the lobby on the third floor. Items ere found in the stairs outside flats on the third floor. Housing partner has been informed. | Low | 1/7/26 | Housing Partner |

Items in lobby of flats 1 to 4 to be removed.

| Action Plan - Fire | | | | | |
|---|---|---|---|---|---|
| Is the standard of housekeeping adequate? | Ther were items within the lobby area on the first floor and items within the lobby on the third floor. Items ere found in the stairs outside flats on the third floor. Housing partner has been informed. | Low | 01/07/26 | Housing Partner | |

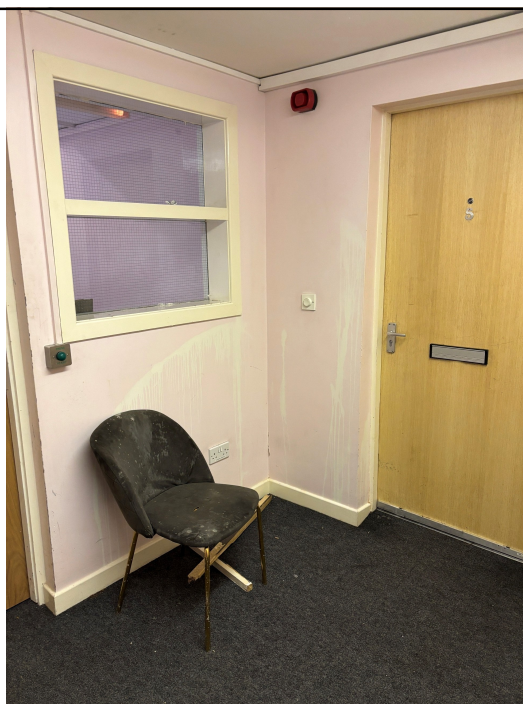
Photo No. 6

Items in lobby outside flat 5 to be removed.

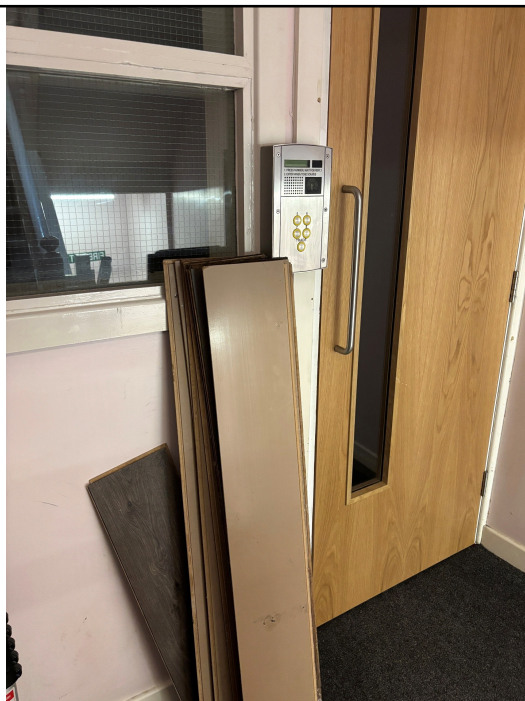
Photo No. 7

| 10.3 | Exits easily and immediately openable where necessary, without a key? | Yes | There were no obstructions on the means of escape at the time of inspection. Some items were found within the stairs but do not cause an obstruction. The items are to be removed as per 7.1 | . | | |

Items in stairs outside lobby of flats 5 to 8

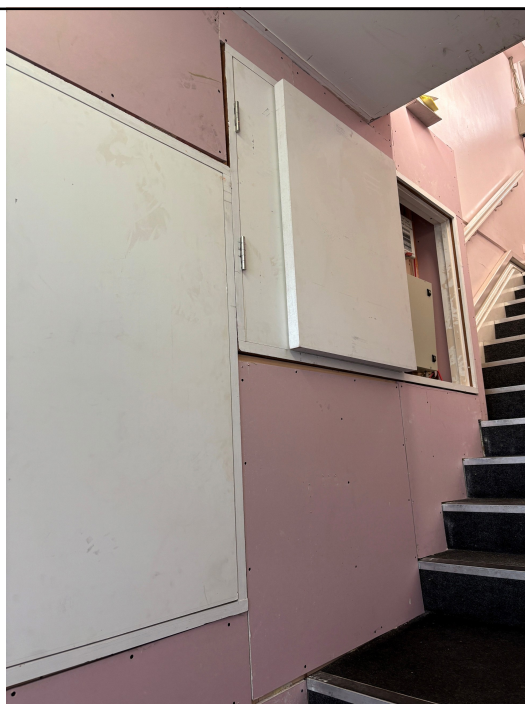
Photo No. 8

| 7.2 | Are all electrical/intake/service cupboards secure and free from general waste, contractors waste and residents personal items. | Other | Electric cupboard doors are being replaced, the work is due to be completed this week. Smoke seals still to be fitted and walls to be skimmed, break glass and exit button have been fastened to plasterboard temporarily until the work is complete. | . | | |

1 hour fire doors to protect electric meters, work to be completed Wednesday this week.

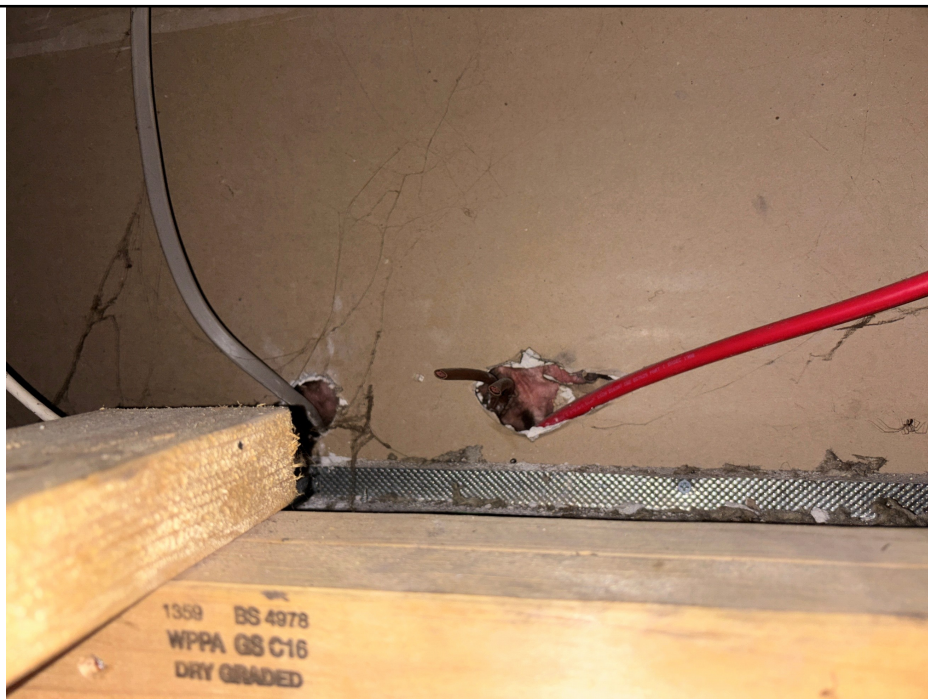
Photo No. 9

| 11.4 | Compartmentation within roof spaces of a satisfactory standard? | No | Some penetrations were found within the roof space on the top floor. WO 1380834 | Low | 31/7/26 | Building Safety Project manager |

Fire stopping required within the loft space on top floor.

| Action Plan - Fire | | | | | |
|---|---|---|---|---|---|
| Compartmentation within roof spaces of a satisfactory standard? | Some penetrations were found within the roof space on the top floor. WO 1380834 | Low | 31/07/26 | Building Safety Project | |

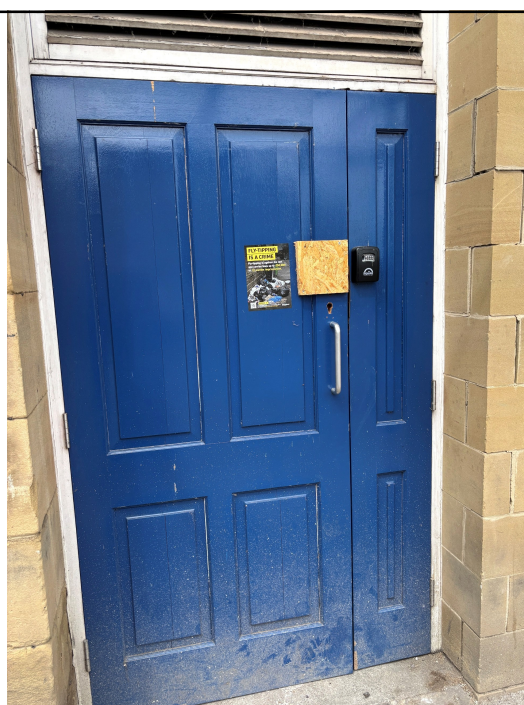
Photo No. 10

External bin store. No access, unknown code

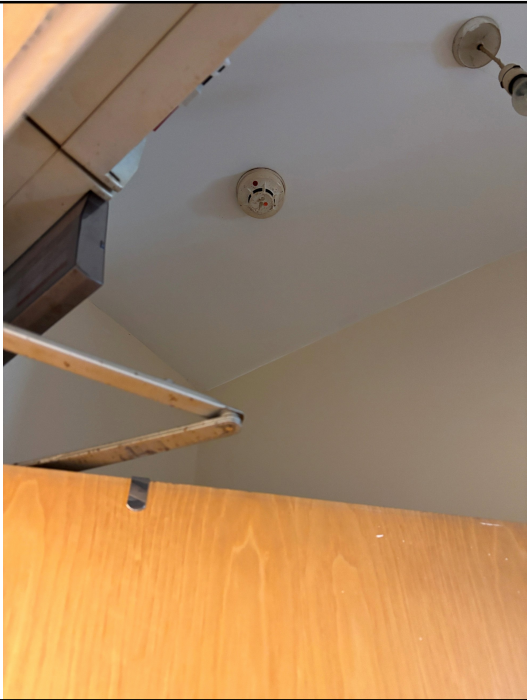
| Photo No. 11 | Heat detector in hallway of flats. |
