## ACCENT HOUSING - FIRE RISK ASSESSMENT

<b>Region :</b>	<b>East</b>
<b>Scheme Name :</b>	<b>Townsend Close/Thurston House</b>
<b>Scheme Address :</b>	<b>Lincoln Road Peterborough PE1 2SQ</b>
<b>Date of Assessment:</b>	<b>27/11/2023</b>
<b>Date of Next Assessment:</b>	<b>26/11/2026</b>
<b>FRA Frequency:</b>	<b>3 Year Re-Assessment</b>
<b>Fire &amp; Safety Assessor</b>	<b>Lynn Betteridge</b>

This Fire Risk Assessment has been conducted upon the instruction of Accent Housing.

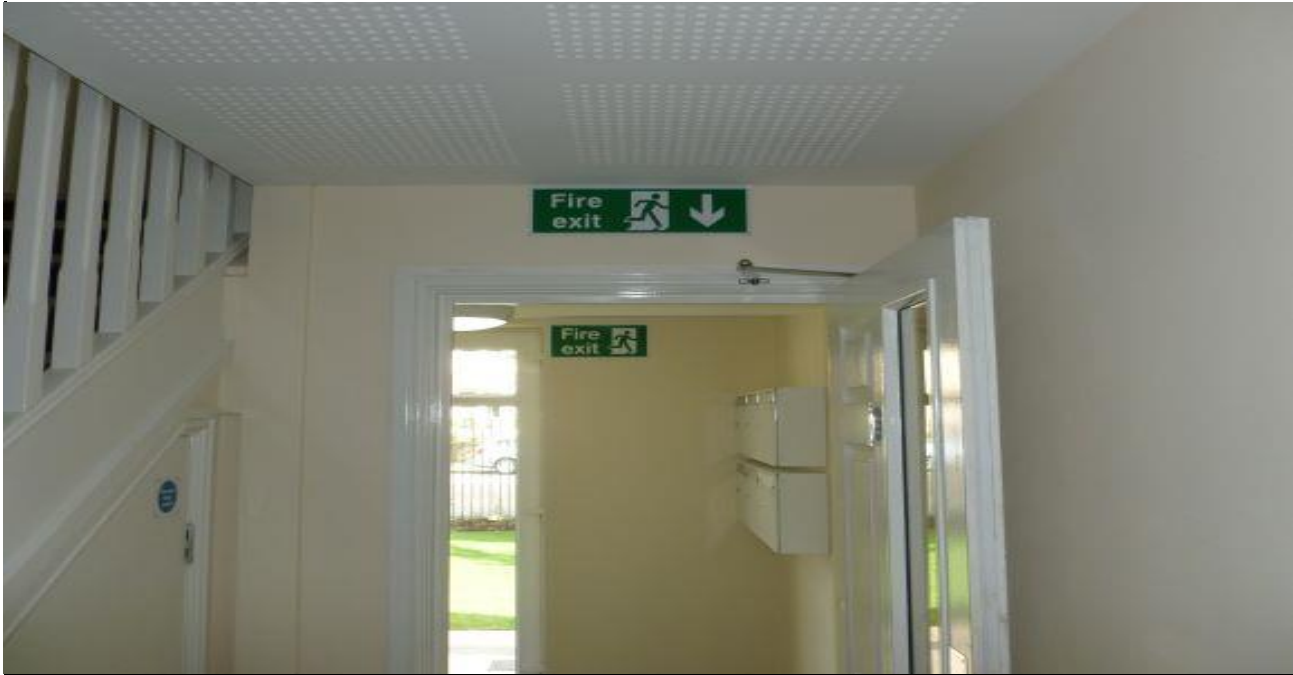
Photo No. 1

Note: Main access and Egress via Communal Door.

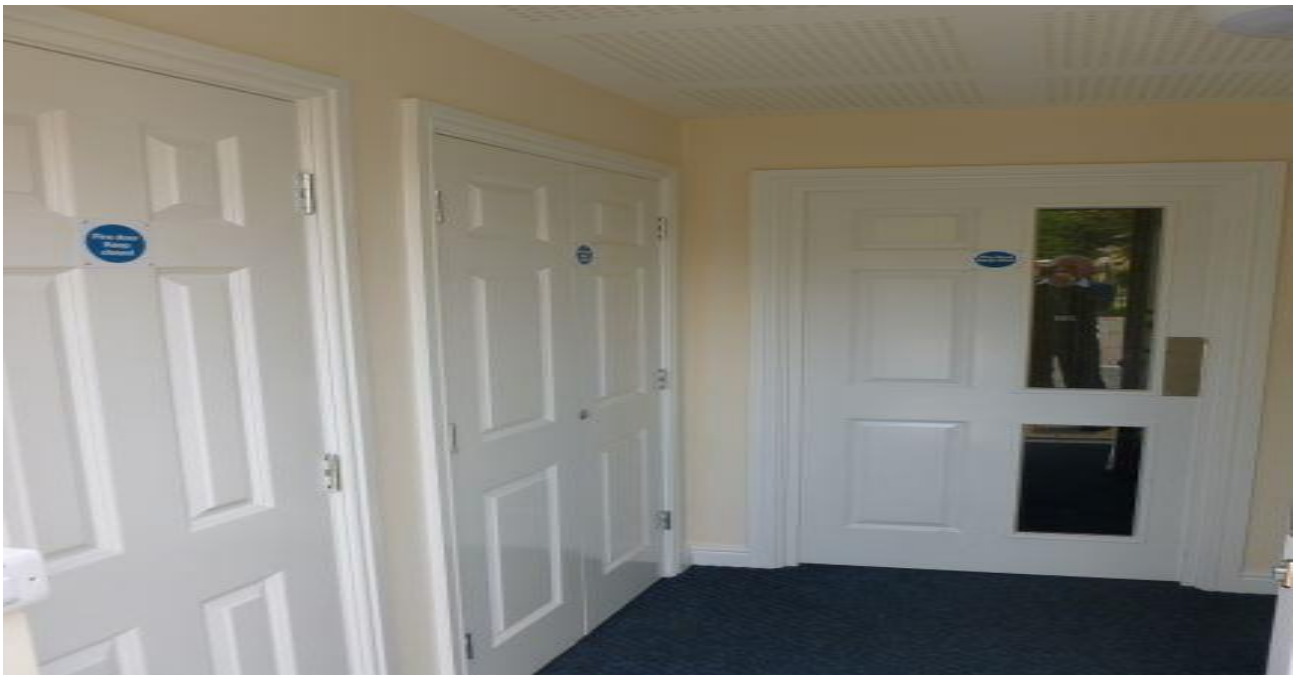
Photo No. 2

Note: Communal Area.

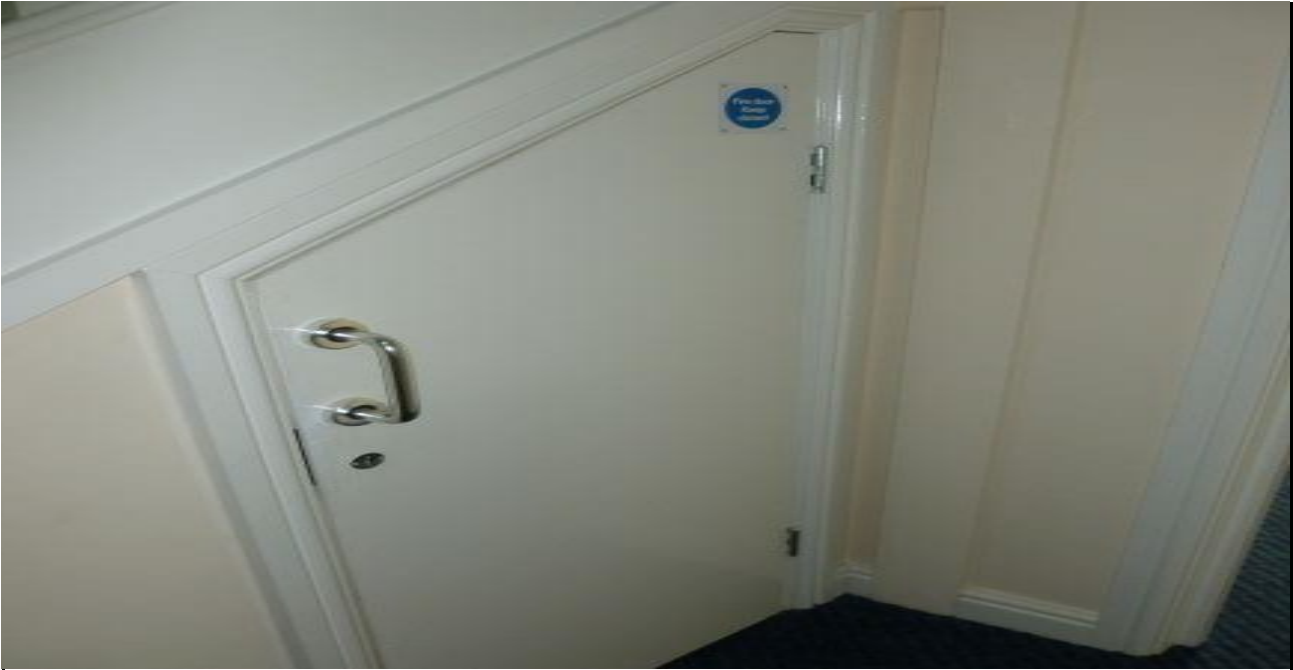
Photo No. 3

Note: Understair compartmentation.

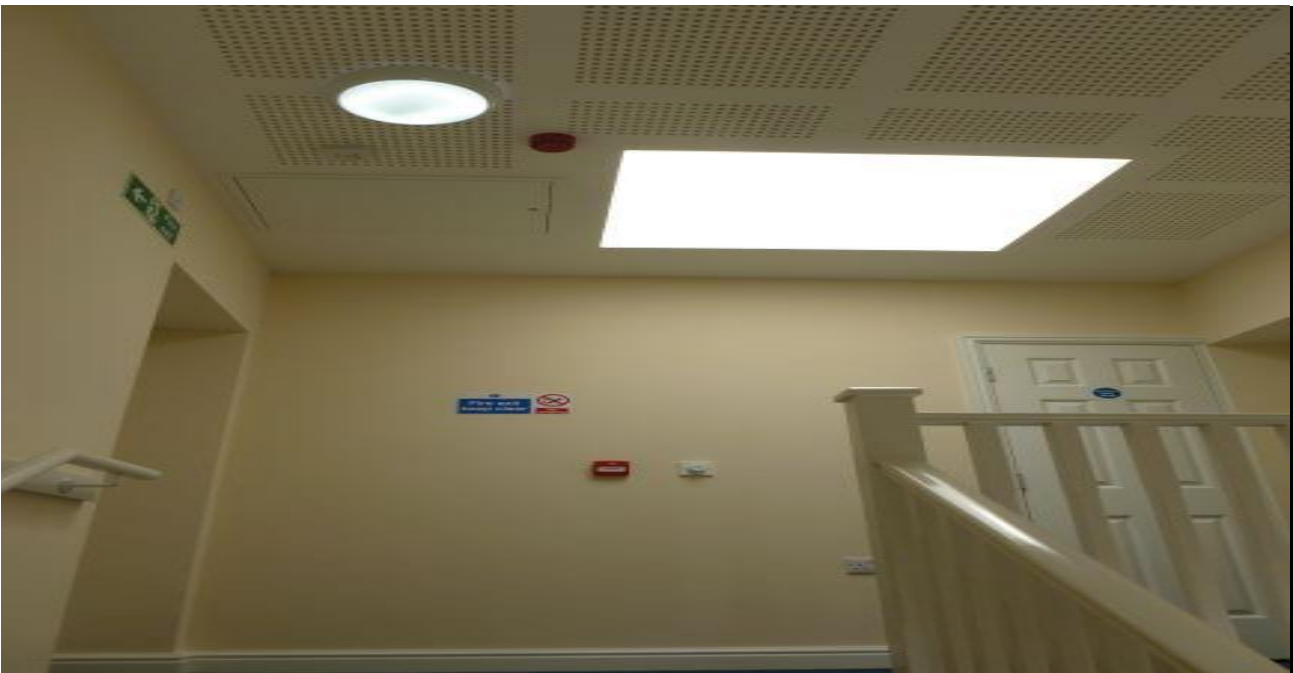
Photo No. 4

Note: 2nd Floor AOV- Loft- Break glass.

11.7	Smoke Control Systems (AOV's) Are records of annual testing available?	Yes	Note: Automatic Vent located at top floor level and tested 31/8/22 and uploaded to Active "H" and M files.	.

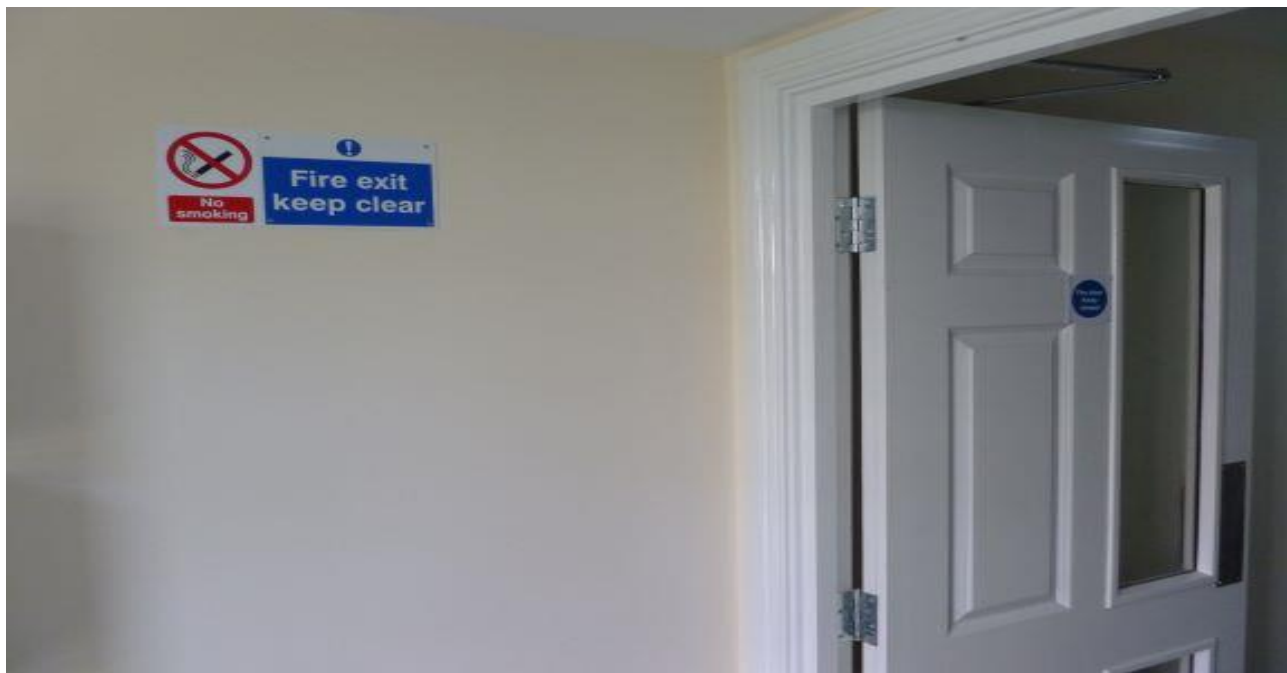
Photo No. 5

Note: Communal Doors require replacement due to excessive Gaps.

Action Plan - Fire					
Townsend Close/Thurston House				27/11/2023	
<b>MODERATE</b>					
Potential area of fire risk	Observation/Comments / Actions Required	Risk Rating	Completion Date	Referred To:	Task ID No.
<b>Fire Hazards</b>					
Communal Area Fire Doors (Inspection to include - construction, closure devices, intumescent/smoke seal condition, glazing systems and maximum gaps between door and frame.					
	No Action Required on Fire Doors Discussion with Housing Partner about general tidyness of scheme and external removal of combustables.

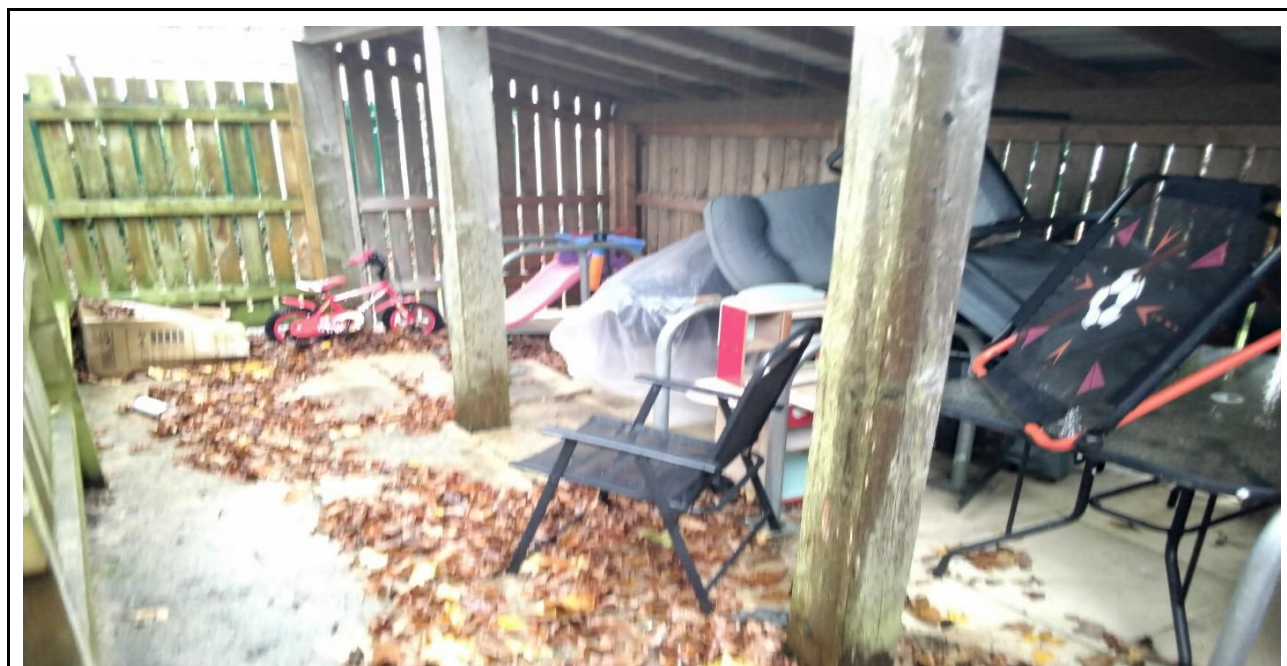
Photo No. 6

Note: Contact made with the HP as combustable build up of items in Bike store causing bikes to be left in stairwell.
