## ACCENT HOUSING - FIRE RISK ASSESSMENT

| <b>Scheme Name :</b> | <b>35 Cowhill Lane</b> |
| <b>Date of Assessment:</b> | <b>30/07/2026</b> |

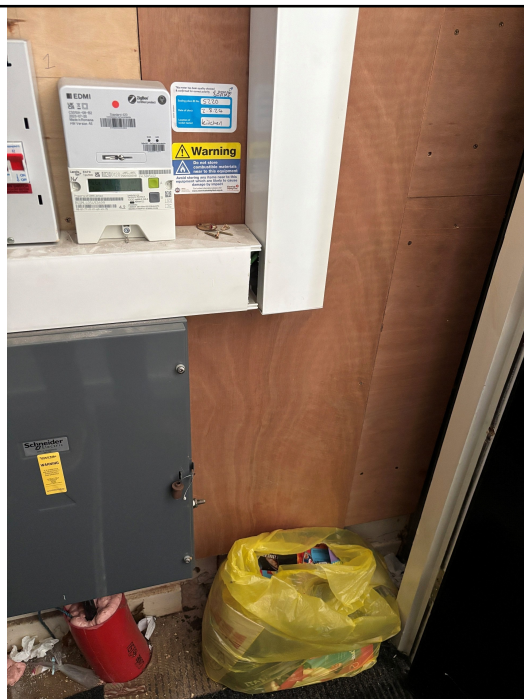
Photo No. 1

| 7.2 | Are all electrical/intake/service cupboards secure and free from general waste, contractors waste and residents personal items. | No | The electrical cupboard doors were found open and not secure. They were secured at the time of inspection. A carrier bag full of old flyers was found inside the electrical meter cupboard. HP to arrange removal and inform residents to dispose of them. | Low | 12/9/26 | Housing Partner |

Rubbish bag with flyers in meter cupboard

| Action Plan - Fire | | | | | |
|---|---|---|---|---|---|
| Are all electrical/intake/service cupboards secure and free from general waste, contractors waste and residents personal items. | The electrical cupboard doors were found open and not secure. They were secured at the time of inspection. A carrier bag full of old flyers was found inside the electrical meter cupboard. HP to arrange removal amd inform residents to dispose of them. | Low | 12/09/26 | Housing Partner | 2169485 |

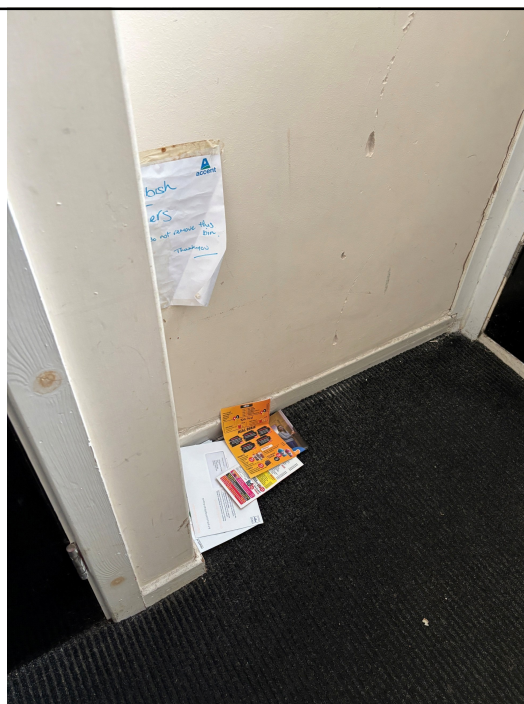
Photo No. 2

| 7.1 | Is the standard of housekeeping adequate? | No | Rubbish bags were located within the rear exit foyer.<br>Rubbish was stored within the communal corridor outside flat 3.<br>Flyers and other mail located in communal hallway nr front door. HP to arrange removal and inform residents to dispose of them.<br>Unable to access the basement. HP to check that it is clear of flammable items. | Low | 12/9/26 | Housing Partner |

Flyers behind front door

| Action Plan - Fire | | | | | |
|---|---|---|---|---|---|
| Is the standard of housekeeping adequate? | Rubbish bags were located within the rear exit foyer.<br>Rubbish was stored within the communal corridor outside flat 3.<br>Flyers and other mail located in communal hallway nr front door. HP to arrange removal and inform residents to dispose of them.<br>Unable to access the basement. HP to check that it is clear of flammable items. | Low | 12/09/26 | Housing Partner | 2169485 |

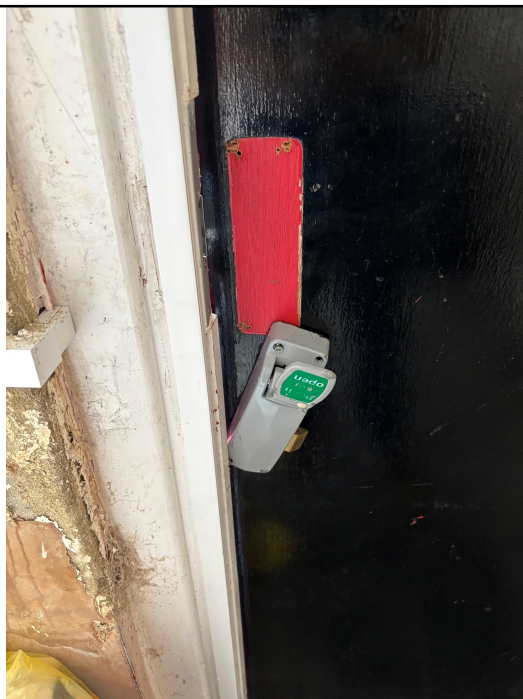
Photo No. 3

| 3.1 | Adequate security against arson? | No | Front door secure at time of inspection. Rear door with access to street is insecure and is open to access Work order 1397309 | Low | 12/9/26 | Building Safety Project manager |

| 10.3 | Exits easily and immediately openable where necessary, without a key? | Yes | Push pad (broken see 3.1) on rear door, front door has thumbturn fitted and electronic release with emergency facility. | . | | |

Push pad broken on rear exit door

| Action Plan - Fire | | | | | |
|---|---|---|---|---|---|
| Adequate security against arson? | Front door secure at time of inspection. Rear door with access to street is insecure and is open to access Work order 1397309 | Low | 12/09/26 | Building Safety Project manager | |

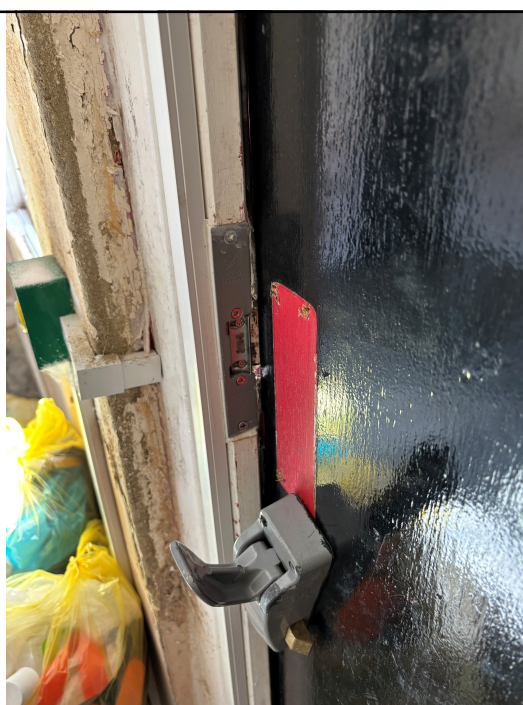
Photo No. 4

Push pad broken on rear exit door.

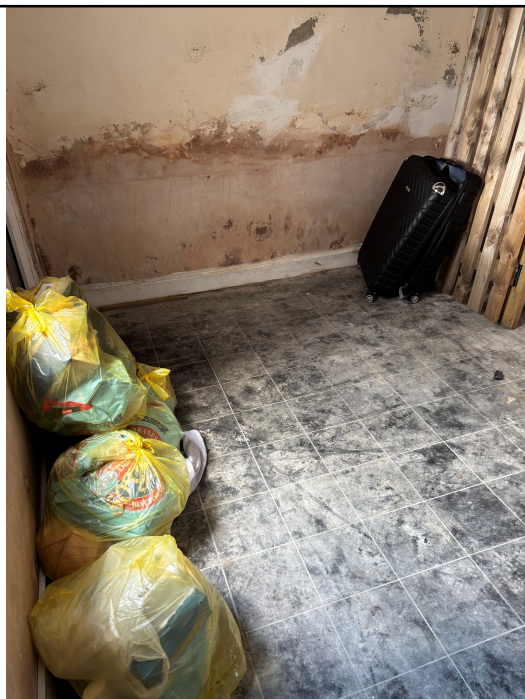
Photo No. 5

Rubbish bags stored in rear exit foyer

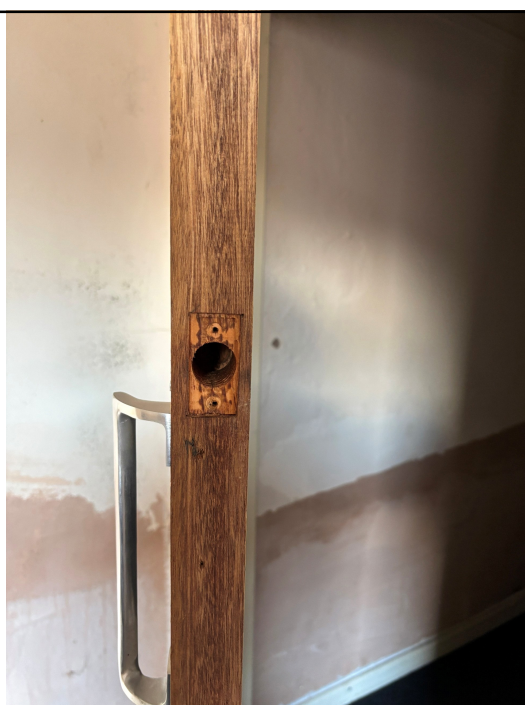
Photo No. 6

| 12.1 | Communal fire doors to FD30s standard and in a serviceable condition, | No | The door leading into the rear exit foyer has had a lock removed and a hole has been left in the door. Work order 1397309 | . | | |

Lock removed and hole in door to rear exit foyer

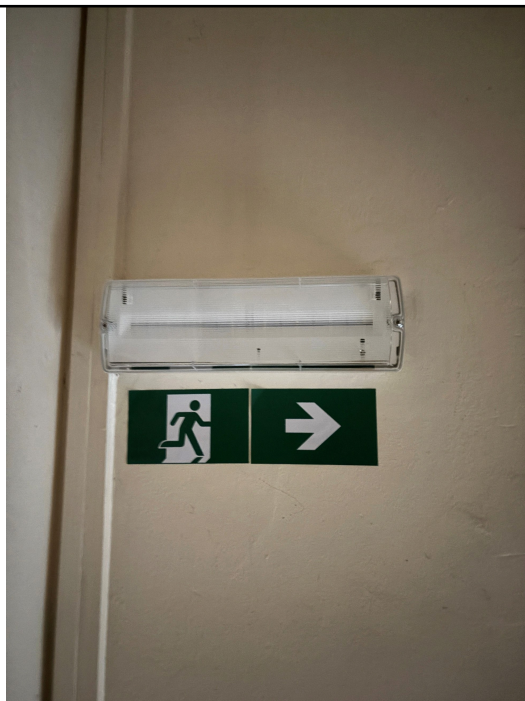
Photo No. 7

| 15.2 | Are all emergency lighting units in good condition and securely fixed to walls/ceilings | No | No indicator lights on EL luminaires. Recent test report by Tunstall shows that multiple luminaires have failed. Tunstall to provide a quote for repair | Med | 31/8/26 | Building Safety Project manager |

EL Lumiaires - no indication light

| Are all emergency lighting units in good condition and securely fixed to walls/ceilings | No indicator lights on EL luminaires. Recent test report by Tunstall shows that multiple luminaires have failed. Tunstall to provide a quote for repair | Med | 31/08/26 | Building Safety Project manager | |

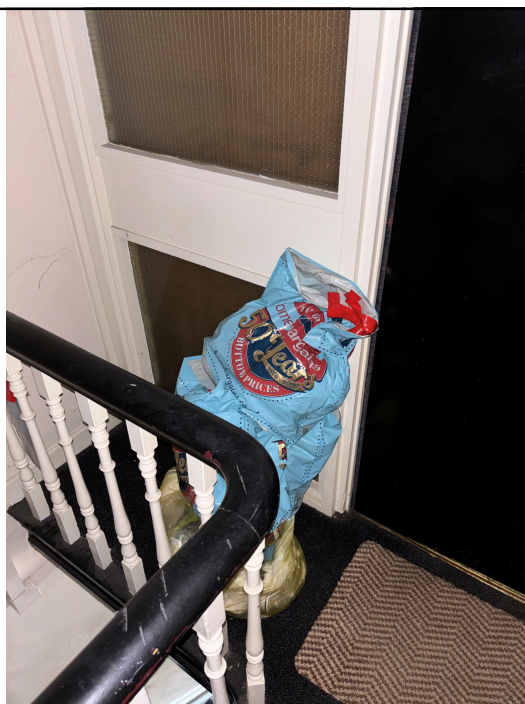
Photo No. 8

Personal items outside Flat 3

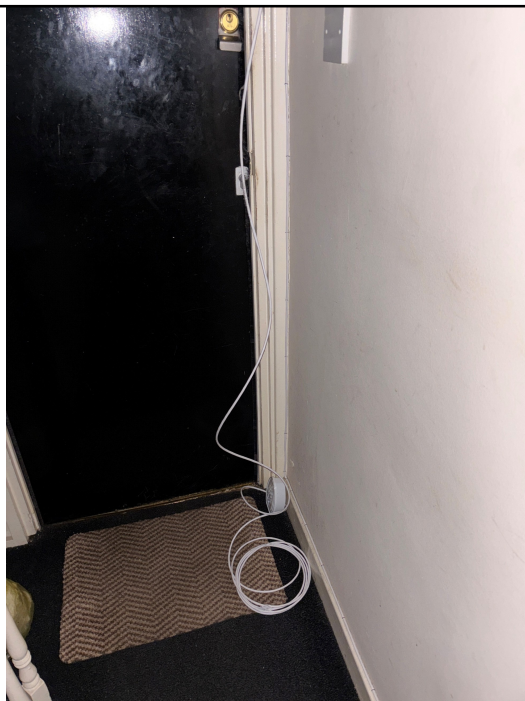
Photo No. 9

| Significant Findings - Fire | | | | | | |
|---|---|---|---|---|---|---|
| 1.5 | Absence of trailing leads and adapters | No | A coil of cable was found outside the flat front door of Flat 3. This would constitute a trip hazard and could cause entanglement. HP to arrange removal | Med | 31/8/26 | Housing Partner |

Coil of cable outside Flat 3

| Action Plan - Fire | | | | | |
|---|---|---|---|---|---|
| Absence of trailing leads and adapters | A coil of cable was found outside the flat front door of Flat 3. This would constitute a trip hazard and could cause entanglement. HP to arrange removal | Med | 31/08/26 | Housing Partner | 2169485 |

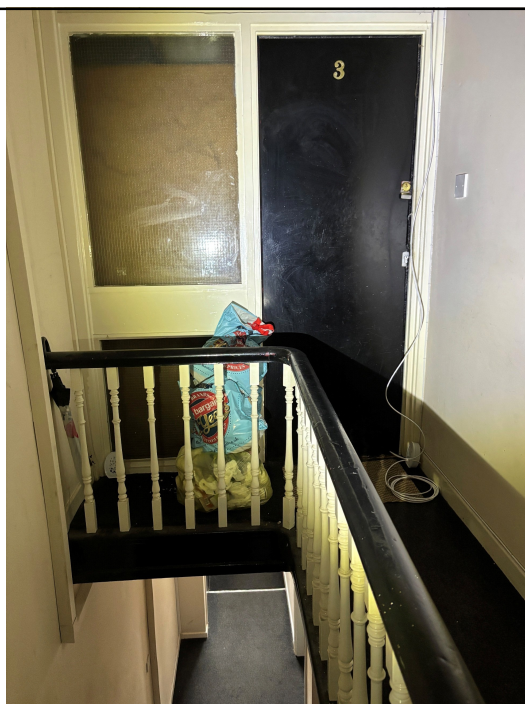
Photo No. 10

Personal items and cable coil outside Flat 3
