# ACCENT HOUSING - FIRE RISK ASSESSMENT

| **Scheme Name :** | **45-53 Hanbury** |
| **Date of Assessment:** | **03/03/2026** |

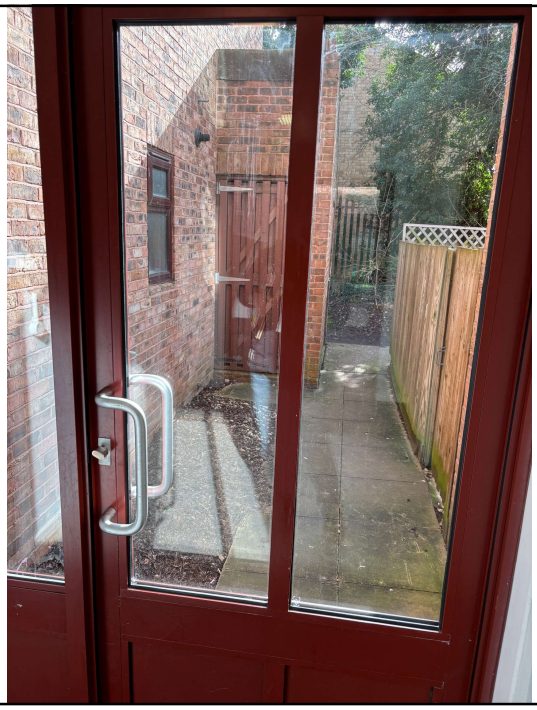
| Photo No. 1 | Main Entrance Keypad and trades Access. |
