ACCENT HOUSING - FIRE RISK ASSESSMENT

Region :	**Yorkshire**
Scheme Name :	**48 - 66 Church View**
Scheme Address :	**Church View Sherburn in Elmet LS25 6HZ**
Date of Assessment:	**14/08/2026**
Date of Next Assessment:	**15/08/2027**
FRA Frequency:	**Annual Re-Assessment under the Regulatory Reform (Fire Safety) Order 2005**
Fire & Safety Assessor	**Steve Manners Tech IOSH MIFSM MFPA DipFD**

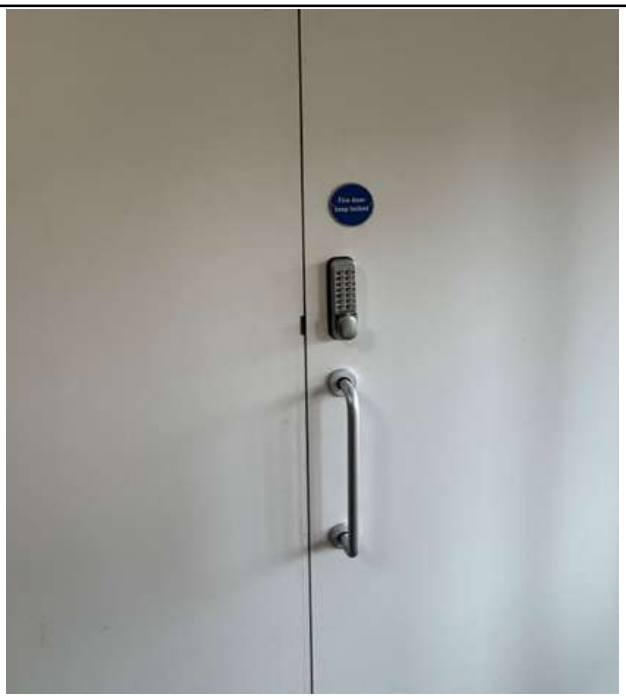
7.1	Is the standard of housekeeping adequate?	Yes		'		
7.2	Are all electrical/intake/service cupboards secure and free from general waste, contractors waste and residents personal items.	Yes	The Elecctrical cuboards were upgraded to 1 Hour fire rated doors last year.	'

Photo No. 1	1 Hour Fire doors newly installed
