ACCENT HOUSING - FIRE RISK ASSESSMENT

Region :	**East**
Scheme Name :	**Carpenters Court 1-8**
Scheme Address :	**Rectory Lane Somersham PE28 3YZ**
Date of Assessment:	**08/10/2026**
Date of Next Assessment:	**08/10/2029**
FRA Frequency:	**3 Year Re-Assessment under the Regulatory Reform (Fire Safety) Order 2005**
Fire & Safety Assessor	**Lynn Betteridge GIFireE DipNEBOSH DipFD**

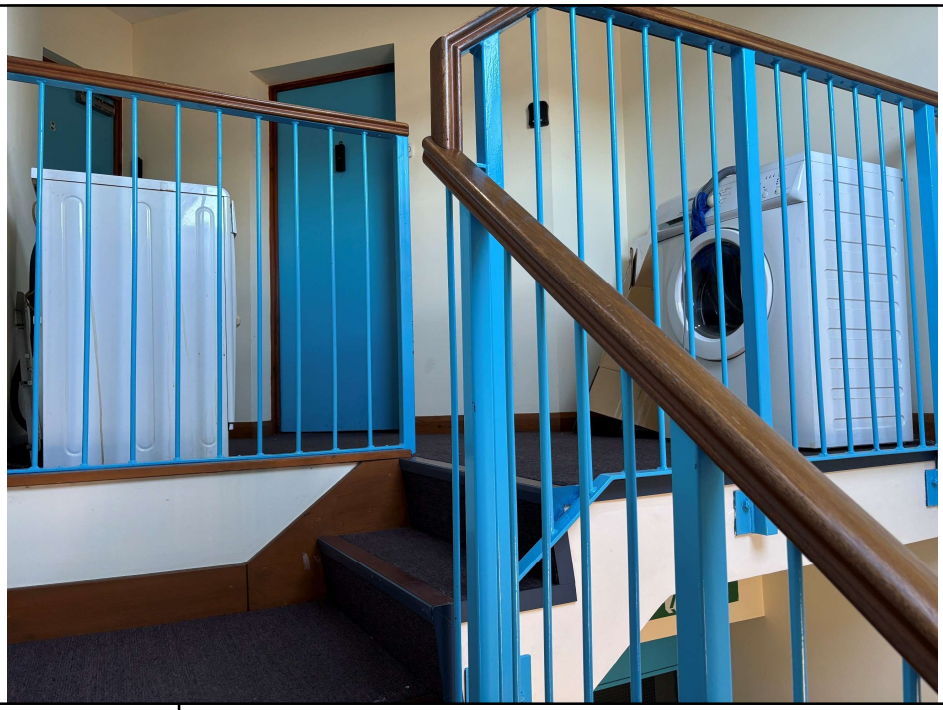
Photo No. 3	Block standard Fire Door self closer cover missing.
