ACCENT HOUSING - FIRE RISK ASSESSMENT

Region :	**East**
Scheme Name :	**11-18 Hanbury**
Scheme Address :	**Orton Goldhay Peterborough PE2 5QT**
Date of Assessment:	**03/03/2026**
Date of Next Assessment:	**03/03/2029**
FRA Frequency:	**3 Year Re-Assessment under the Regulatory Reform (Fire Safety) Order 2005**
Fire & Safety Assessor	**Lynn Betteridge GIFireE DipNEBOSH**

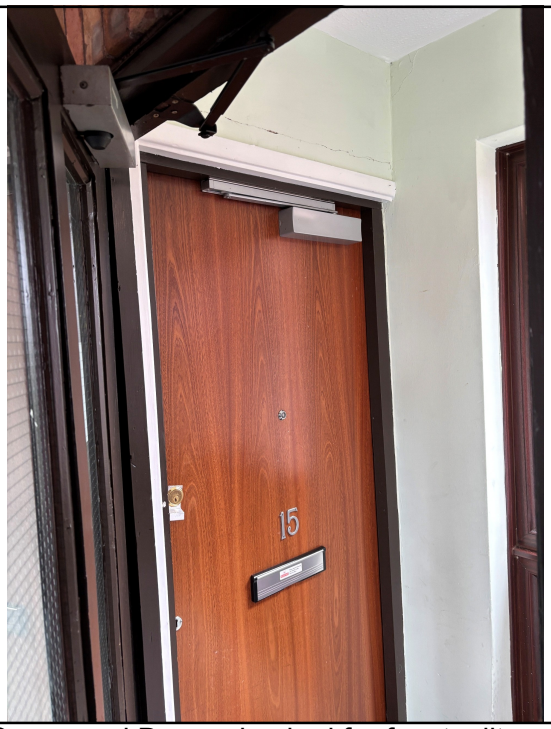
Photo No. 5	Communal Doors checked for functuality and meets specification.
