ACCENT HOUSING - FIRE RISK ASSESSMENT

Region :	**East**
Scheme Name :	**The Moorings 3-12**
Scheme Address :	**Ramsey Huntingdon PE26 2AL**
Date of Assessment:	**27/08/2026**
Date of Next Assessment:	**27/08/2029**
FRA Frequency:	**3 Year Re-Assessment under the Regulatory Reform (Fire Safety) Order 2005**
Fire & Safety Assessor	**Lynn Betteridge GIFireE DipNEBOSH**

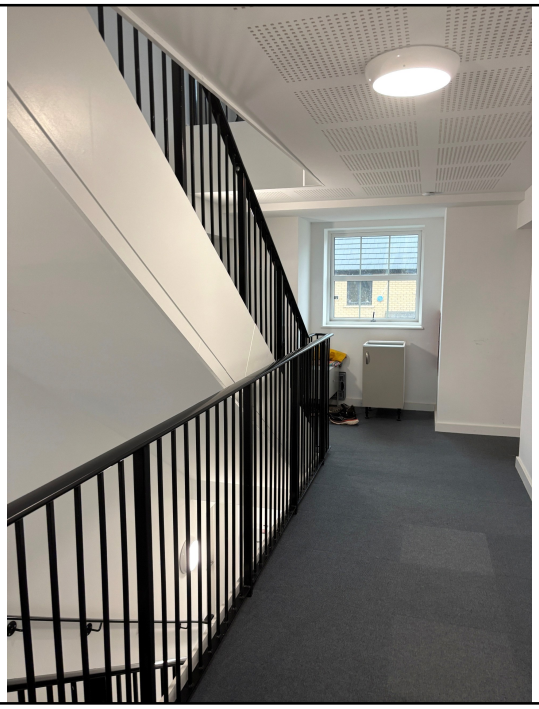
Photo No. 3	I spoke to resident and removed these items located first floor.
