ACCENT HOUSING - FIRE RISK ASSESSMENT

Region :	**East**
Scheme Name :	**36-44 Hanbury**
Scheme Address :	**Orton Goldhay Peterborough PE2 5QT**
Date of Assessment:	**03/03/2026**
Date of Next Assessment:	**03/03/2029**
FRA Frequency:	**3 Year Re-Assessment under the Regulatory Reform (Fire Safety) Order 2005**
Fire & Safety Assessor	**Lynn Betteridge GIFireE DipNEBOSH**

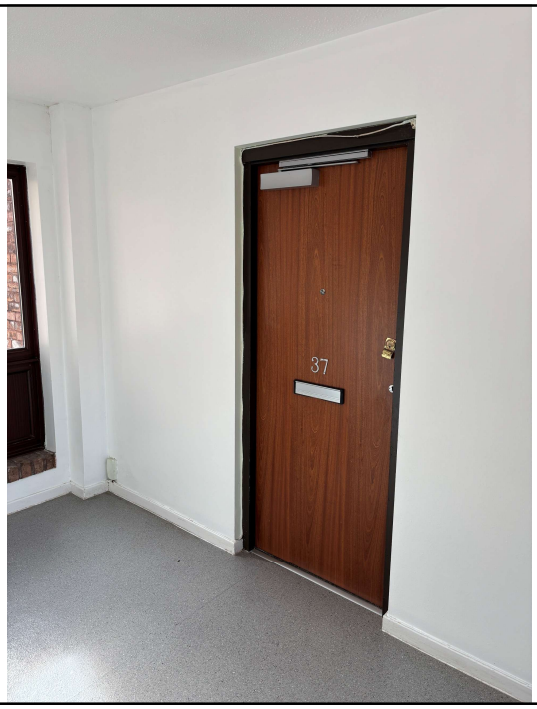
Photo No. 3	Main Entrance to the Block Right side and communal door to stairwell.
