ACCENT HOUSING - FIRE RISK ASSESSMENT

Region :	**Yorkshire**
Scheme Name :	**68 - 70 Church View**
Scheme Address :	**Church View Sherburn in Elmet LS25 6HZ**
Date of Assessment:	**14/08/2026**
Date of Next Assessment:	**15/08/2027**
FRA Frequency:	**Annual Re-Assessment under the Regulatory Reform (Fire Safety) Order 2005**
Fire & Safety Assessor	**Steve Manners Tech IOSH MIFSM MFPA DipFD**

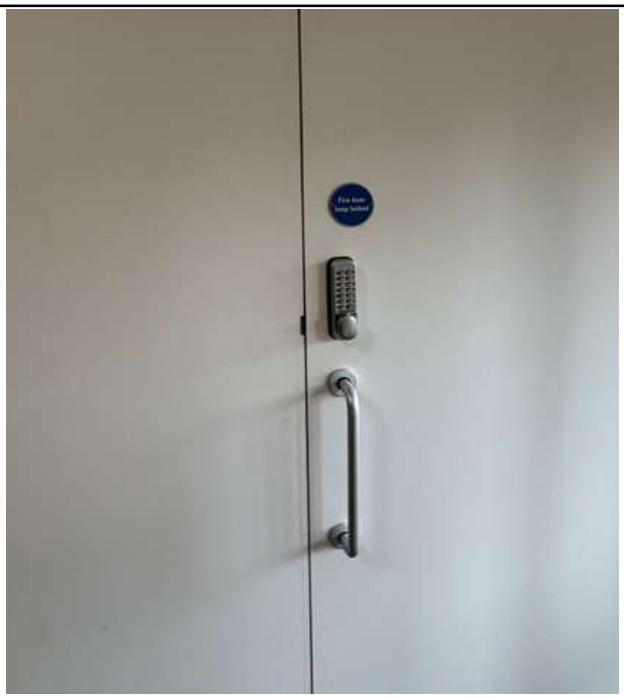
Photo No. 1	1 Hour Fire doors newly installed

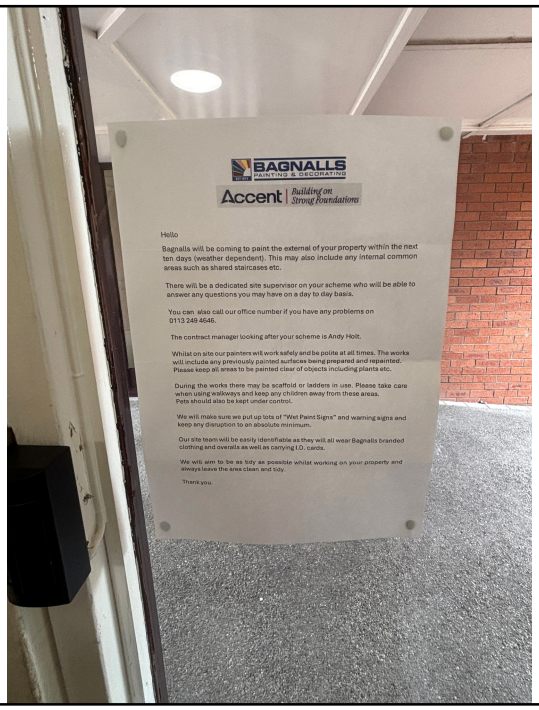
16.1	Are the correct Fire Action/Advice notices displayed in prominent locations within the common areas?	Other	The fire action notices have been taken down for re decoration to take place, decorators were present at the scheme at the time of inspection. The notices will be repaced immediately on completion of decorating	.

Photo No. 5	Some signage has been temporaraly removed for decoration. SHP to inform when signage is re hung after decorating
