ACCENT HOUSING - FIRE RISK ASSESSMENT

Region :	**Yorkshire**
Scheme Name :	**1 - 6 Fairfield Court**
Scheme Address :	**Fairfield Court Leeds LS13 3BL**
Date of Assessment:	**09/09/2026**
Date of Next Assessment:	**09/09/2029**
FRA Frequency:	**3 Year Re-Assessment under the Regulatory Reform (Fire Safety) Order 2005**
Fire & Safety Assessor	**Steve Manners Tech IOSH MIFSM MFPA DipFD**

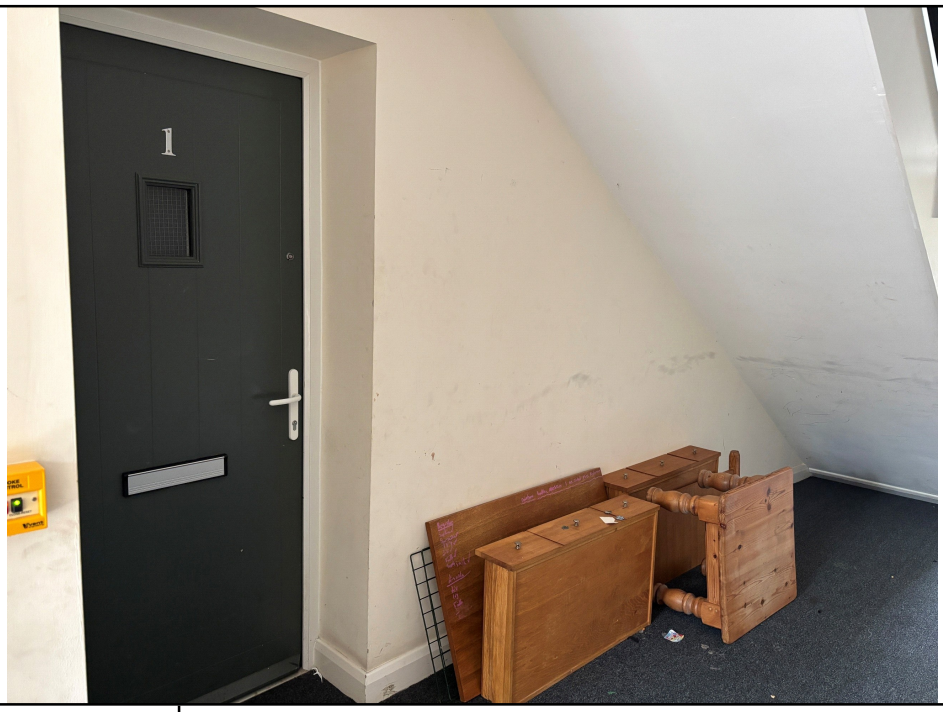
7.1	Is the standard of housekeeping adequate?	No	Items wer found within the communal area Housing partner in Attendance is dealing.	**Low**	**23/9/26**	**Housing Partner**

7.4	Are unnecessary accumulations of combustible materials or waste avoided?	No	7.1	-

10.1	Is it considered that the building is provided with reasonable means of escape in case of fire?	Yes		.		
10.2	Escape routes unobstructed and safe to use?	No	7.1	.

Photo No. 1	Items to be removed, Housing Partner in attendance and dealing.

Photo No. 2	Items to be removed, Housing Partner in attendance and dealing.

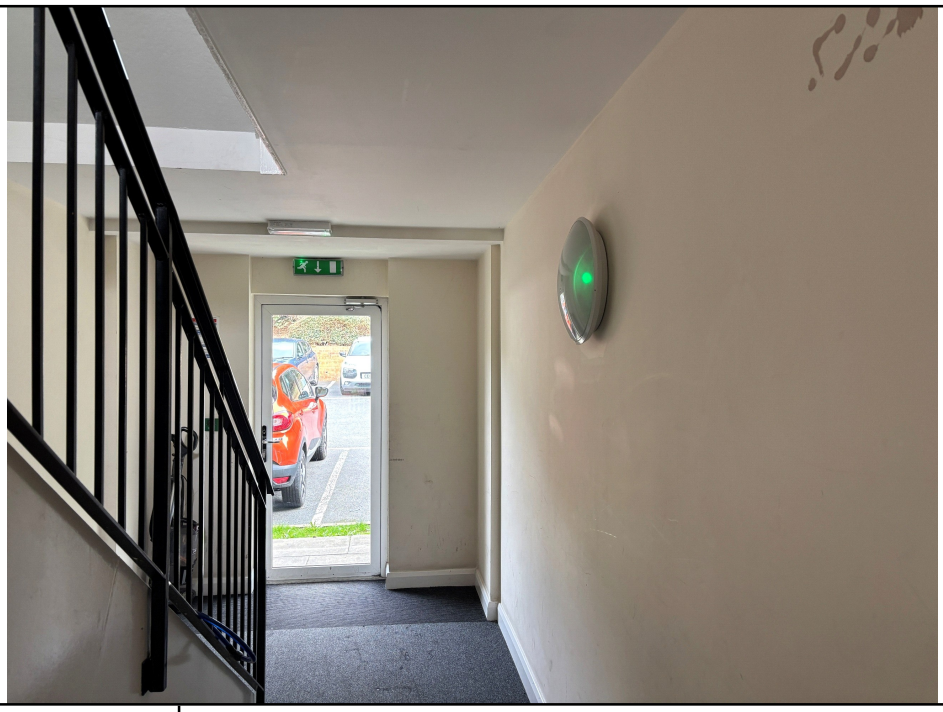
Photo No. 3	Emergency Lighting.

Photo No. 4	Directional exit signage.
