ACCENT HOUSING - FIRE RISK ASSESSMENT

Region :	**Yorkshire**
Scheme Name :	**76 - 94 Church View**
Scheme Address :	**Church View Sherburn in Elmet LS25 6HZ**
Date of Assessment:	**14/08/2026**
Date of Next Assessment:	**15/08/2027**
FRA Frequency:	**Annual Re-Assessment under the Regulatory Reform (Fire Safety) Order 2005**
Fire & Safety Assessor	**Steve Manners Tech IOSH MIFSM MFPA DipFD**

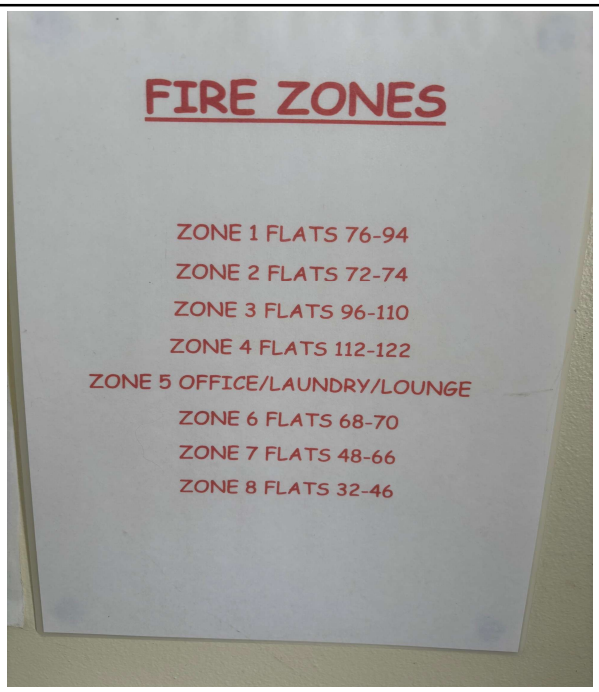
Photo No. 7	Fire alarm and zone plan

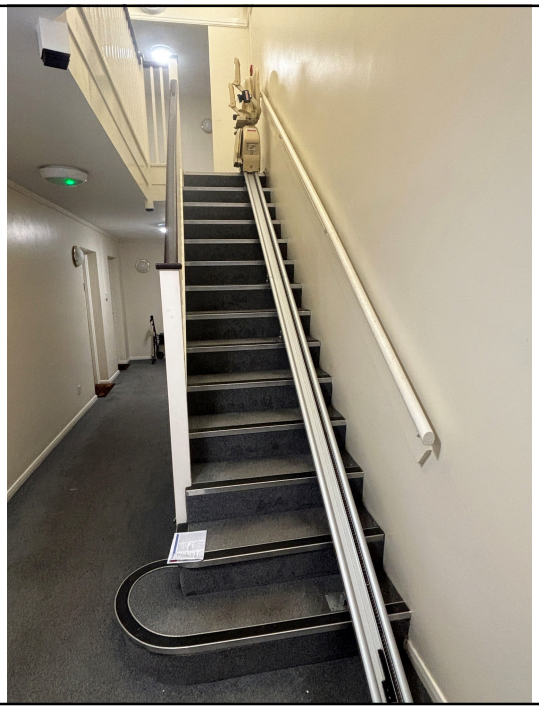
Photo No. 8	Stairlift to first floor not used in a fire emergency.
