ACCENT HOUSING - FIRE RISK ASSESSMENT

Region :	**Yorkshire**
Scheme Name :	**96 - 110 Church View**
Scheme Address :	**Church View Sherburn in Elmet LS25 6HZ**
Date of Assessment:	**14/08/2026**
Date of Next Assessment:	**15/08/2027**
FRA Frequency:	**Annual Re-Assessment under the Regulatory Reform (Fire Safety) Order 2005**
Fire & Safety Assessor	**Steve Manners Tech IOSH MIFSM MFPA DipFD**

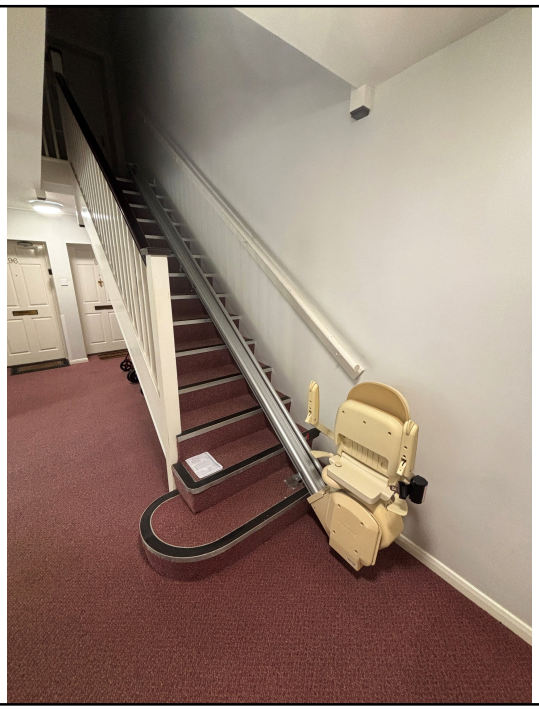
Photo No. 7	Stairlift to first floor not used in Fire evacuation.
