ACCENT HOUSING - FIRE RISK ASSESSMENT

Region :	**East**
Scheme Name :	**27-35 Hanbury**
Scheme Address :	**Orton Goldhay Peterborough PE2 5QT**
Date of Assessment:	**03/03/2026**
Date of Next Assessment:	**03/03/2029**
FRA Frequency:	**3 Year Re-Assessment under the Regulatory Reform (Fire Safety) Order 2005**
Fire & Safety Assessor	**Lynn Betteridge GIFireE DipNEBOSH**

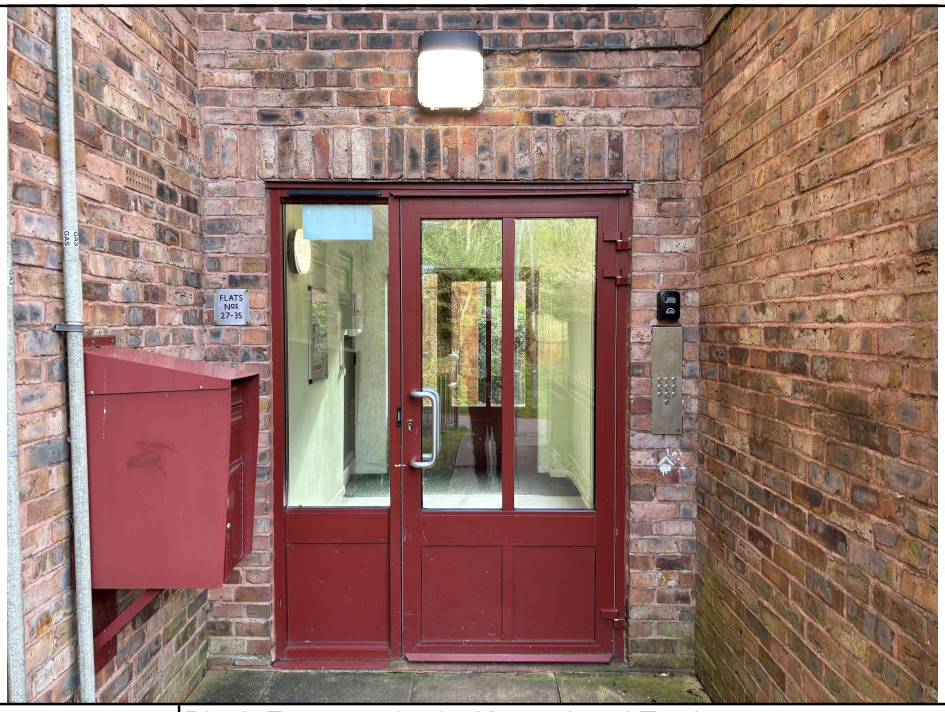
Photo No. 1	Block Entrance 27-35 Keypad and Trades.

Photo No. 2	Internal Foyer 2 Directions of Travel if required Main Fire Exit and rear.

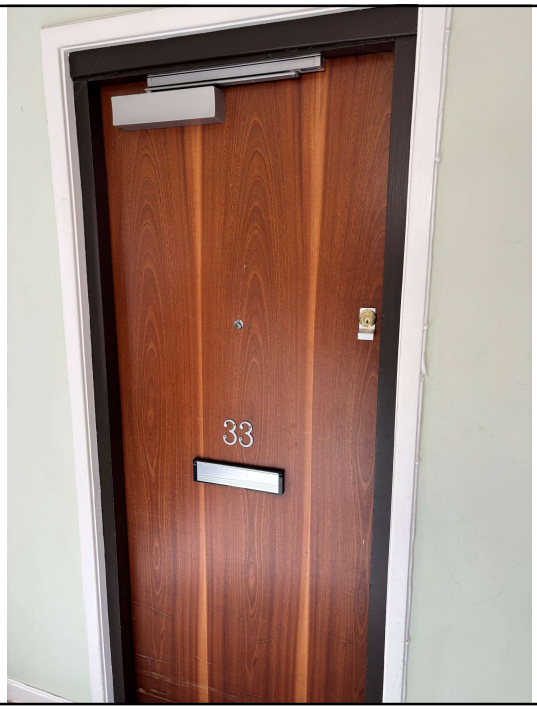
Photo No. 3	Standard Flat door throughout Block.

Photo No. 4	Communal Door from protected staircase.
