ACCENT HOUSING - FIRE RISK ASSESSMENT

Region :	**East**
Scheme Name :	**1-4 Stanwick Court**
Scheme Address :	**Stanwick Peterborough PE3 6BW**
Date of Assessment:	**30/03/2026**
Date of Next Assessment:	**30/03/2029**
FRA Frequency:	**3 Year Re-Assessment under the Regulatory Reform (Fire Safety) Order 2005**
Fire & Safety Assessor	**Lynn Betteridge GIFireE DipNEBOSH**

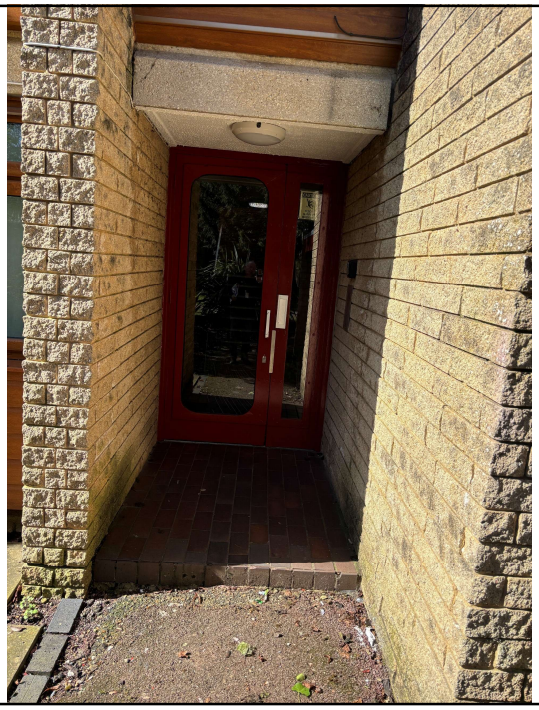
Photo No. 1	Main Access to 1-4 Stanwick Block of only 2 Floors x 4 Flats

Photo No. 2	Main Communal looking at Exit Door. Notice Board with Fire Routine. Maintained Lighting System on both Floors.

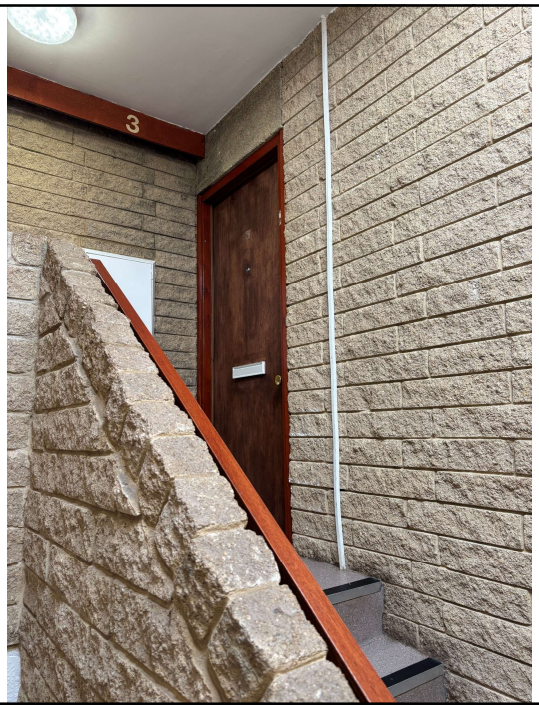
Photo No. 3	Standard Flat Door in this Block.

Photo No. 4	First Floor Communal area, Maintained Lighting and 2 Flats. Secure amenities cupboard adjacent to Flats.

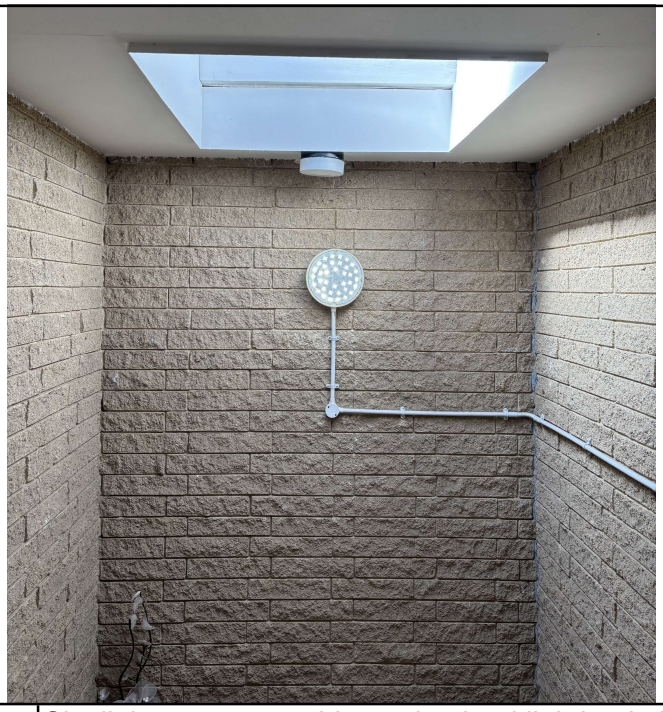
Photo No. 5	Sky light non openeable, maintained lighting in Block.

Photo No. 6	Blocks 1- and 5-8 are 2 Floors only on this scheme of 6 Blocks.
