ACCENT HOUSING - FIRE RISK ASSESSMENT

Region :	**East**
Scheme Name :	**27-28 Stanwick Court**
Scheme Address :	**Stanwick Peterborough PE3 6BW**
Date of Assessment:	**30/03/2026**
Date of Next Assessment:	**30/03/2029**
FRA Frequency:	**3 Year Re-Assessment under the Regulatory Reform (Fire Safety) Order 2005**
Fire & Safety Assessor	**Lynn Betteridge GIFireE DipNEBOSH**

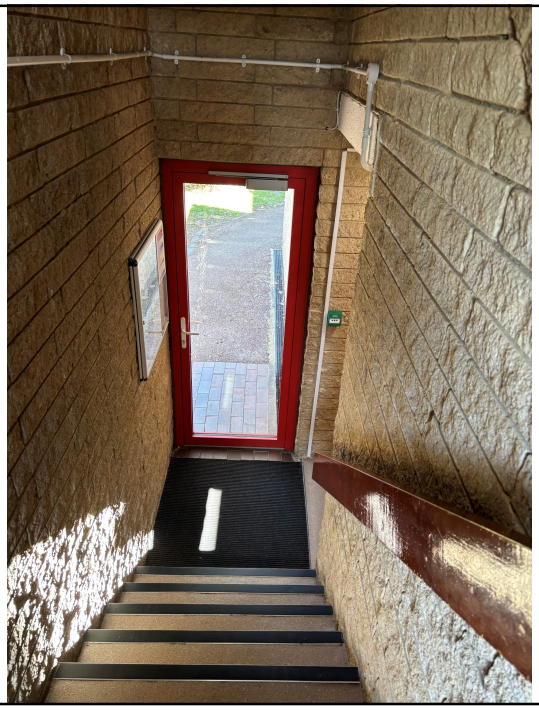
Photo No. 3	Ground Floor Flat and store only 1 flat ground floor No 27
