ACCENT HOUSING - FIRE RISK ASSESSMENT

Region :	**East**
Scheme Name :	**1-10 Hanbury**
Scheme Address :	**Orton Goldhay Peterborough PE2 5QT**
Date of Assessment:	**03/03/2026**
Date of Next Assessment:	**03/03/2029**
FRA Frequency:	**3 Year Re-Assessment under the Regulatory Reform (Fire Safety) Order 2005**
Fire & Safety Assessor	**Lynn Betteridge GIFireE DipNEBOSH**

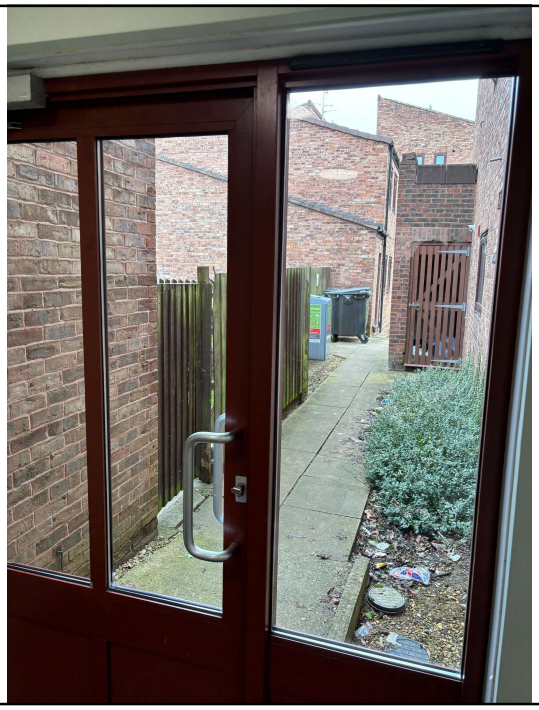
Photo No. 1	Main MOE front and Back with Keypad front door.

Photo No. 2	Standard Block Flat Door.

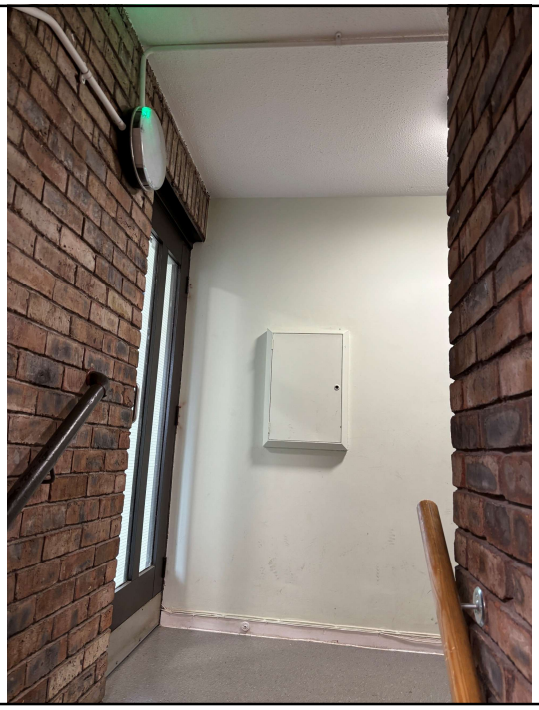
Photo No. 3	Communal first floor and communal doors and utilty Box

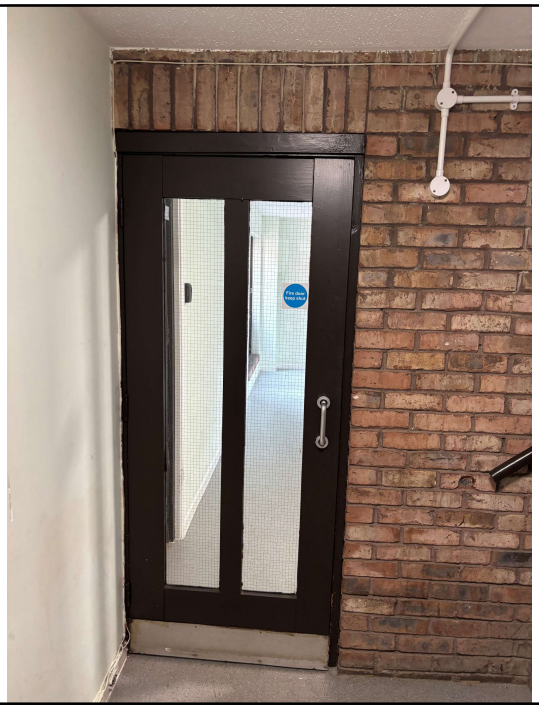
Photo No. 4	Ground Floor
