ACCENT HOUSING - FIRE RISK ASSESSMENT

Region :	**East**
Scheme Name :	**Swifts Corner 24-34**
Scheme Address :	**Fulbourn Cambridge CB21 5AE**
Date of Assessment:	**09/06/2026**
Date of Next Assessment:	**09/06/2029**
FRA Frequency:	**3 Year Re-Assessment under the Regulatory Reform (Fire Safety) Order 2005**
Fire & Safety Assessor	**Lynn Betteridge GIFireE DipNEBOSH**

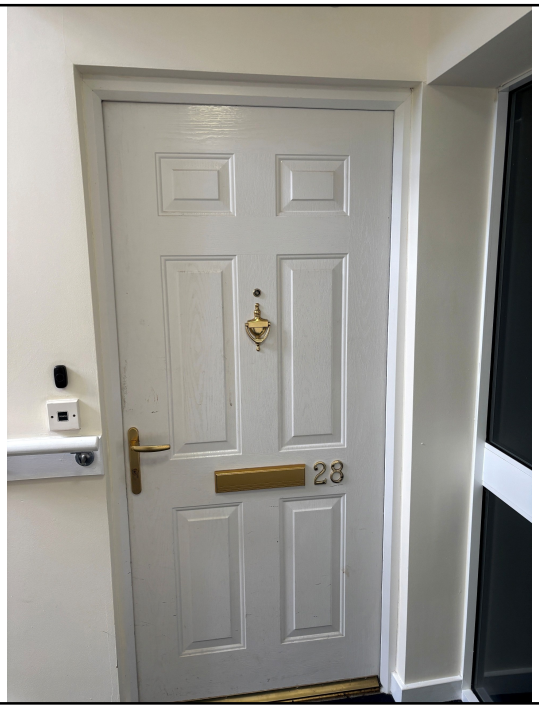
Photo No. 3	Standard Door Fitted to the Block.
