ACCENT HOUSING - FIRE RISK ASSESSMENT

Region :	**Yorkshire**
Scheme Name :	**11 Moorcroft Drive**
Scheme Address :	**Moorcroft Drive Bradford BD4 6NJ**
Date of Assessment:	**05/10/2026**
Date of Next Assessment:	**05/10/2027**
FRA Frequency:	**Annual Re-Assessment under the Regulatory Reform (Fire Safety) Order 2005**
Fire & Safety Assessor	**Steve Manners Tech IOSH MIFSM MFPA DipFD**

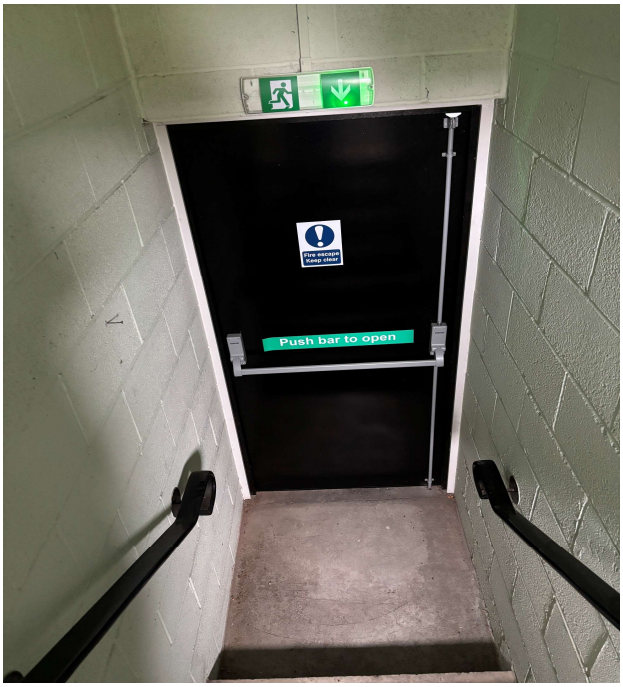
Photo No. 3	Directional Signage and Emergency Lighting.

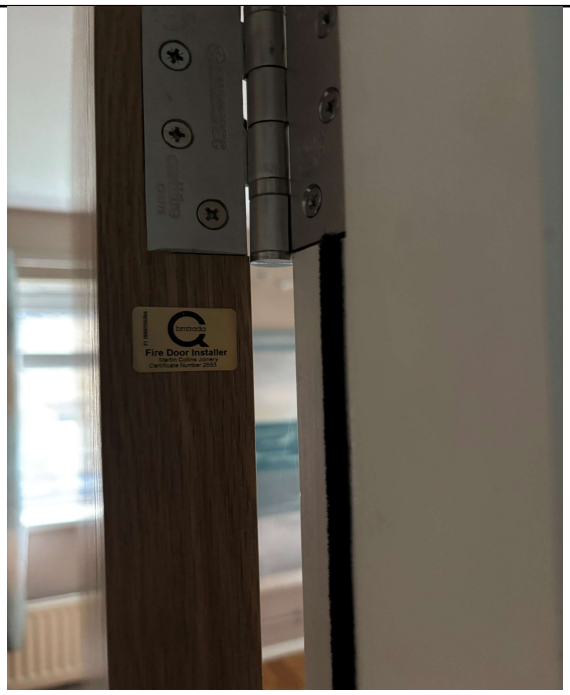
Photo No. 5	New Fire doors fitted this year.

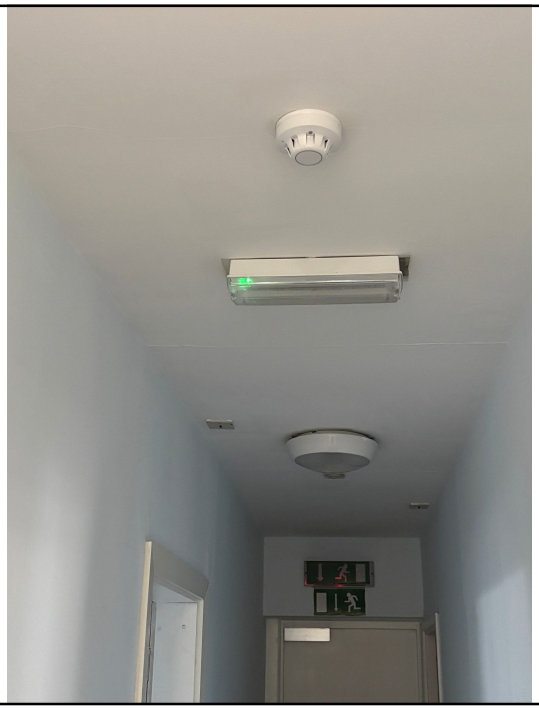
Photo No. 6	Communal area detection signage and Emergency Lighting.

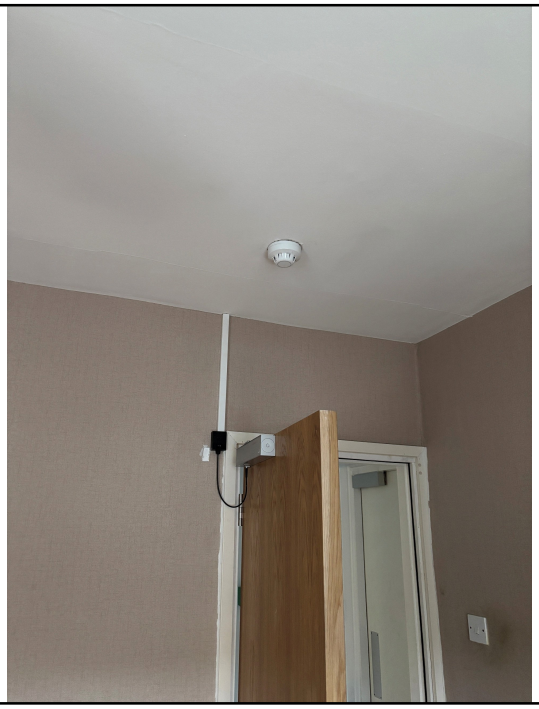
Photo No. 7	Detection within flats / rooms.
