ACCENT HOUSING - FIRE RISK ASSESSMENT

Region :	**South**
Scheme Name :	**1-5 Lawrence Lodge**
Scheme Address :	**Camberley Surrey GU1547Y**
Date of Assessment:	**02/09/2026**
Date of Next Assessment:	**02/09/2027**
FRA Frequency:	**Annual Re-Assessment under the Regulatory Reform (Fire Safety) Order 2005**
Fire & Safety Assessor	**Gary Bredin AIFireE DipFD**

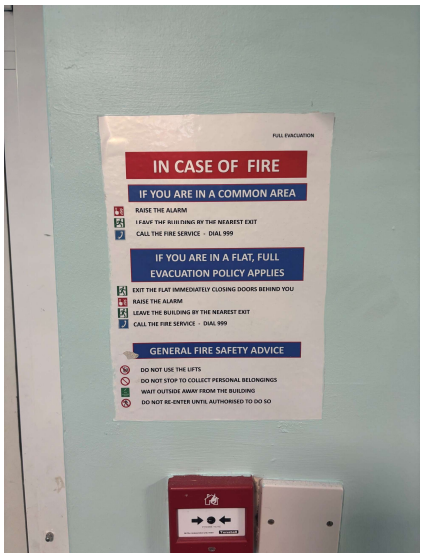
Photo No. 2	Evacuation policy posted throughout the building.

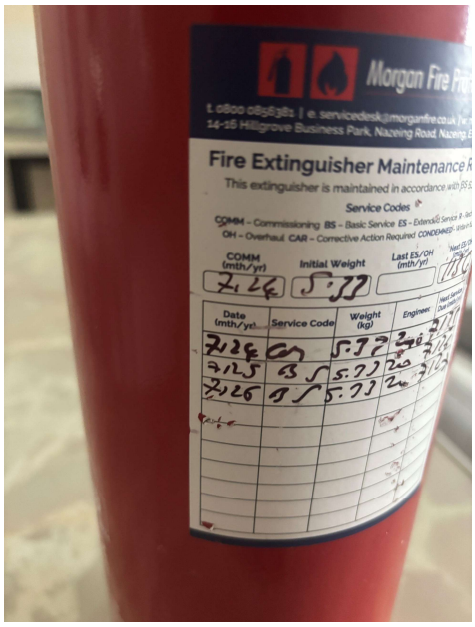
Photo No. 5	All Extinguishers were in date.

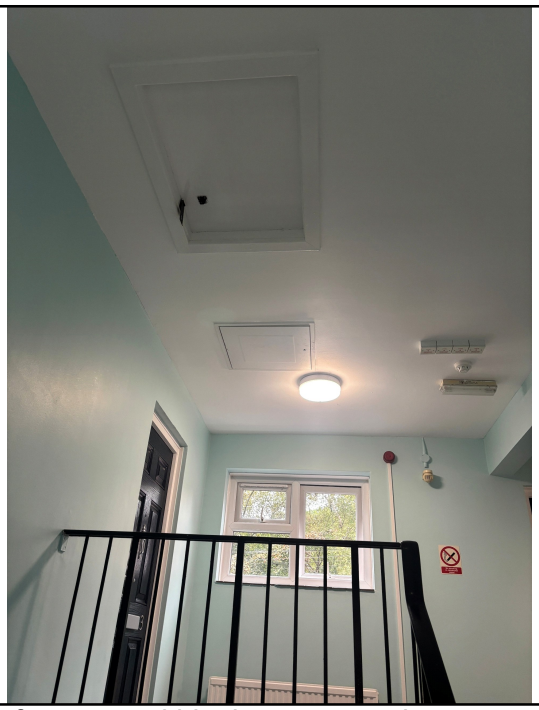
11.4	Compartmentation within roof spaces of a satisfactory standard?	Yes		'		
11.5	Loft hatches fire resisting?	Yes	Old loft hatches not accessible form the ground are double FR boarded above. New hatches comply with the latest standards.	'

Photo No. 7	Loft spaces within the communal area were Fire Resistant or double board
