ACCENT HOUSING - FIRE RISK ASSESSMENT

Region :	**South**
Scheme Name :	**39-42 Burchetts Close**
Scheme Address :	**Haywards Heath West Sussex RH16 4RJ**
Date of Assessment:	**28/09/2026**
Date of Next Assessment:	**28/09/2029**
FRA Frequency:	**3 Year Re-Assessment under the Regulatory Reform (Fire Safety) Order 2005**
Fire & Safety Assessor	**Gary Bredin AIFireE DipFD**

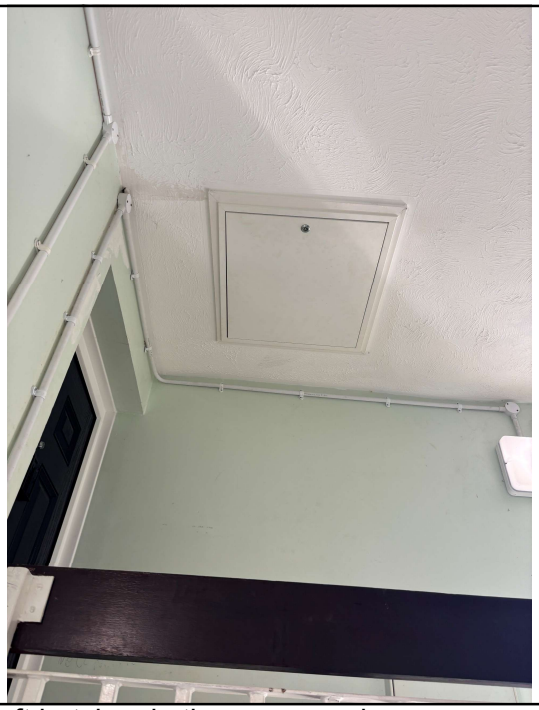
Photo No. 5	Loft hatches in the communal areas were all Fire Rated.

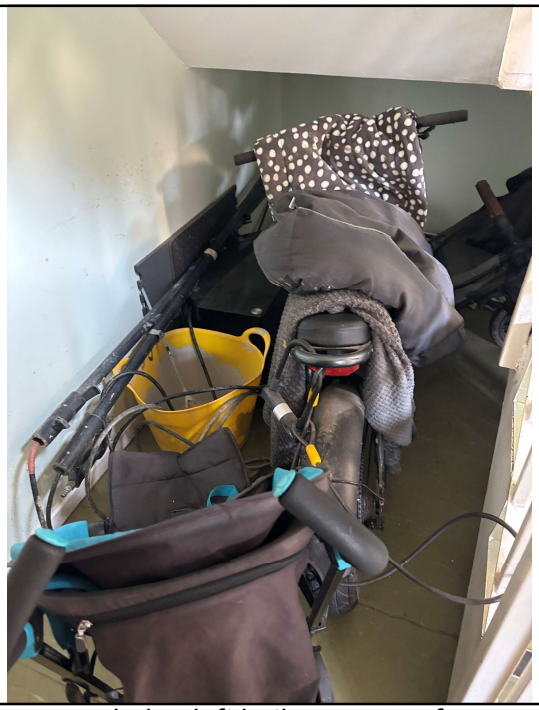
7.1	Is the standard of housekeeping adequate?	No	Fly tipping under the stairwell and communal areas.	**Med**	**ASAP**	**Housing Partner**
7.2	Are all electrical/intake/service cupboards secure and free from general waste, contractors waste and residents personal items.	Yes		'

10.1	Is it considered that the building is provided with reasonable means of escape in case of fire?	Yes		'		
10.2	Escape routes unobstructed and safe to use?	No		'

Photo No. 6	Items are being left in the means of escape.
