ACCENT HOUSING - FIRE RISK ASSESSMENT

Region :	**South**
Scheme Name :	**Albion Court**
Scheme Address :	**19-24 25-30 Burgess Hill West Sussex RH15 9QF**
Date of Assessment:	**17/09/2026**
Date of Next Assessment:	**17/09/2029**
FRA Frequency:	**3 Year Re-Assessment under the Regulatory Reform (Fire Safety) Order 2005**
Fire & Safety Assessor	**Gary Bredin AIFireE DipFD**

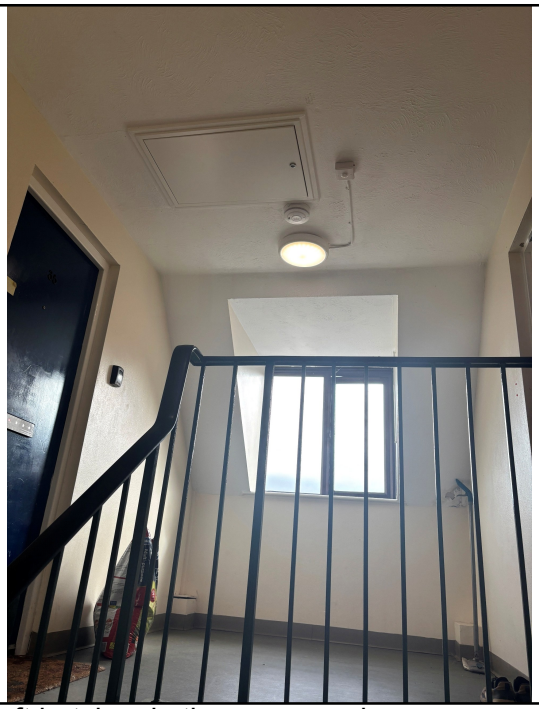
Photo No. 5	Loft hatches in the communal areas were all Fire Rated.

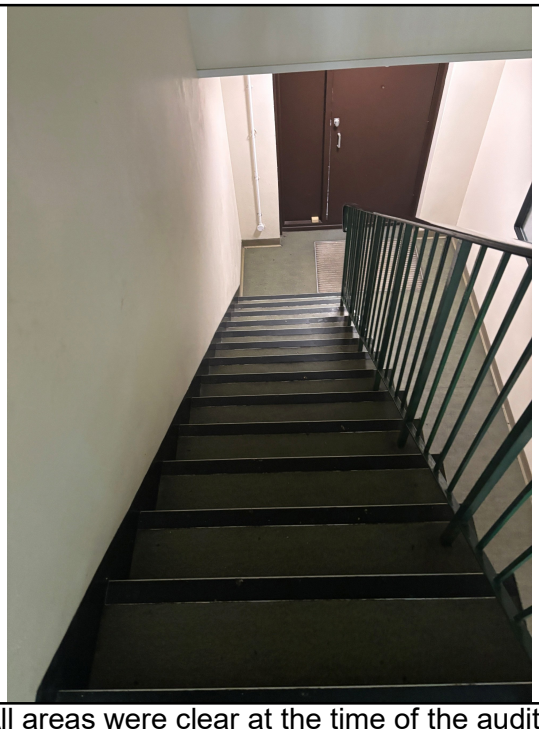
Photo No. 6	All areas were clear at the time of the audit.
