ACCENT HOUSING - FIRE RISK ASSESSMENT

Region :	**South**
Scheme Name :	**16-20 Lawrence Lodge**
Scheme Address :	**Camberley Surrey GU1547Y**
Date of Assessment:	**02/09/2026**
Date of Next Assessment:	**02/09/2027**
FRA Frequency:	**Annual Re-Assessment under the Regulatory Reform (Fire Safety) Order 2005**
Fire & Safety Assessor	**Gary Bredin AIFireE DipFD**

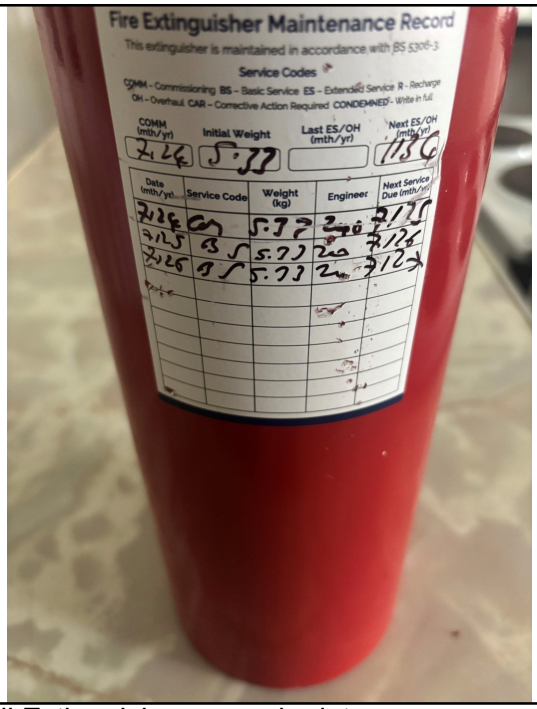
Photographs - Fire	
02/09/2026	11-15 Lawrence Lodge
