ACCENT HOUSING - FIRE RISK ASSESSMENT

Region :	**South**
Scheme Name :	**1-7 Providence House**
Scheme Address :	**Guildford Road Bagshot GU19 5JN**
Date of Assessment:	**08/09/2026**
Date of Next Assessment:	**08/09/2029**
FRA Frequency:	**3 Year Re-Assessment under the Regulatory Reform (Fire Safety) Order 2005**
Fire & Safety Assessor	**Gary Bredin AIFireE DipFD**

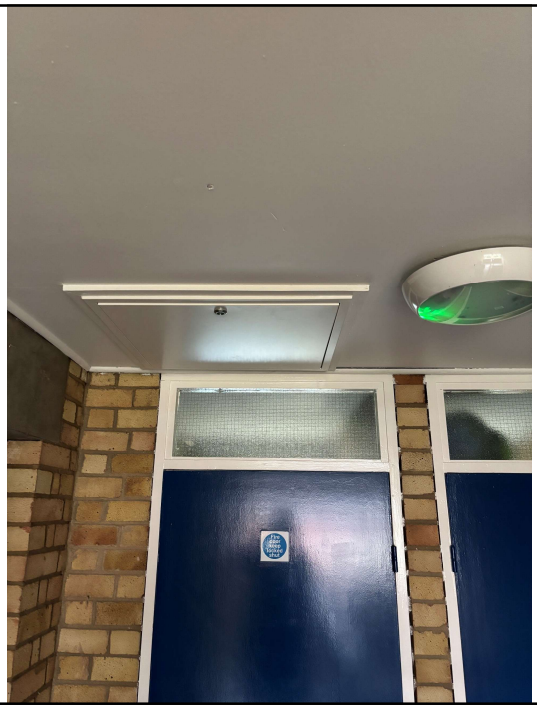
Photo No. 3	Satisfactory Signage throughout the block.

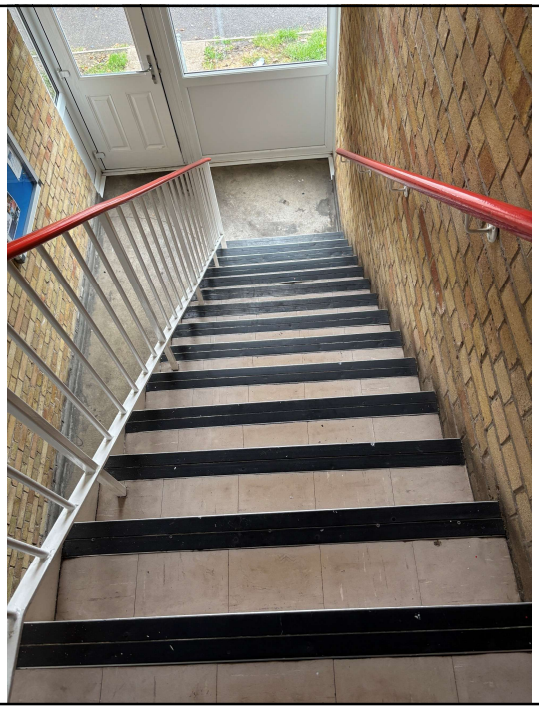
Photo No. 5	All areas were clear at the time of the audit.
