ACCENT HOUSING - FIRE RISK ASSESSMENT

Region :	**South**
Scheme Name :	**26-32 Lawrence Lodge**
Scheme Address :	**Camberley Surrey GU1547Y**
Date of Assessment:	**02/09/2026**
Date of Next Assessment:	**02/09/2027**
FRA Frequency:	**Annual Re-Assessment under the Regulatory Reform (Fire Safety) Order 2005**
Fire & Safety Assessor	**Gary Bredin AIFireE DipFD**

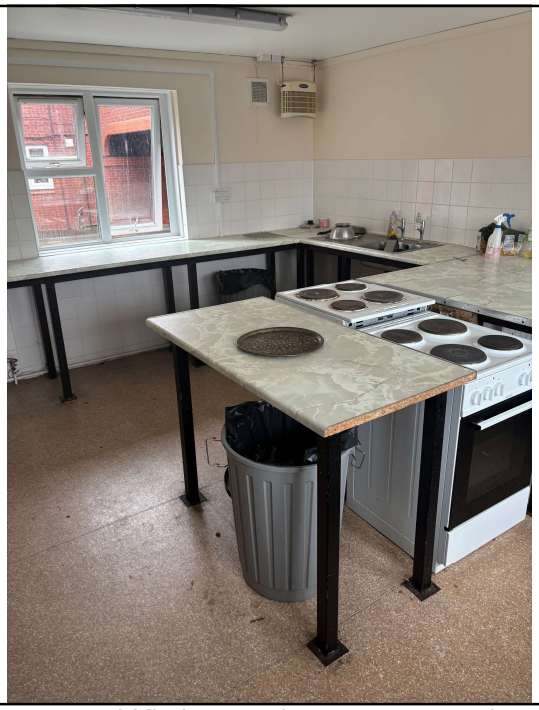
Photo No. 3	Communal Kitchen and escape route clear at the time of the audit

Photo No. 4	Laundry room filters clear at the time of the audit.
