This report shows all the responses to the Fire Risk Assessment survey , including raised tasks.

Asset ID: 31 Denford Court Trent Boulevard, Nottingham

Cover Sheet

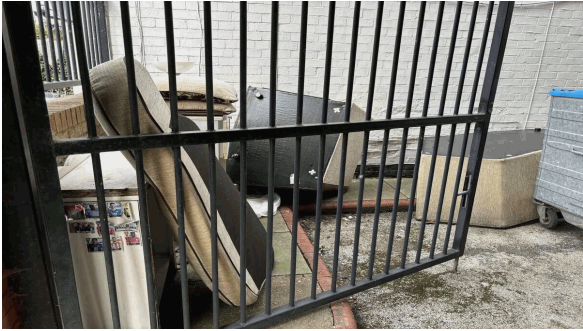
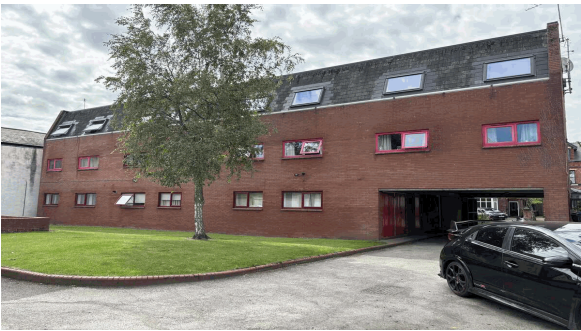
Managed by HP but a sofa has appeared and requires disposal discussion with HP.

| Observation | Priority | Referred To | Required By: | Task ID |
|---|---|---|---|---|
| Discarded sofa bin area. | Internal - Medium | Housing Partner | | |
