ACCENT HOUSING - FIRE RISK ASSESSMENT

Region :	East
Scheme Name :	Thrapston Avenue
Scheme Address :	Calverton Road Nottingham NG5 8LH
Date of Assessment:	10/08/2022
Date of Next Assessment:	09/08/2025
FRA Frequency:	3 Year Re-Assessment
Fire & Safety Assessor	Lynn Betteridge

Scheme Details		Thrapston Avenue
Region:	East	
Scheme Name:	Thrapston Avenue	
Site Address:	Street:	Calverton Road
	Town:	Nottingham
	Post Code:	NG5 8LH
Block & Asset No.	Block 1-7 Asset 685	
Scheme Tel. No:		
Date of this Assessment	10/08/2022	
Date of Next Review	09/08/2025	
Fire Risk Assessment Frequency	3 Years	
Health & Safety Assessment Frequency	3 Years	
Purpose of Fire Risk Assessment	3 Year Re-Assessment	
Fire & Safety Assessor	Lynn Betteridge	
Director of Customer Experience	Alex Liburd	
Customer Partnership Manager	Keith Bowman	
Contract Manager	Kevin Turner	
Scheme Manager/Customer Partner	Denise Watt/Naterlie Bennett	
Other staff in attendance	None	
Use of Building	General Needs	
Approximate Number of occupants	4	
Occupancy Profile	Families	
Familiarity of the occupants	Fully Familiar	
Likely state of the Occupants	Alert	
PEEPs in place where necessary	N/A	
Number of on-site Accent staff	None	
Nu

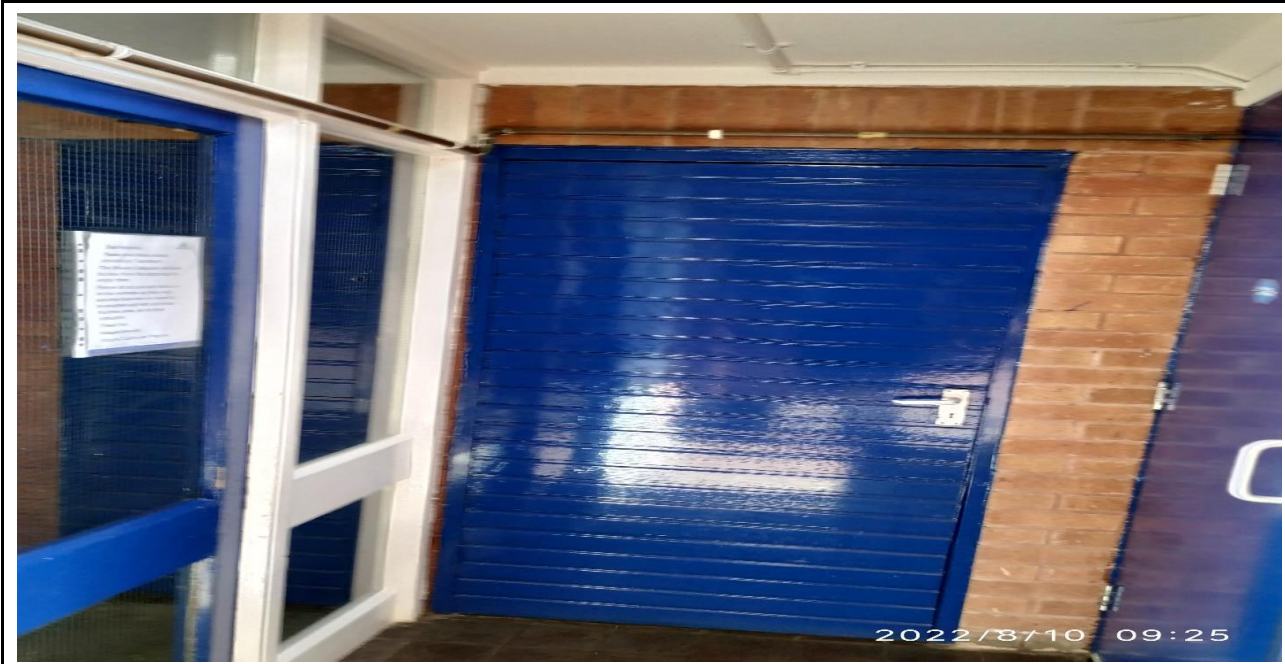
Photo No. 1

Note: Communal area Stairs to right also services cupboard.
Locked storage in front and garden exit to left Georgian wired.

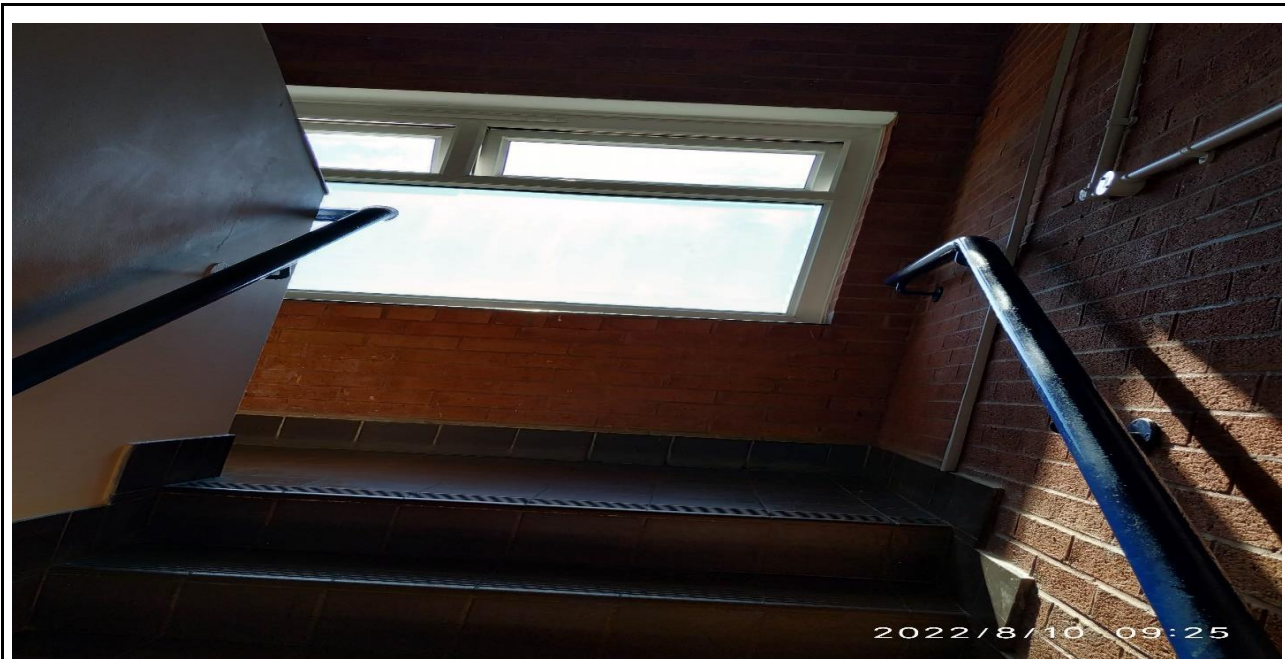
Photo No. 2

Note: Ground to first Floor tiled floors clear from obstructions.

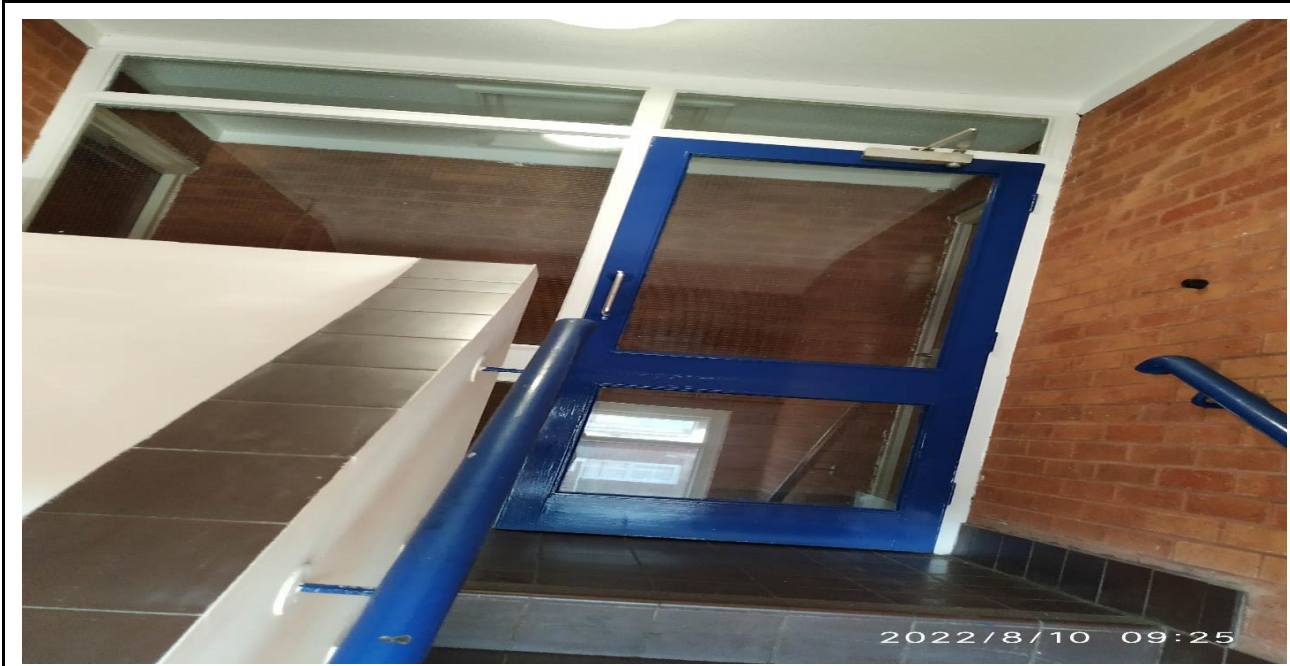
Photo No. 3

12.1	Communal fire doors to FD30s standard and in a serviceable condition,	Yes	Note: One internal Communal Fire door to provide smoke lobby and protect stairwell corridors. See photo 3.	.

Note: First floor communal door georgian wired with self closer
Flats to left and right in smoke lobby and loft hatch

11.5	Loft hatches fire resisting?	Other	Note: Low Risk and within smoke lobby will be added to planned replacement.	.		
11.6	Fire stopping above cross-corridor fire doors within suspended ceiling void of a satisfactory standard	N/A		.

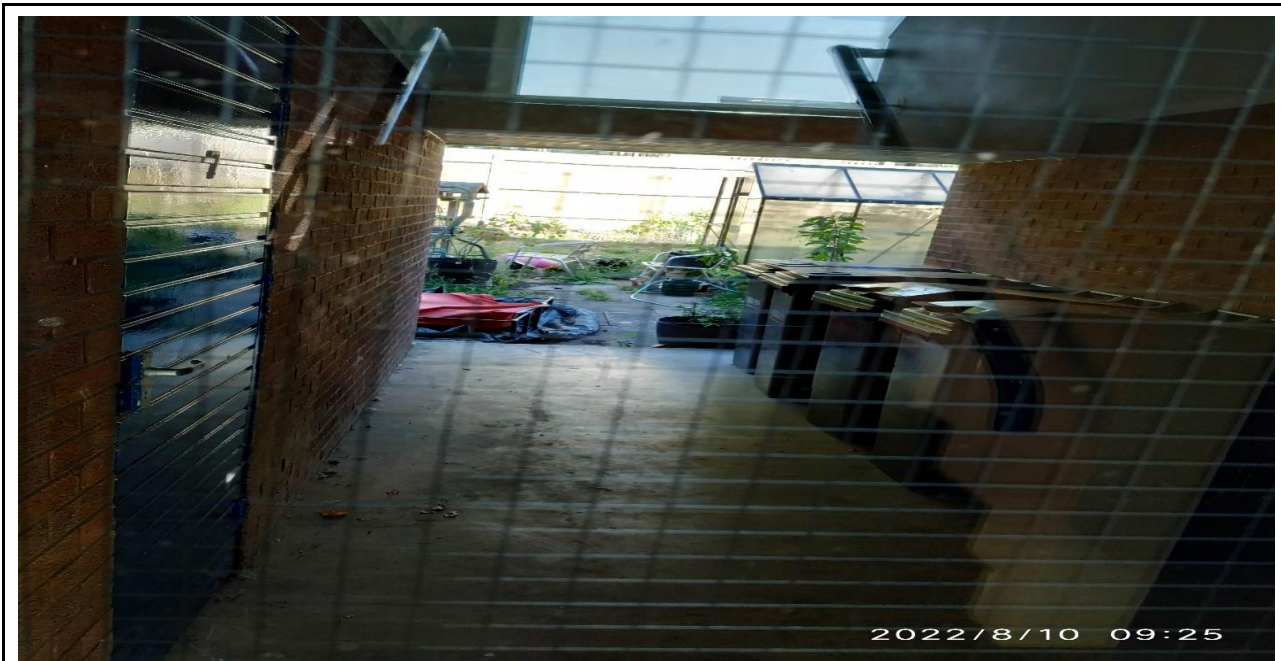
Photo No. 4

7.1	Is the standard of housekeeping adequate?	Other	Note: Well maintained scheme by Accent and by Residents slight issue on inspection CP to clear.	·

7.3	Are combustible materials separated from ignition sources and stored appropriately?	Other	Note: On this inspection some accumulation of furniture or Combustable items. CP tasked re removal.	'

Note: Customer Partner discussed clear exit Route and general
Tidy up around bin storage.
