## ACCENT HOUSING - FIRE RISK ASSESSMENT

| <b>Scheme Name :</b> | <b>6 - 12 Wharfe View</b> |
| <b>Date of Assessment:</b> | <b>18/05/2026</b> |
| <b>FRA Frequency:</b> | <b>3 Year Re-Assessment under the<br/>Regulatory Reform (Fire Safety) Order<br/>2005</b> |

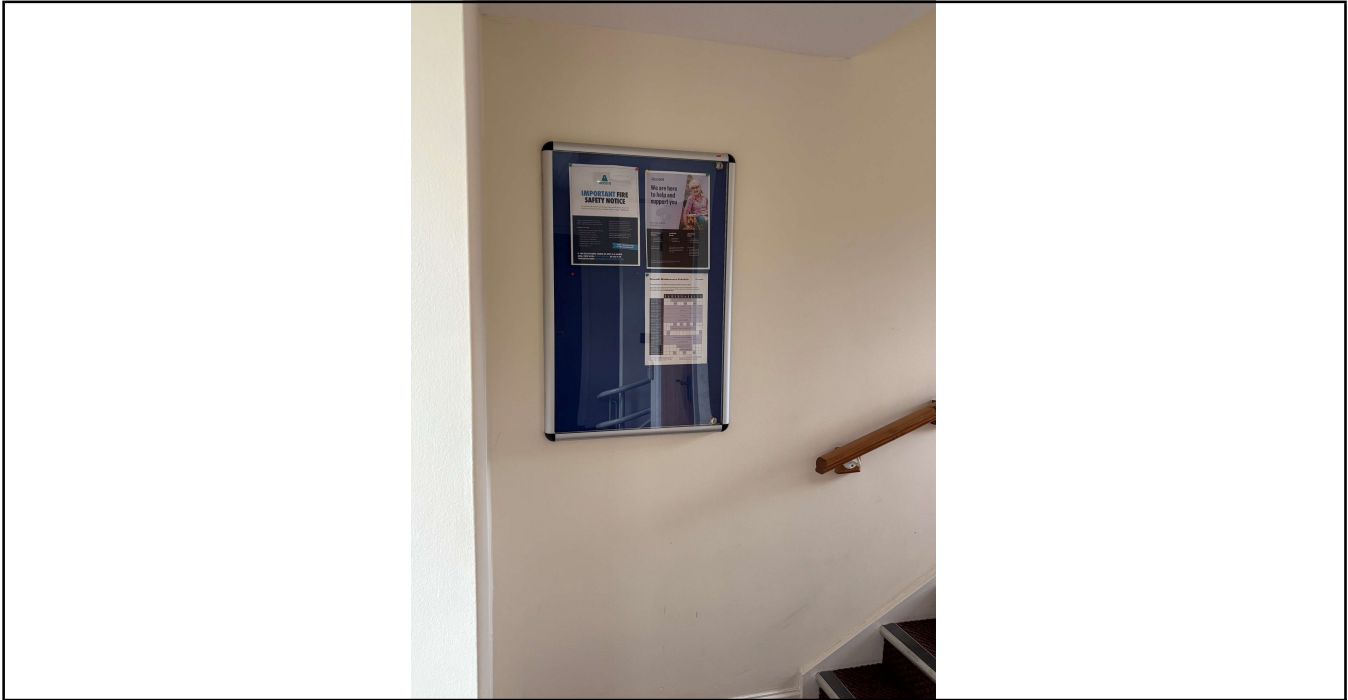
| 11.2 | Is there reasonable limitation of surface finishes that might promote fire spread (walls, floors, ceilings)? | Yes | Signs and notices are behind a Perspex cover. | . | | |

| Photo No. 1 | Covered Notice board |

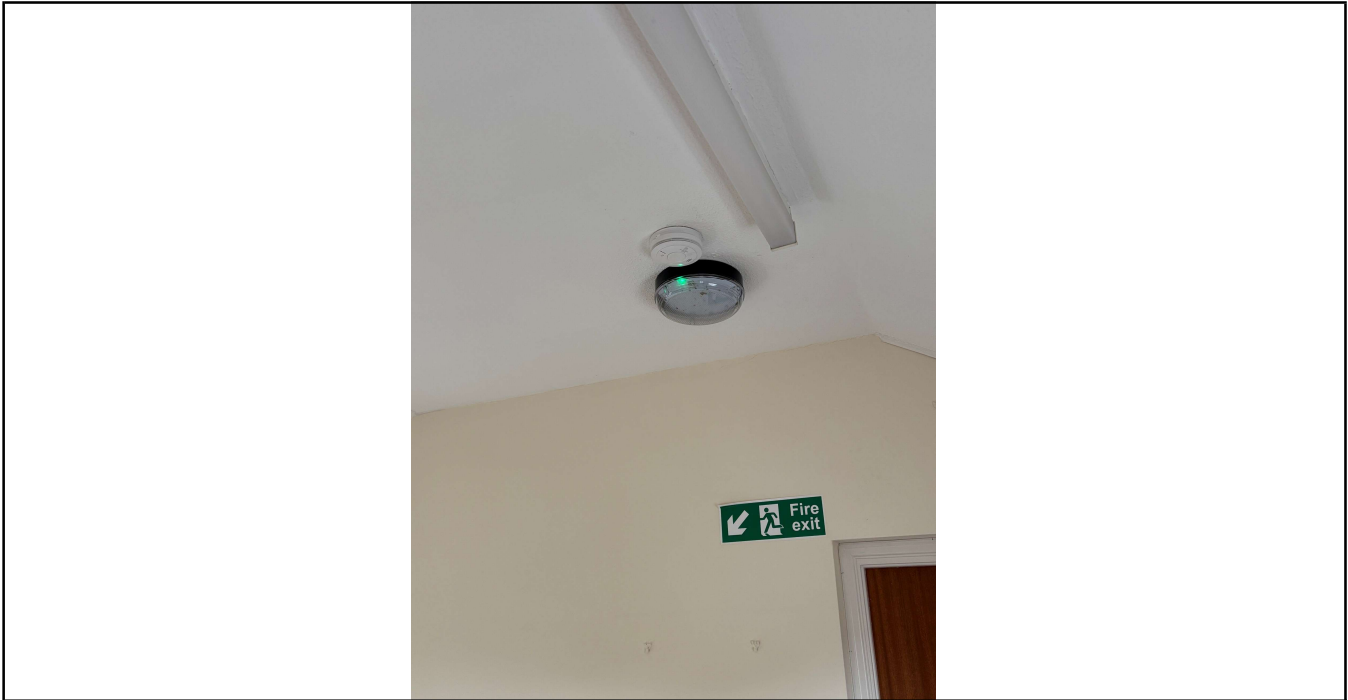
| Building Details | 6 - 12 Wharfe View |
|---|---|
| Emergency Lighting Provision | Non Maintained System - |

| 15.2 | Are all emergency lighting units in good condition and securely fixed to walls/ceilings | Yes | All in good condition at the time of inspection. | . | |

| Photo No. 2 | None Maintained EL and Directional Exit Signage. |

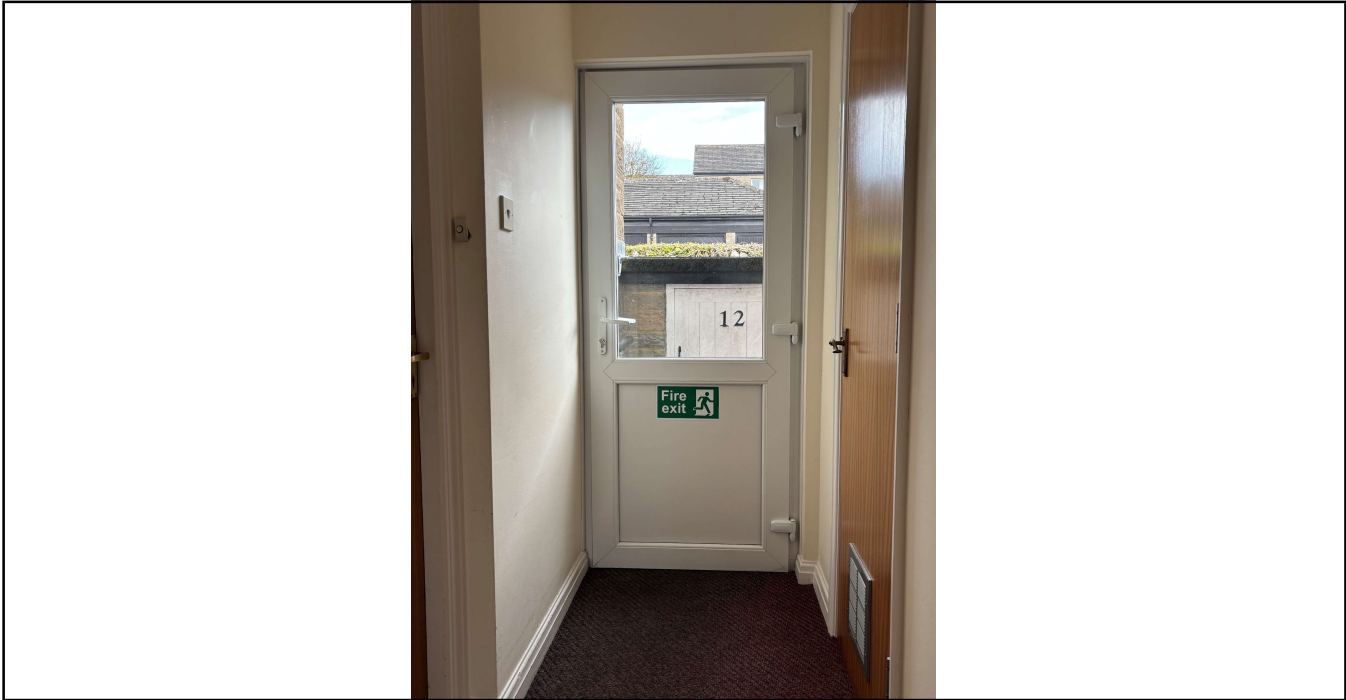
| Photo No. 5 | Alternative exit. |
