This report shows all the responses to the Fire Risk Assessment survey, including raised tasks.

Asset ID: 190 **Lime Kiln Close, Peterborough**

Cover Sheet

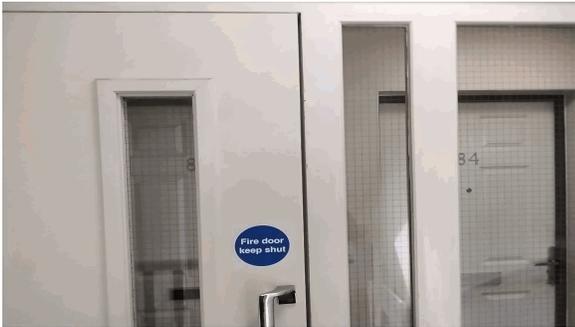
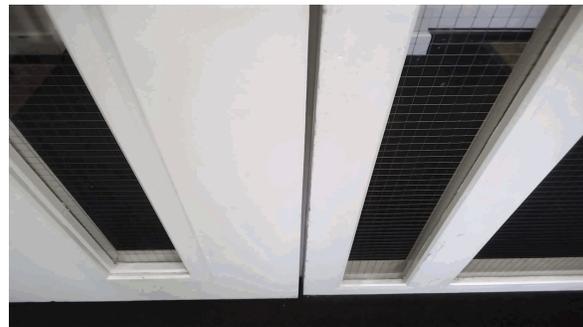
Observation	Priority	Referred To	Required By:	Task ID
Fire door replacement excessive gap door leaf.	Internal - Medium	Building Safety Manager	01/10/2023	1691284

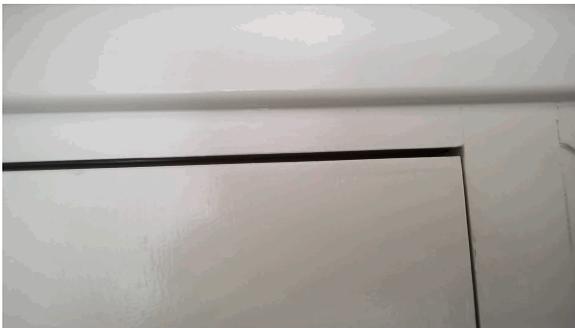
Observation	Priority	Referred To	Required By:	Task ID
New fire door ground floor excessive gaps not adjustable	Internal - Medium	Building Safety Manager	01/10/2023	1691285

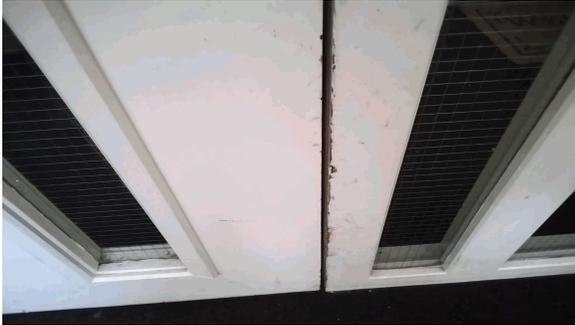
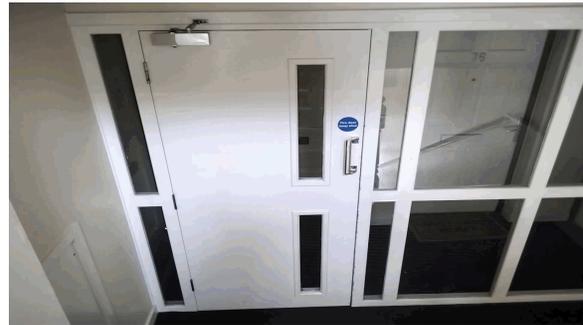
Observation	Priority	Referred To	Required By:	Task ID
Fire door communal adjustment to decrease excessive gaps to 4mm second floor.	Internal - Medium	Building Safety Manager	20/07/2023	1691286

Fire door second floor,oor excessive gap on opening leaf to frame.
