This report shows all the responses to the Fire Risk Assessment survey, including raised tasks.

**Netherton House Clayton Street, Blackburn**

## Cover Sheet

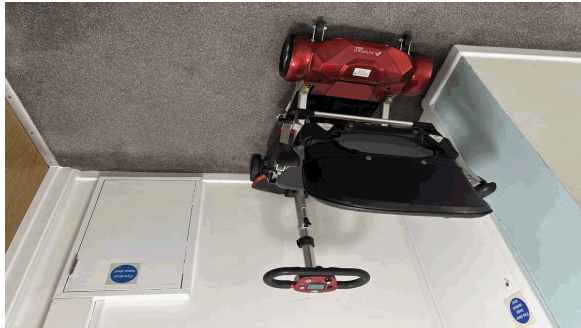
Mobility scooter seen in the communal corridor outside Flat 12. This has been reported previously. SHP informed at time of inspection and followed up by e-mail 21st November 25

| Observation | Priority | Referred To | Required By: | Task ID |
|---|---|---|---|---|
| A mobility scooter is being kept in communal corridor nr Flat 12. This has been observed on previous visits and the customer has been advised to store it in the flat. SHP has been informed via email on 21st Nov 25 | Internal - High | Housing Partner | 28/11/2025 | 2049142 |

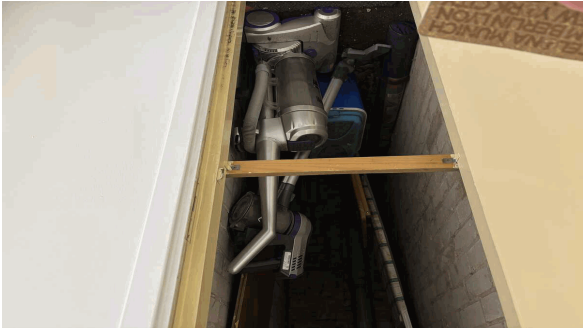
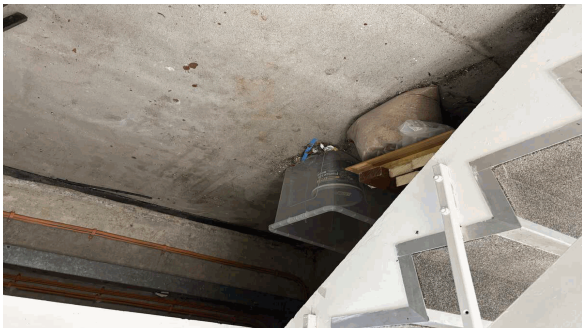
| Comment | Electrical personal items stored in riser cupboard nr Flat 16 |

| Observation | Priority | Referred To | Required By: | Task ID |
|---|---|---|---|---|
| Personal electrical items found in riser cupboard nr Flat 16<br>Items found underneath stairs nr basement door. SHP emailed 21/11/25 | Internal - Low | | | |

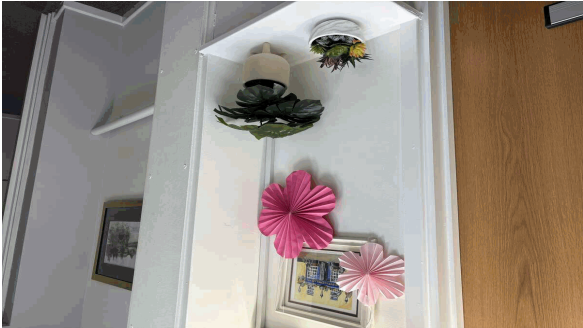
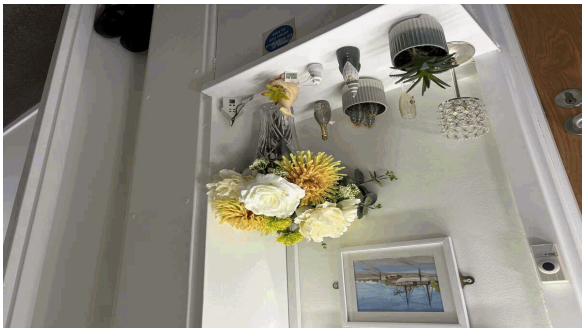
| Comment | Several flats have placed Flammable ornamental items outside their front doors which need to be removed. SHP informed at time of inspection. E-mail sent to SHP 21/12/25 |

| Observation | Priority | Referred To | Required By: | Task ID |
|---|---|---|---|---|
| Several flats are displaying Flammable ornaments outside their front doors which need to be removed.<br>E-mail sent to SHP 21/11/25 | Internal - Low | | | |

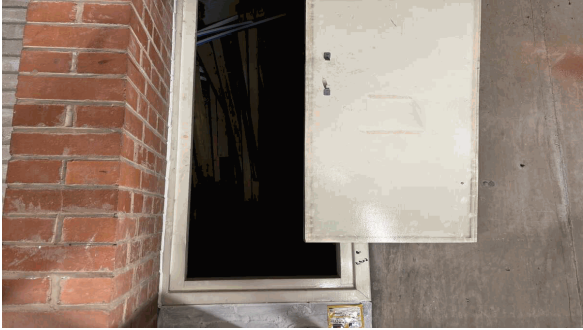
| Observation | Priority | Referred To | Required By: | Task ID |
|---|---|---|---|---|
| A fire door within the boiler room connecting to an ante room has been removed from its hinges and is propped up next to the opening. This requires rehangng and the compartmentation reinstating Work order 1329300 | Repair - Non<br>Emergency | | | |

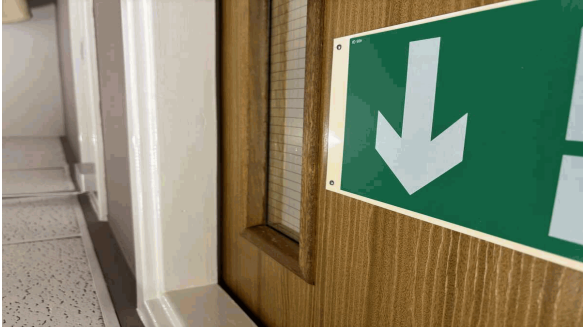
| Observation | Priority | Referred To | Required By: | Task ID |
|---|---|---|---|---|
| Doors in the following locations require attention to ensure they are close fitting and effectively self closing into their frames.<br>1. Corridor door nr Flat 37 - not closing into frame<br>2. Corridor door adjacent to Flat 15 - not closing into frame<br>Work Order 1329300 | Repair - Non<br>Emergency | | | |

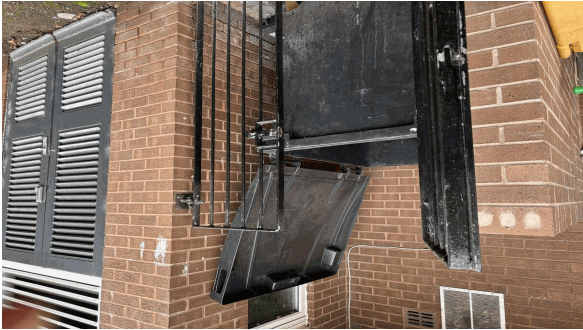
| Comment | Internal bin store clean and tidy. External recycling area away from building.<br>A paper recycling dumpster bin was located adjacent to the building under a canopy and needs to be relocated. SHP informed at time of inspection, bin was moved to a new area. SHP informed formally by e-mail 21st Nov to ensure it stays away from the building. |

| Observation | Priority | Referred To | Required By: | Task ID |
|---|---|---|---|---|
| Large recycling dumpster containing paper stored adjacent to external wall and under a canopy which poses a high fire risk. SHP informed at the time and the dumpster was removed to a safer location. SHP informed by e-mail 21/11/25 to ensure it is stored away from the building | Internal - Low | | | |

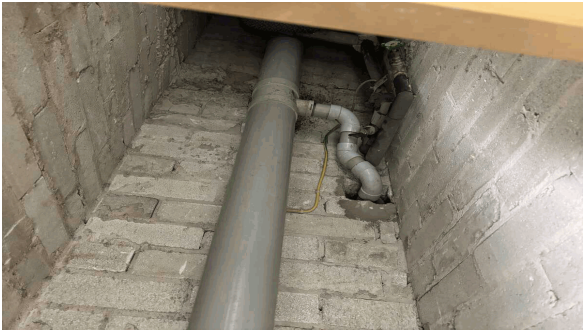
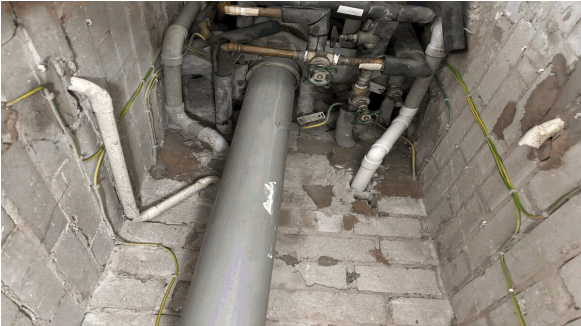
A large number of service/riser cupboards have breaches of the compartmentation due to wires/pipes penetrating but not fire stopped correctly afterwards. A compartmentation survey will be required in all service cupboards.  
A couple of communal fire doors require attention to ensure they are effectively self closing into their frames.  
A fire door in the boiler room was detached from its frame and requires re hanging

| Observation | Priority | Referred To | Required By: | Task ID |
|---|---|---|---|---|
| The majority of service/riser cupboards have breaches of the compartmentation by pipes and cables. A compartmentation survey is required to identify all the areas and all breaches to me reinstated to 1 hour fire resistance. Work Order 1329291 | Repair - Non<br>Emergency | | | |
