**Asset ID: 29**      **Longthorpe Court, Nottingham**

## Cover Sheet

| Purpose of Fire Risk Assessment | 3 year Re-Assessment |
| Type of Fire Risk Assessment | Type 3 (Common Parts and Flats - Non Destructive) |

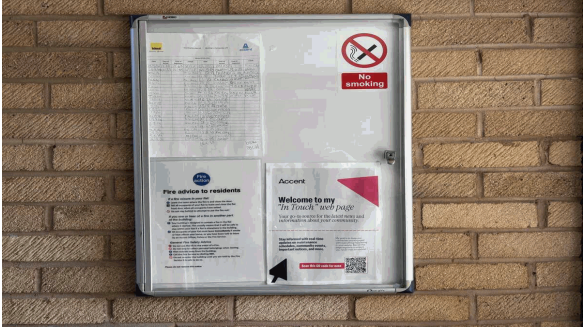
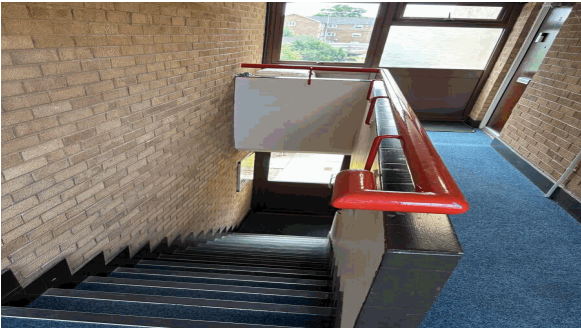
| Observation | Priority | Referred To | Required By: | Task ID |
|---|---|---|---|---|
| New fire routine signage required. | Internal - Low | Housing Partner | | |
| <div><div>A fire routine signage board mounted on a brick wall. It contains a 'No smoking' sign, a fire advice leaflet, and a 'Welcome to my 7th Floor' leaflet.</div><div>A view of an exit staircase with blue carpeting and red handrails. The staircase is located next to a brick wall and a window.</div></div> | | | | |

| Comment | Fire routine notices require updating contact made with the Housing Partner. |

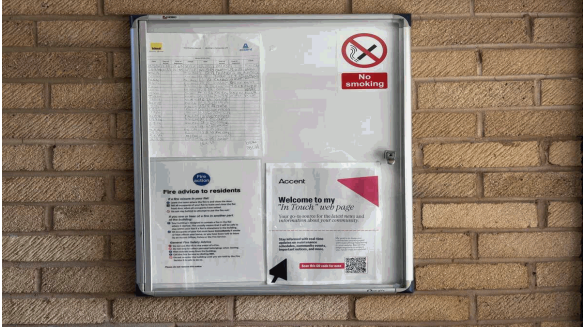
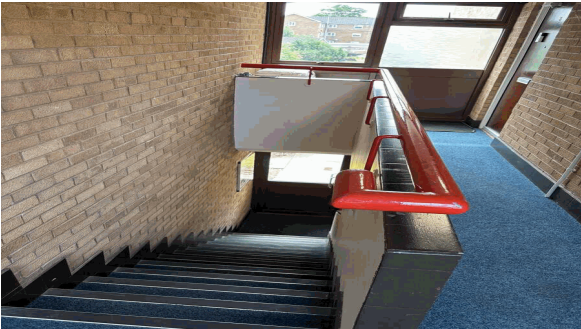
| Observation | Priority | Referred To | Required By: | Task ID |
|---|---|---|---|---|
| New fire routine signage required. | Internal - Low | Housing Partner | | |
| <div><div>A fire routine signage board mounted on a brick wall. It contains a 'No smoking' sign, a fire advice leaflet, and a 'Welcome to my 7th Floor' leaflet.</div><div>A view of an exit staircase with blue carpeting and red handrails. The staircase is located next to a brick wall and a window.</div></div> | | | | |
