## ACCENT HOUSING - FIRE RISK ASSESSMENT

| <b>Scheme Name :</b> | <b>1 - 6 Pye Nest Court</b> |
| <b>Date of Assessment:</b> | <b>22/04/2026</b> |

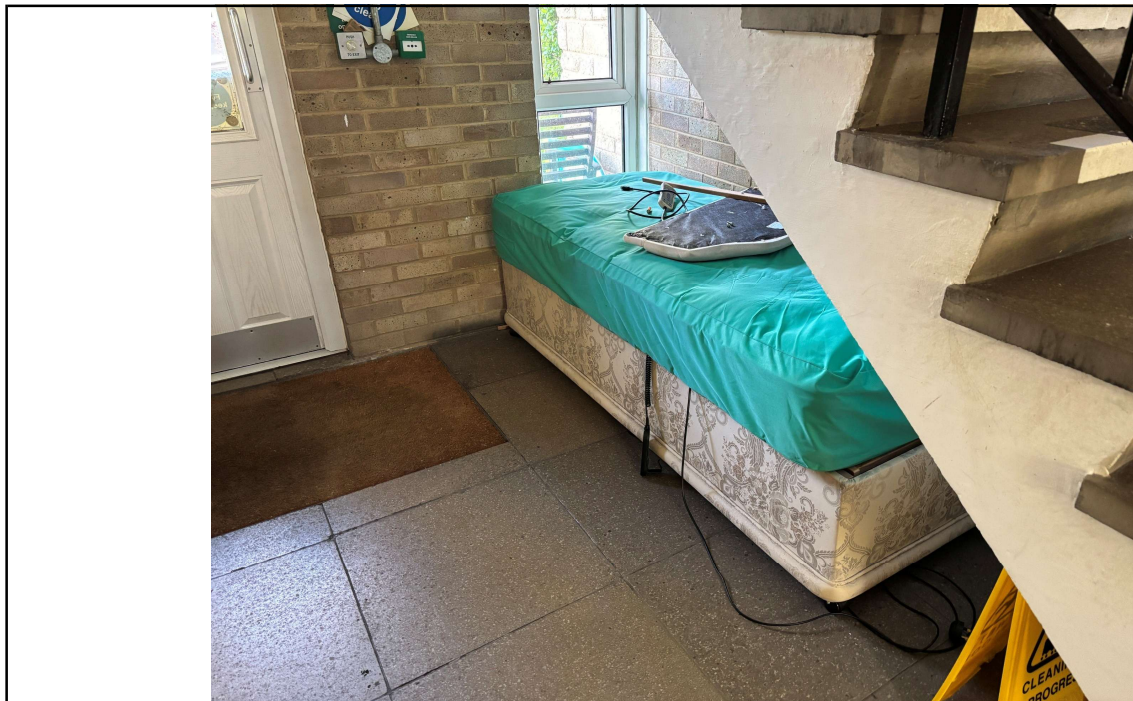
Photo No. 1

| 7.1 | Is the standard of housekeeping adequate? | No | Ther was a bed being stored under the stairs.<br>Housing partner informed. Needs to be removed. | Med | 22/5/26 | Housing<br>Partner |

Bed being stored under stairs to be removed, Housing Partner informed

| Action Plan - Fire | | | | | |
|---|---|---|---|---|---|
| Is the standard of housekeeping adequate? | Ther was a bed being stored under the stairs. Housing partner informed. Needs to be removed. | Med | 22/05/26 | Housing Partner | |

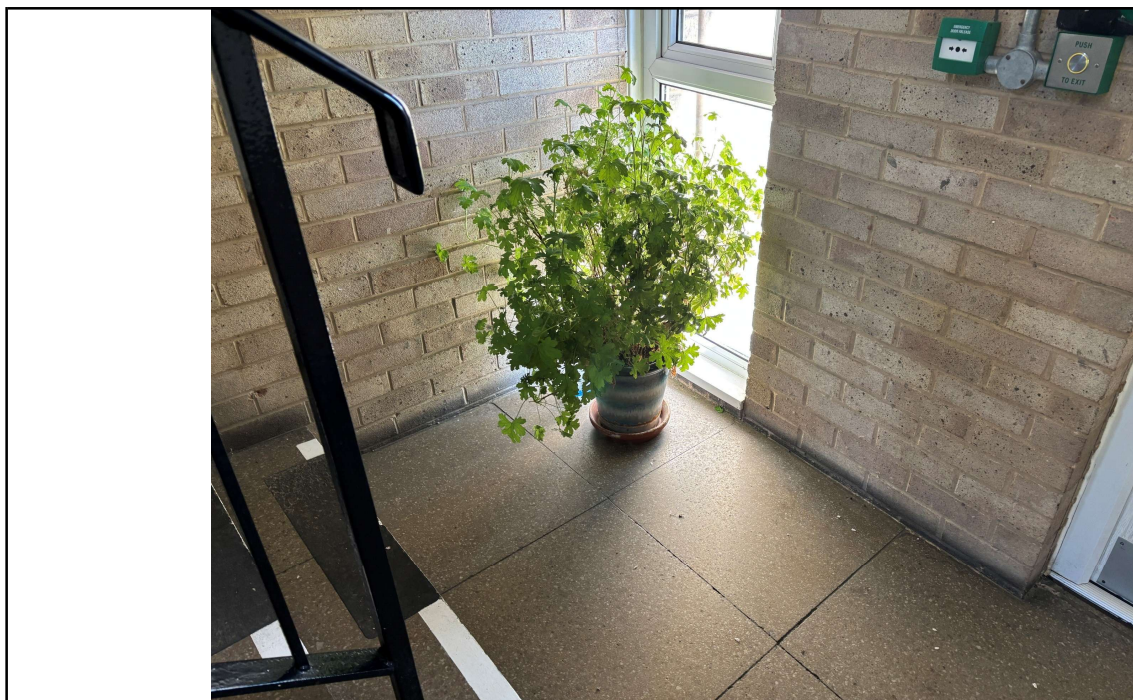
Photo No. 2

Plant and pot on means of escape to be removed, Housing Partner informed.

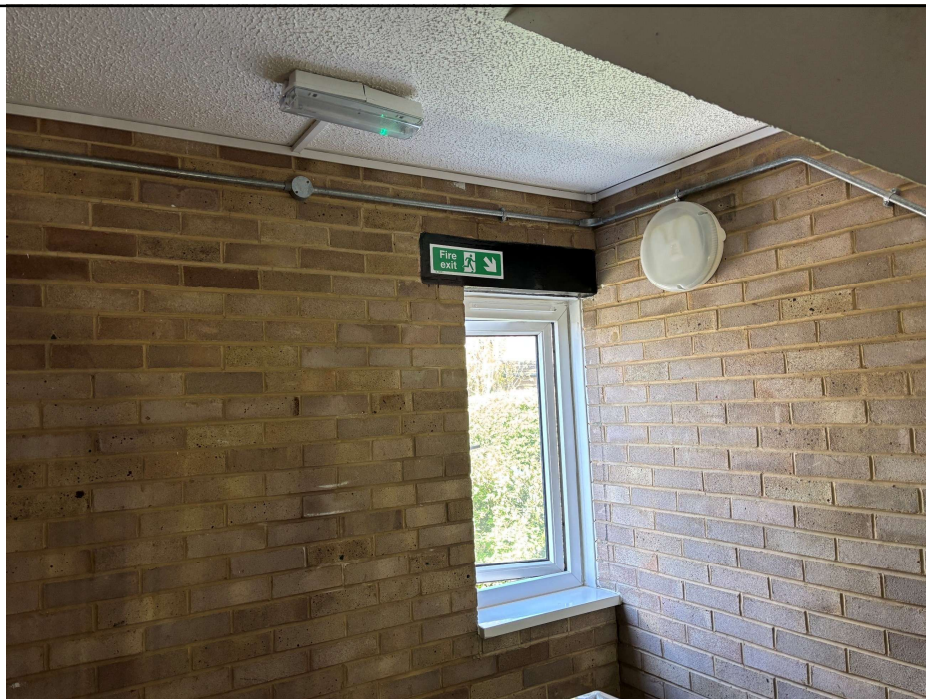
Photo No. 3

| 15.2 | Are all emergency lighting units in good condition and securely fixed to walls/ceilings | Yes | All in good condition at the time of inspection. | . | | |

Fire signage and Non-Maintained Emergency Lighting on each floor.

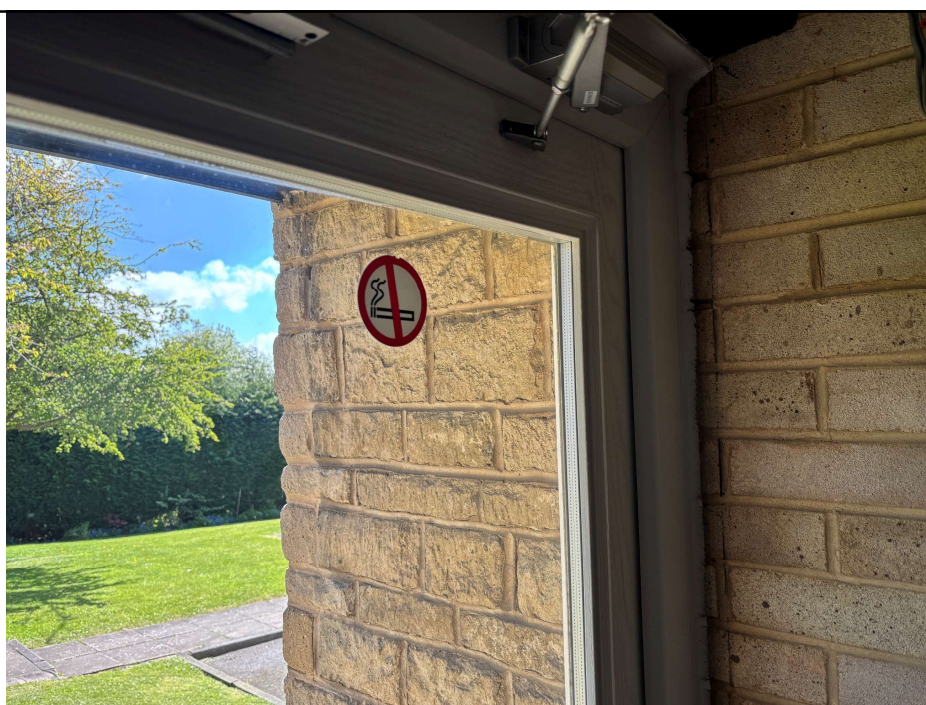
Photo No. 4

| Significant Findings - Fire | | | | | | |
|---|---|---|---|---|---|---|
| 2.1 | Are there any risks associated with smoking in the building? | No | Smoking is not allowed within the communal areas. Smoking is only permitted within flats. There are smoking signs present within the communal areas. | . | | |

No Smoking signs throughout the building.
