## ACCENT HOUSING - FIRE RISK ASSESSMENT

<b>Region :</b>	<b>South</b>
<b>Scheme Name :</b>	<b>Mathon Court</b>
<b>Scheme Address :</b>	<b>1-18 Mathon Court Kennington, Ashford. Kent TN24 9JS</b>
<b>Date of Assessment:</b>	<b>01/11/2023</b>
<b>Date of Next Assessment:</b>	<b>01/11/2026</b>
<b>FRA Frequency:</b>	<b>3 Year Re-Assessment</b>
<b>Fire &amp; Safety Assessor</b>	<b>Gary Bredin</b>

Mathon Court

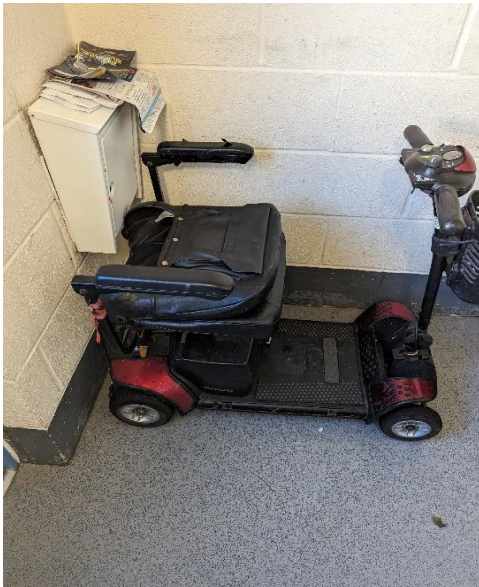
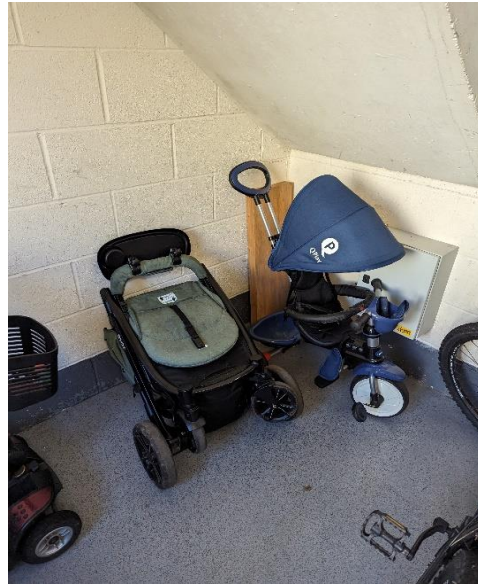
Photo No. 2

Electric scooter being stored in the means of escape.

1.5	Absence of trailing leads and adapters	Yes		.		
1.6	Mobility Scooters - Stored/charged in common areas, purpose built store/resident flat	Yes	Mobility Scooters being stored or charged in block 2-4 at the time of this inspection.	High	ASAP	Partnership Manager 1
<b>2</b>	<b>Smoking:</b>

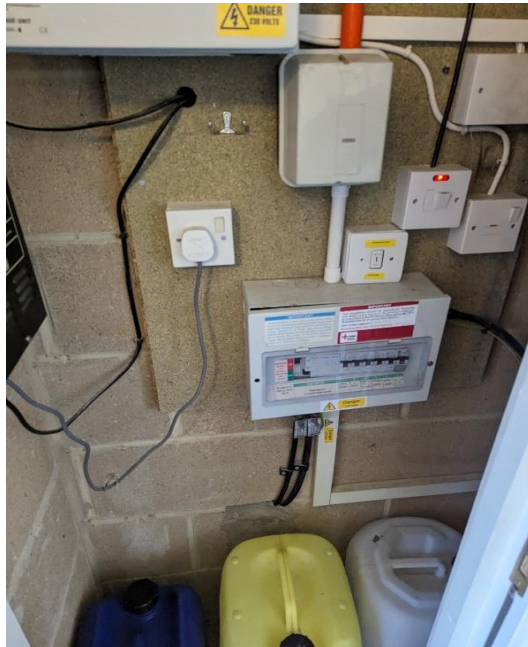
Photo No. 3

Observation - Items being stored in the Electrical cupboard.

7.5	Are hazardous materials stored appropriately (i.e. oxygen cylinders, flammable materials, explosive products, oxidising products, aerosols)	Other	Unknown liquids being stored in the electrical cupboard.	Med	1/12/23	Partnership Manager 1
<b>8</b>	<b>Furniture/furnishings on escape routes and other communal areas:</b>

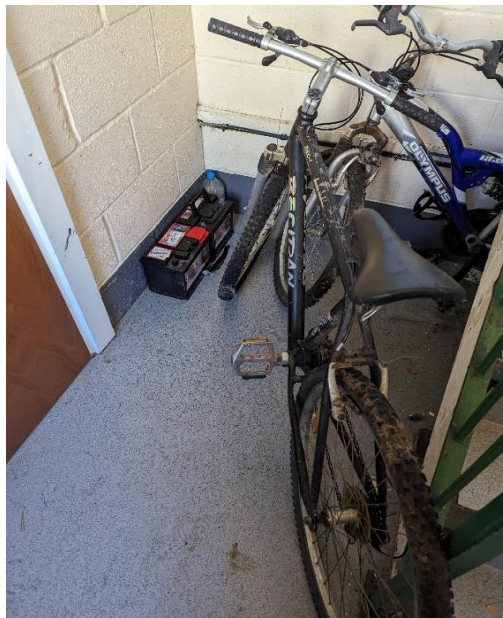
Photo No. 4

Observation- Items are being stored in the communal areas.

10.2	Escape routes unobstructed and safe to use?	Other	General items stored in the area at the base of the stairs. Managed approached adopted, CP monitors compliance	.

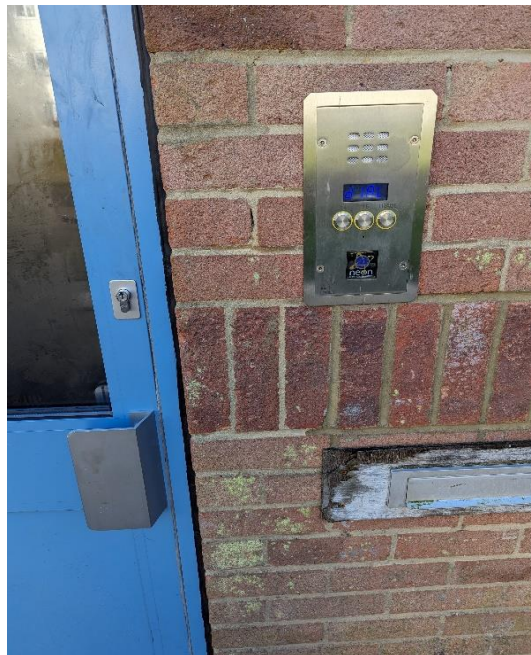
Photo No. 7

Observation - External electronic door entry system in place and manual on exit. Thumb turn exit sign installed during the audit.

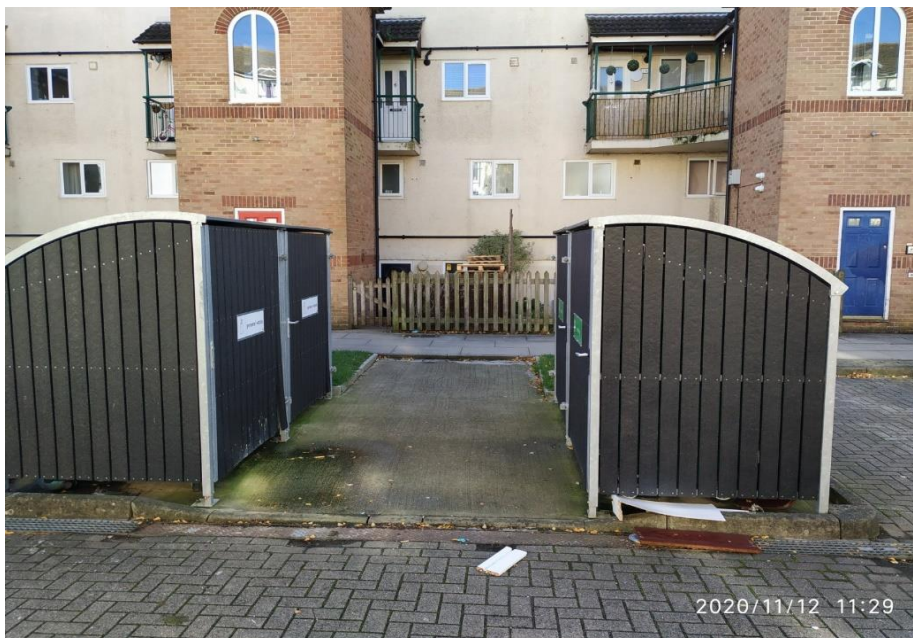
Photo No. 8

Observation - Satisfactory location and condition of bin area
