This report shows all the responses to the Fire Risk Assessment survey , including raised tasks.

Asset ID: 46 Yarwell Court Highfield Crescent, Kettering

| Type of Fire Risk Assessment | Type 1 (Common Parts Only - Non Destructive) |

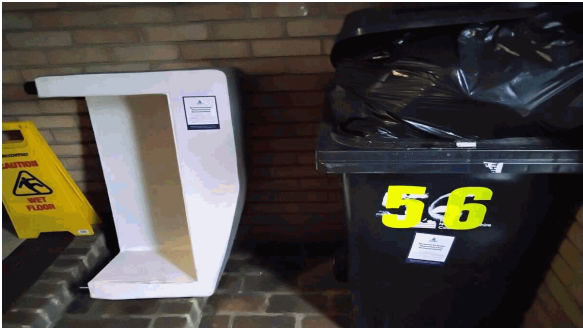
| Observation | Priority | Referred To | Required By: | Task ID |
|---|---|---|---|---|
| Flat 56 has refuse storage in the communal.Housing partner has contacted the resident to remove and fire safety officer has stickard the items. | Internal - Medium | Housing Partner | 03/10/2024 | 1869789 |

I have discussed with the housing partner at the time of inspection that a resident has stored a refuse bin near to final exit. Removal notice applied and letter sent to resident to remove.
