This report shows all the responses to the Fire Risk Assessment survey, including raised tasks.

**Asset ID: 15**      **Black Prince Avenue, Peterborough**

## Cover Sheet

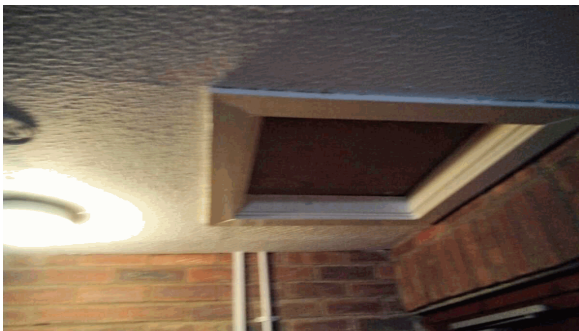
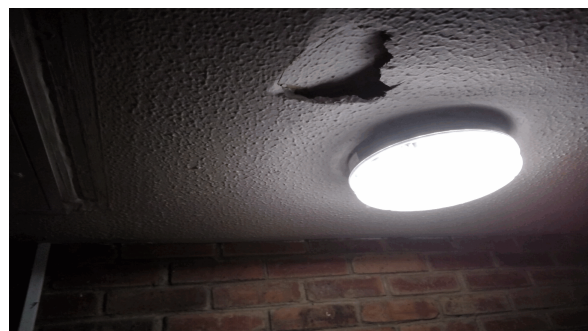
| Observation | Priority | Referred To | Required By: | Task ID |
|---|---|---|---|---|
| 2 blocks require remedial work on second floor ceilings coated in Artex ,a hole in one ceiling and a new fire resisting loft hatch. Blocks 99-105 & 115-121 | Internal - Medium | Building Safety Manager | 01/09/2023 | 1681821 |

| Comment | 2 blocks require remedial works one is a hole in the ceiling the other a new fire resistant loft hatch. |
