## ACCENT HOUSING - FIRE RISK ASSESSMENT

<b>Region :</b>	<b>East</b>	
<b>Scheme Name :</b>	<b>19-24 Heyford Close</b>	
<b>Scheme Address :</b>	<b>Peterborough PE47PR</b>	<b>0</b>
<b>Date of Assessment:</b>	<b>15/01/2026</b>	
<b>Date of Next Assessment:</b>	<b>15/01/2029</b>	
<b>FRA Frequency:</b>	<b>3 Year Re-Assessment under the Regulatory Reform (Fire Safety) Order 2005</b>	
<b>Fire &amp; Safety Assessor</b>	<b>Gary Bredin AIFireE DipFD</b>

This Fire Risk Assessment has been conducted upon the instruction of Accent Housing.

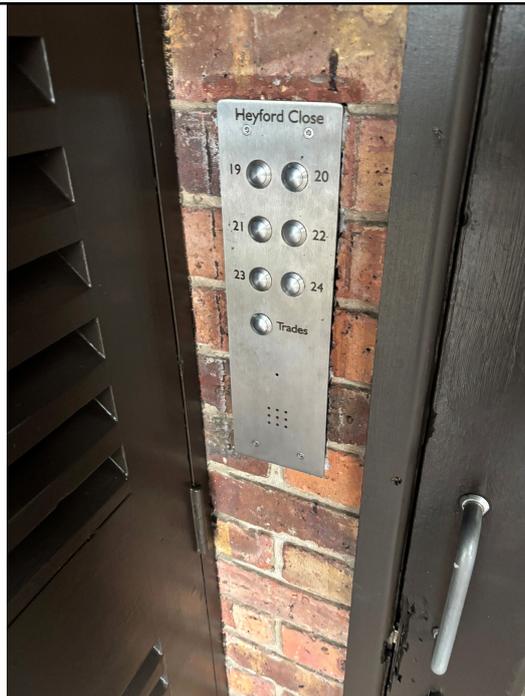
Photo No. 1

Electronic door entry system in place.

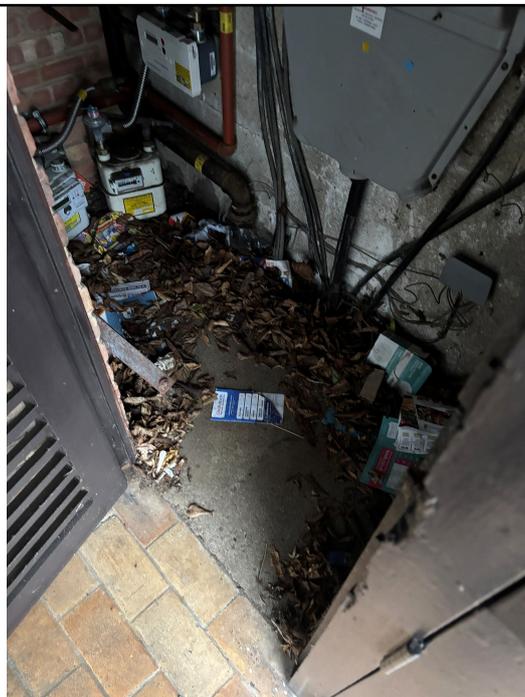
Photo No. 2

3.1	Adequate security against arson?	Yes		.		
3.2	Is there an absence of unnecessary fire load in close proximity to building?	No	Electrical intake cupboard requires clearing of rubbish, leaves etc. HP Dealing.	.

7.2	Are all electrical/intake/service cupboards secure and free from general waste, contractors waste and residents personal items.	No	Electrical intake cupboard requires clearing of rubbish, leaves etc. HP Dealing.	.

Electrical intake cupboard needs clearing of rubbish. HP dealing.

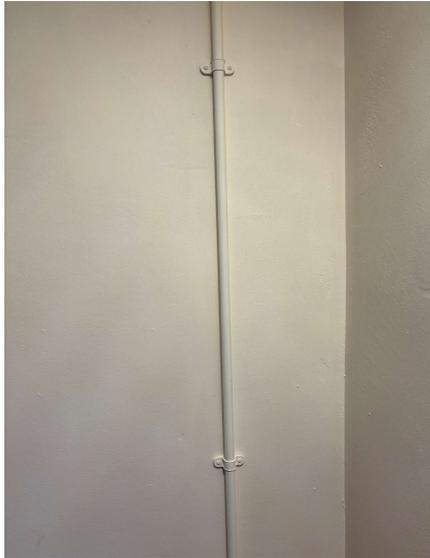
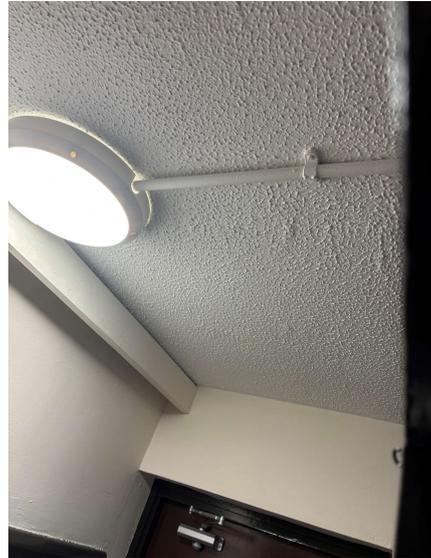
Photo No. 3

9.1	Are there other significant fire hazards that are inadequately controlled?	Yes	Newley installed cable trunking needs to be fitted with metal clips every 300mm to comply with the latest 18th Edition wiring regulations. Job no 1346005	.	
<b>Fire Protection Measures</b>					
<b>10</b>	<b>Means of Escape from Fire:</b>

Plastic conduit requires metal clips to comply to the 18th edition wiring re

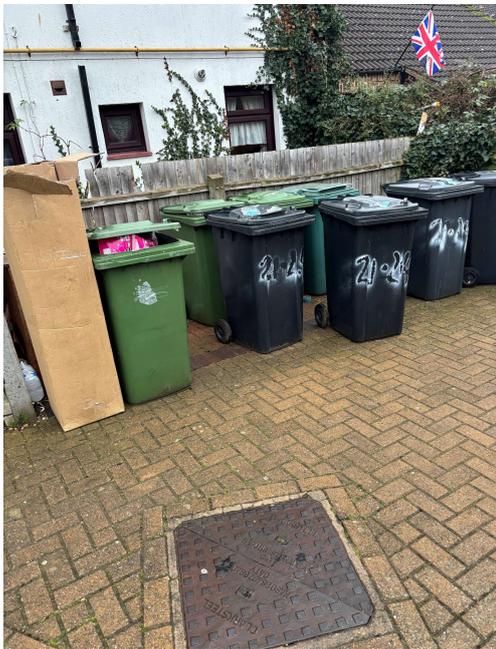
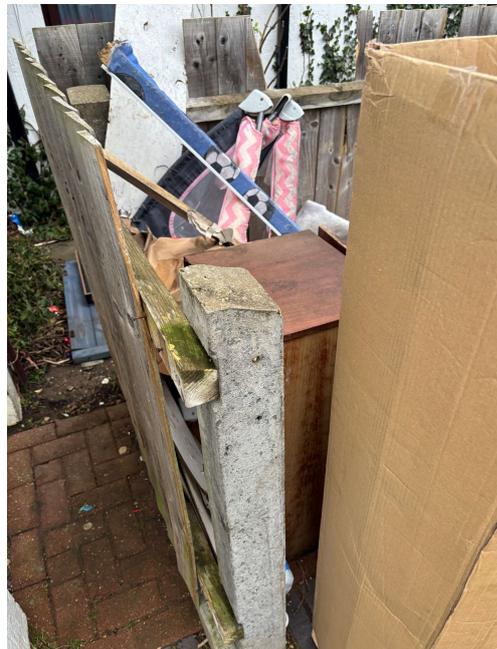
Photo No. 4

7.1	Is the standard of housekeeping adequate?	No	Although there were some fly tipping in the bin area and rubbish in the intake cupboard the HP is working with the residents to keep all areas clear.	.

7.3	Are combustible materials separated from ignition sources and stored appropriately?	Yes		.	
7.4	Are unnecessary accumulations of combustible materials or waste avoided?	No	Fly tipping in the bin area Job raised for clearance by the HP.	.

Fly tipping within the bin store. HP Dealing.

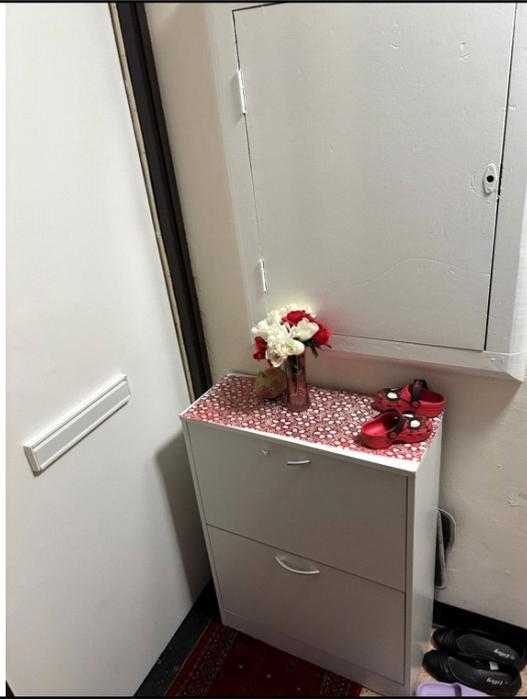
Photo No. 5

Some items were found in the means of escape and require removing. HP Dealing.

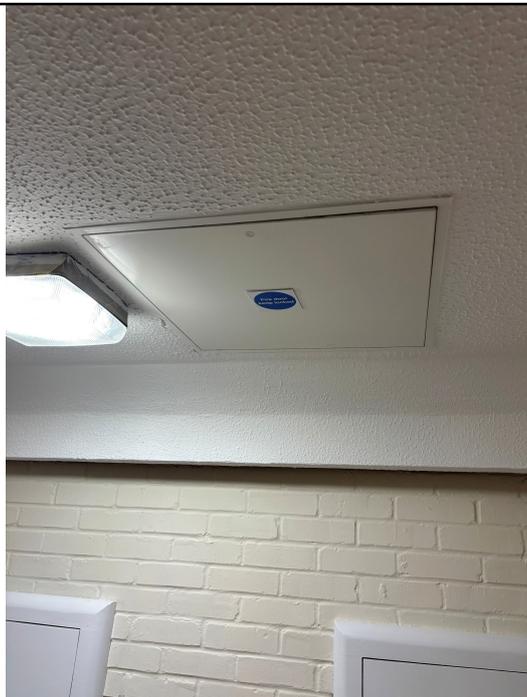
Photo No. 6

Loft Hatch complies to the latest regulations.
