## **ACCENT HOUSING - FIRE RISK ASSESSMENT**

| <b>Scheme Name :</b> | <b>13-18 The Martindales</b> |
| <b>Scheme Address :</b> | <b>The Martindales<br/>Clayton-Le-Woods<br/>PR6 7TJ</b> |
| <b>Date of Assessment:</b> | <b>9th Sept 26</b> |

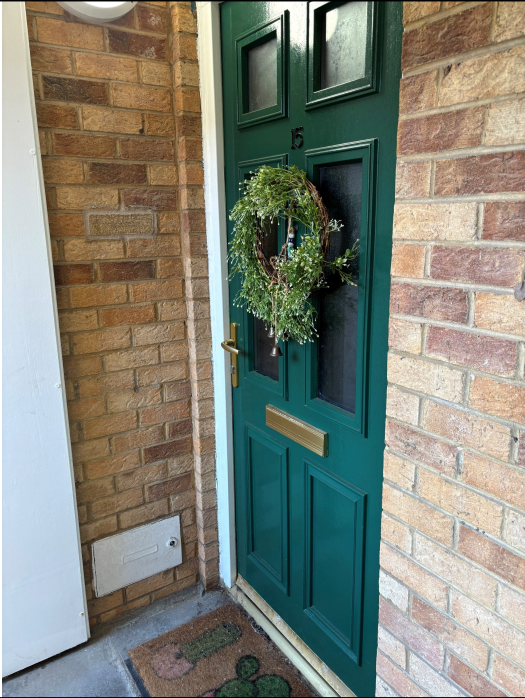
| Photo No. 1 | Flammable personal items outside Flat 15 |

| 7.1 | Is the standard of housekeeping adequate? | No | Flammable personal items were found outside Flats 15 & 18. HP tasked to arrange removal. | Low | 30/9/26 |

| Action Plan - Fire | | | | | |
|---|---|---|---|---|---|
| Is the standard of housekeeping adequate? | Flammable personal items were found outside Flats 15 & 18. HP tasked to arrange removal. | Low | 30/09/26 | Housing Partner | 2181413 |
