This report shows all the responses to the Fire Risk Assessment survey, including raised tasks.

**Asset ID: 708**      **6 - 11 Barton Close, Peterborough**

## Cover Sheet

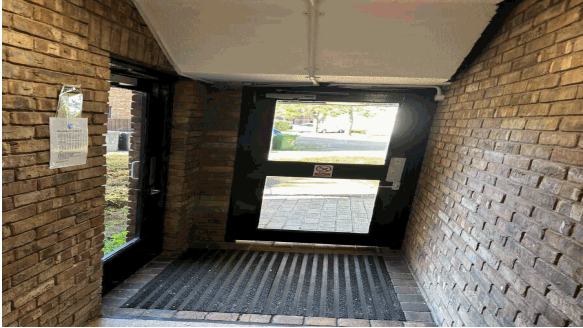
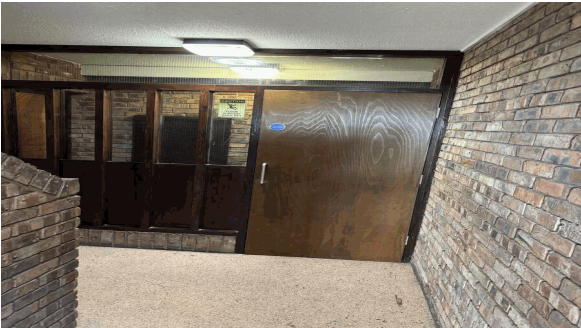
Main route for means of escape clear leading to final exit and safe air.

Escape route provides a clear pathway to final exit.

| Observation | Priority | Referred To | Required By: | Task ID |
|---|---|---|---|---|
| Clear means of escape across the scheme. | No Action | | | |
