# Fire Risk Assessment Report

**Asset ID:** 33419      **Lodge Square Cow Lane, Burnley**

Type 1 (Common Parts Only - Non Destructive)

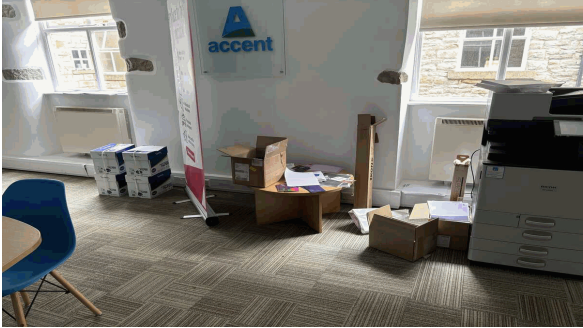
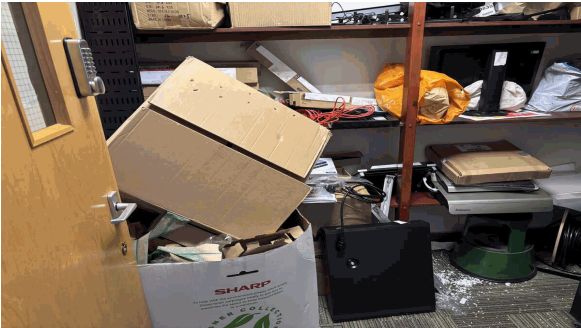
General housekeeping within all areas of the office is not as good as it should be. There are boxes of paper and leaflets in all rooms and general build up of flammable items in store rooms. E-mail sent to Housing team managers to arrange a clean up 4/9/25

| Comment | Items in IT server room and printer area are in close proximity to electrical ignition sources. |

| Observation | Priority | Referred To | Required By: | Task ID |
|---|---|---|---|---|
| General housekeeping in the office is not as good as it should be. Lots of boxes filled with paper and leaflets left lying around. Store rooms were full of flammable items. Recommend a tidy up with a designated storage area and all unwanted items disposed of | Internal - Medium | | | |

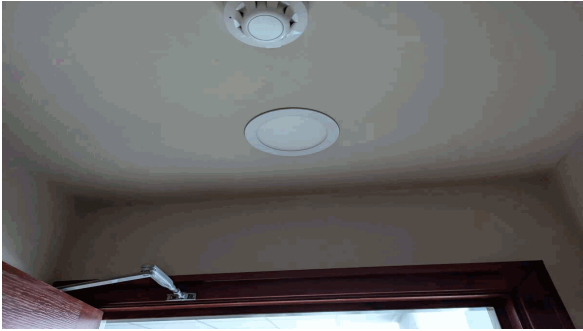
| Comment | A lightbulb has failed in the lobby between the office and the rear exit. This means the area is pitch black and presents a hazard in being able to access the door to the rear escape and creates a fall hazard as there are steps down. Repair order sent |

| Observation | Priority | Referred To | Required By: | Task ID |
|---|---|---|---|---|
| Bulb in the foyer of the rear escape door requires replacing to ensure the area is illuminated should an evacuation be required. | Repair - Non<br>Emergency | | | |
