## **ACCENT HOUSING - FIRE RISK ASSESSMENT**

| <b>Scheme Name :</b> | <b>22 - 28 Wharfe View</b> |
| <b>Date of Assessment:</b> | <b>18/05/2026</b> |

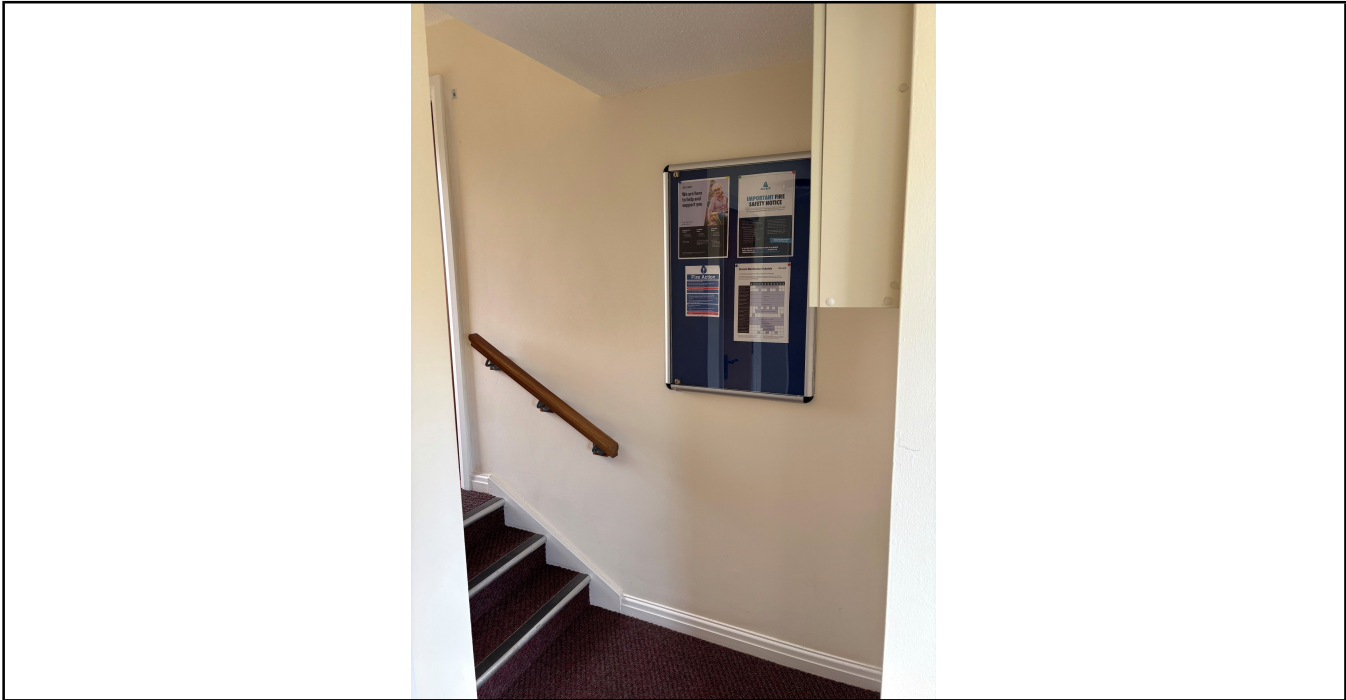
| Photo No. 1 | Covered Notice board |

| 11.2 | Is there reasonable limitation of surface finishes that might promote fire spread (walls, floors, ceilings)? | Yes | Signs and notices are behind a Perspex cover. | . | | |

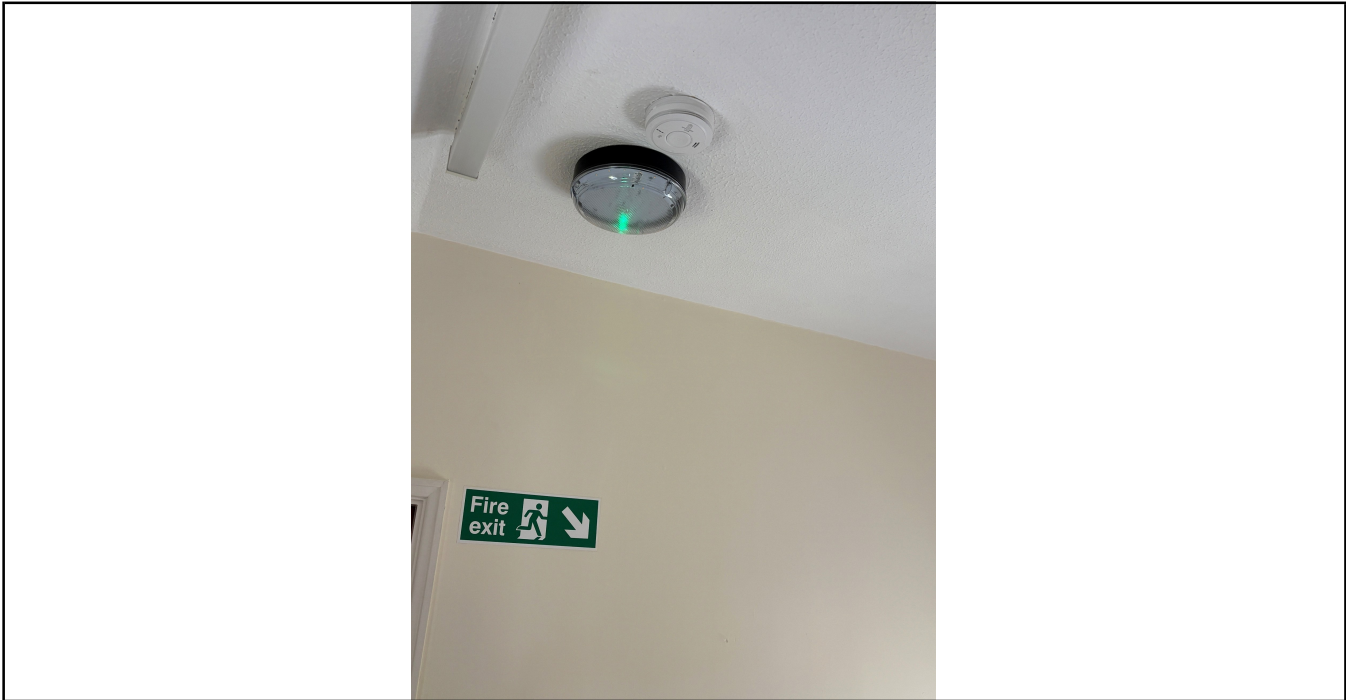
| Photo No. 2 | None Maintained EL and Directional Exit Signage. |

| 15.1 | Is the emergency lighting correctly specified and installed as per BS 5266-1:2016 | Yes | | . | |
| 15.2 | Are all emergency lighting units in good condition and securely fixed to walls/ceilings | Yes | All in good condition at the time of inspection. | . | |

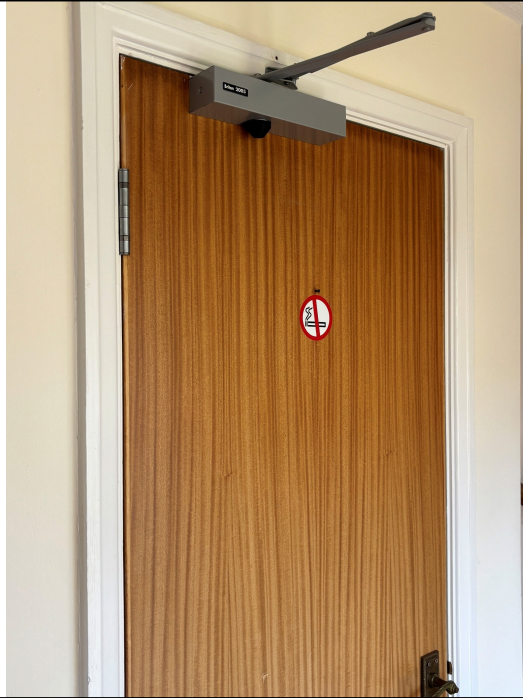
Photo No. 3

| Significant Findings - Fire | | | | | | |
|---|---|---|---|---|---|---|
| 2.1 | Are there any risks associated with smoking in the building? | No | Smoking is not allowed within the communal areas. Smoking is only permitted within flats. There are smoking signs present within the communal areas. | . | | |

No Smoking

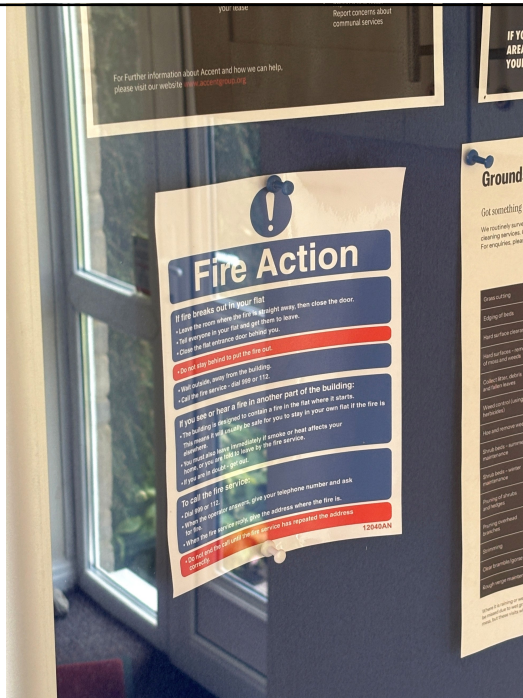
Photo No. 4

| 16.1 | Are the correct Fire Action/Advice notices displayed in prominent locations within the common areas? | Yes | The correct Notices are displayed throughout the scheme as this scheme is designated with a stay put stay safe evacuation strategy being purpose built. There are smoke detectors in the communal area which is not in keeping with the current evacuation strategy. Further investigations to be carried out by FS Manager to determine the correct Evacuation policy. | Low | Fire Safety Manager |

Fire Action Notice.

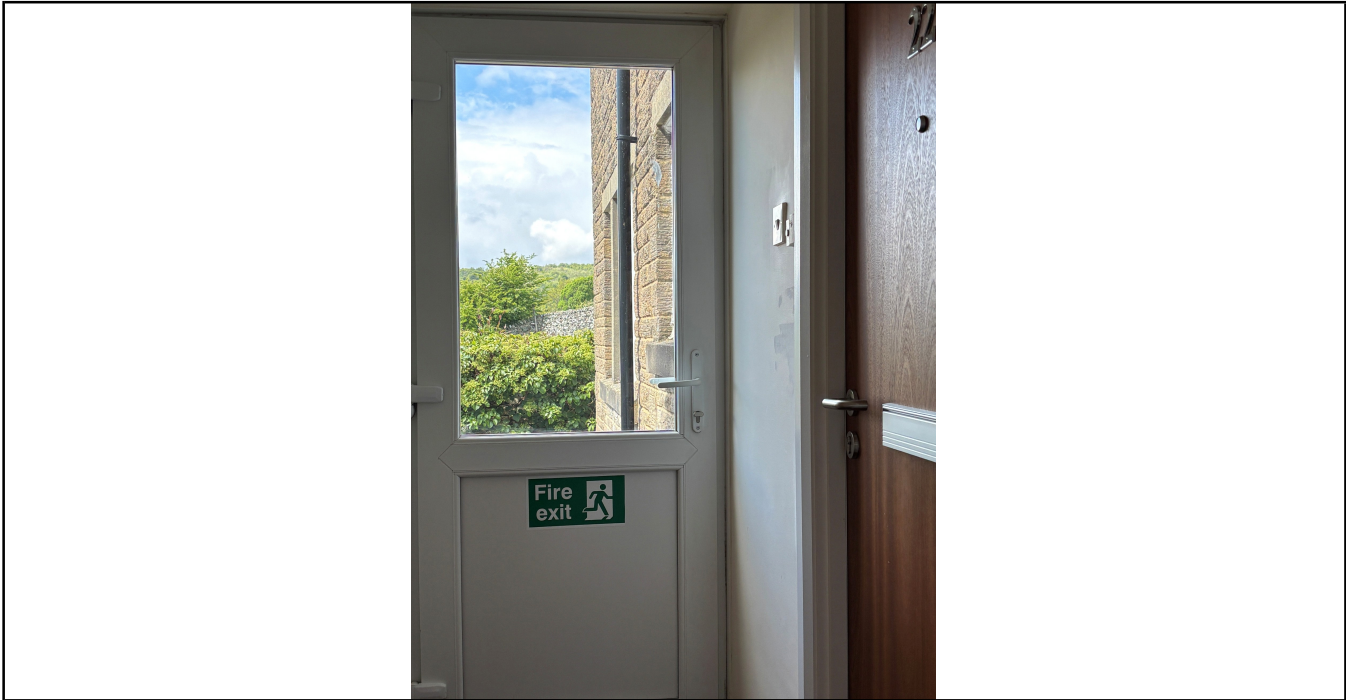
| Photo No. 5 | Alternative exit. |

| 10.3 | Exits easily and immediately openable where necessary, without a key? | Yes | Thumb turns on both exits to the building. | . | | |
