## ACCENT HOUSING - FIRE RISK ASSESSMENT

| <b>Scheme Name :</b> | <b>1-4 Hebbes House</b> |
| <b>Scheme Address :</b> | <b>Wheelwright Way<br/>Biddenham<br/>MK40 4XY</b> |
| <b>Date of Assessment:</b> | <b>12/03/2026</b> |

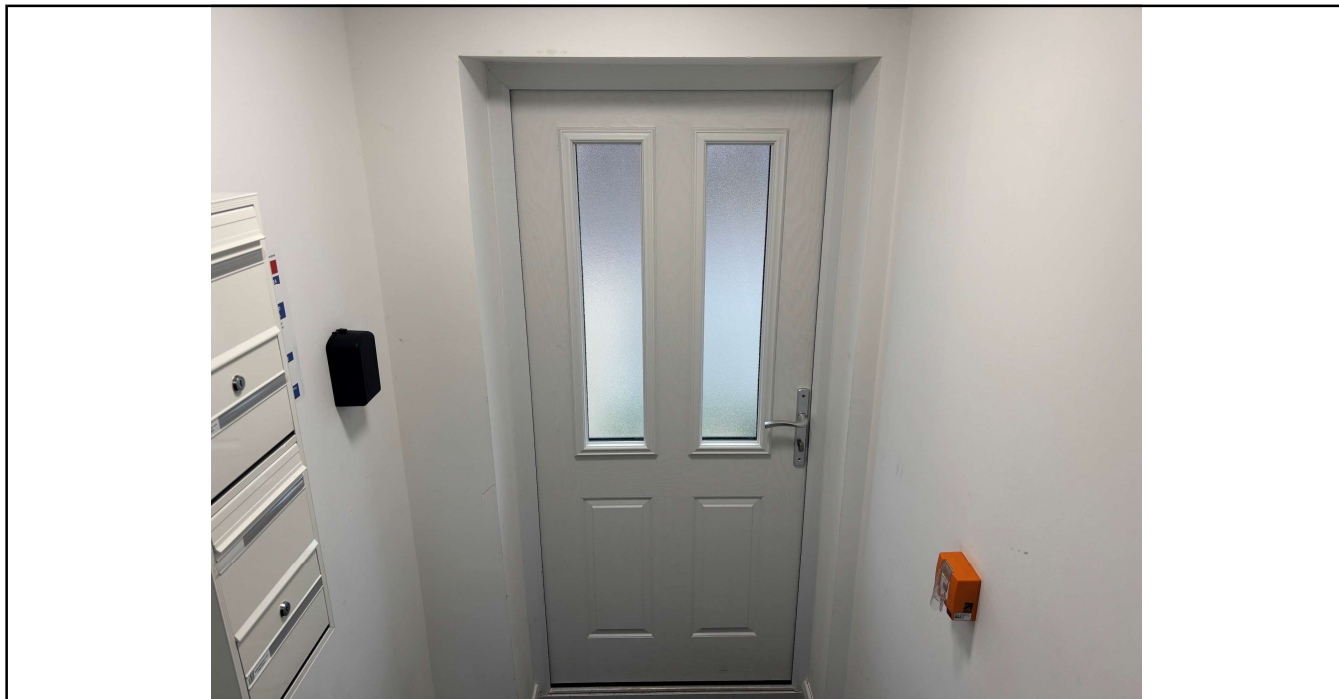
Photo No. 1

Entrance Door Straight access to flats 3-4 head of stairs.  
AOV controller.

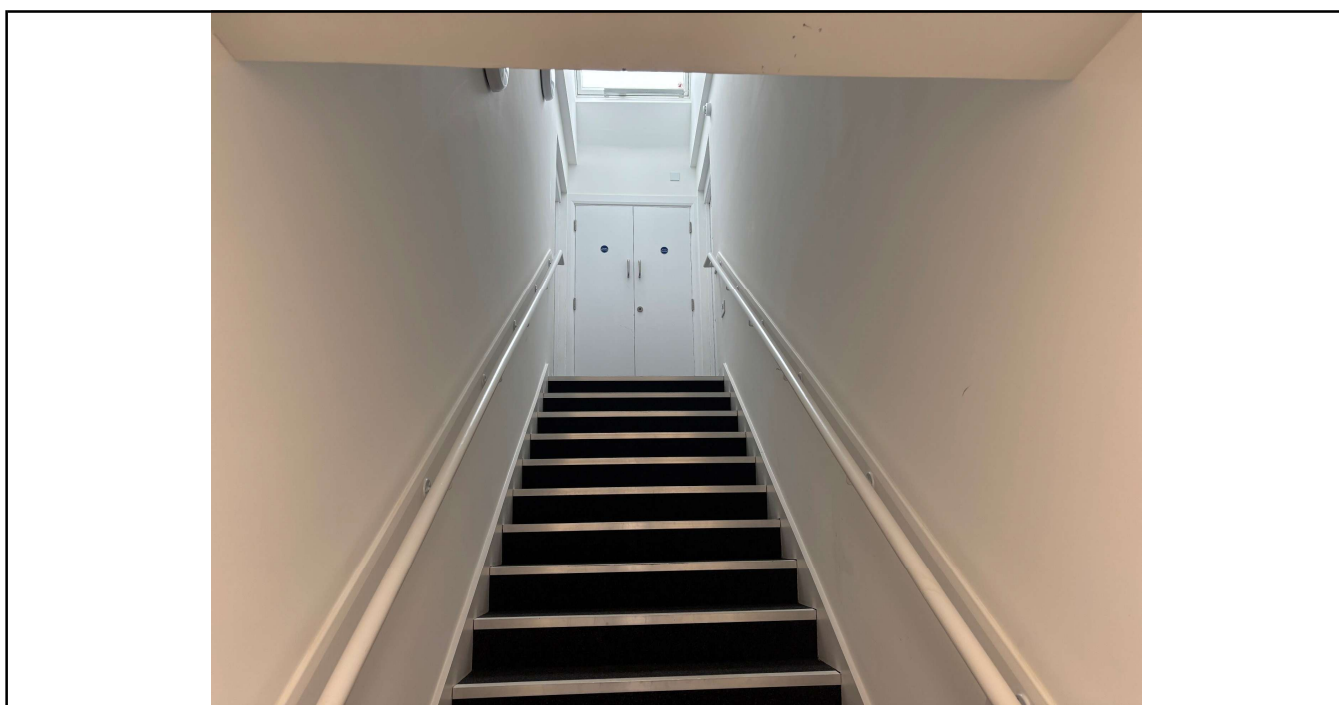
Photo No. 2

Front Door to Head of Stairs. Flats 3-4

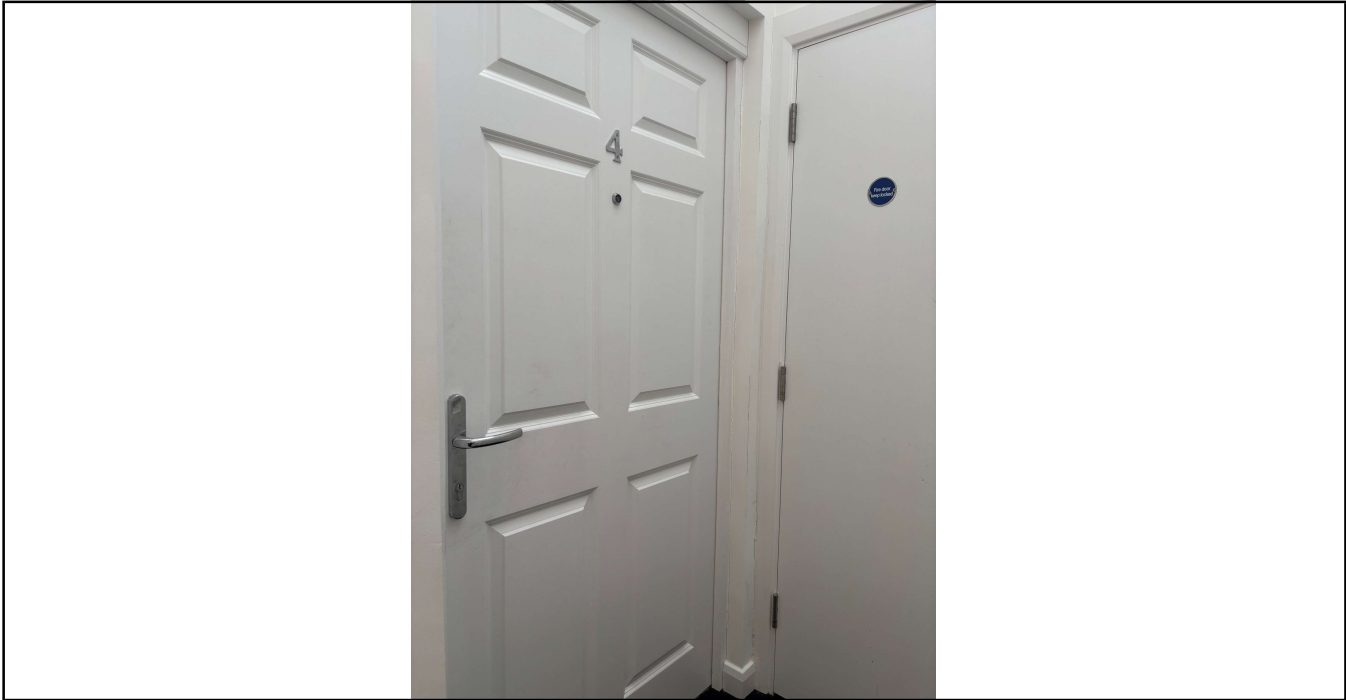
| Photo No. 3 | Head of Stairs no communal landing just left right. |

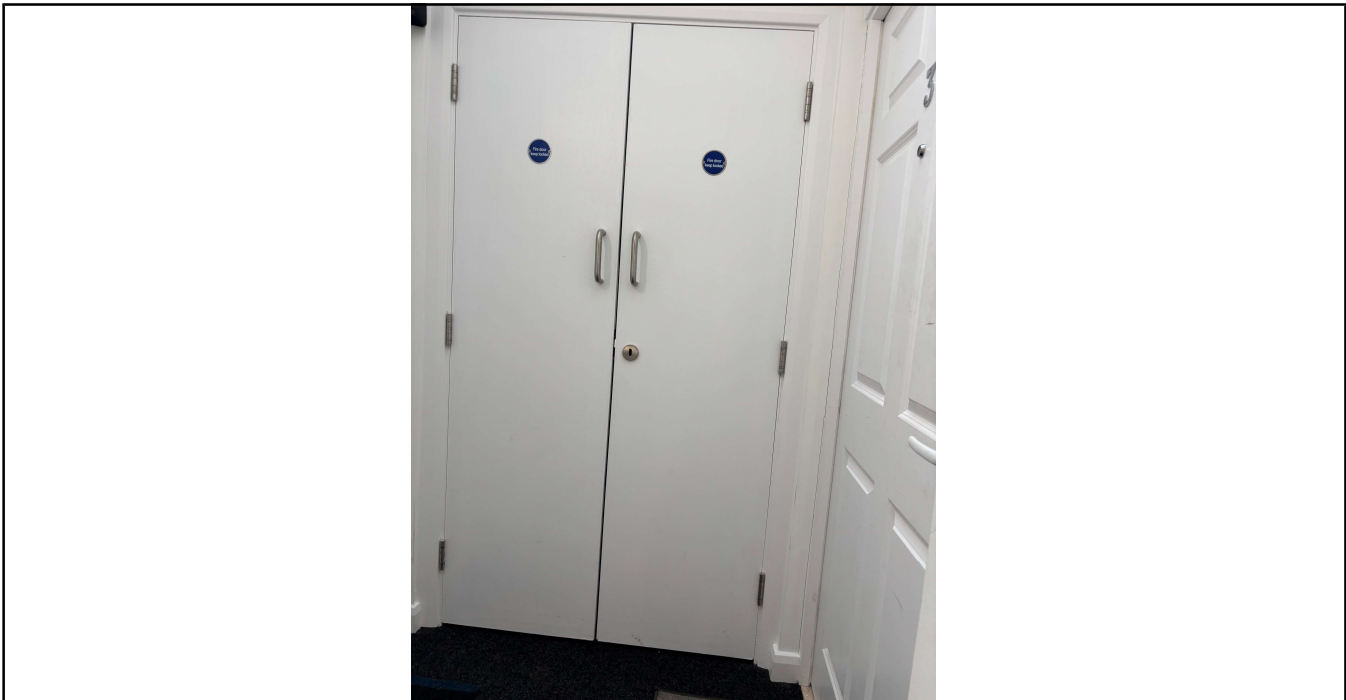
| 7.2 | Are all electrical/intake/service cupboards secure and free from general waste, contractors waste and residents personal items. | Yes | The Electrical equipment and Utilities are locked in double Fire Doors with FB lock at the head of the stairs. | . | | |

| Photo No. 4 | Electrical and Utilities cupboard both Fire Doors. |

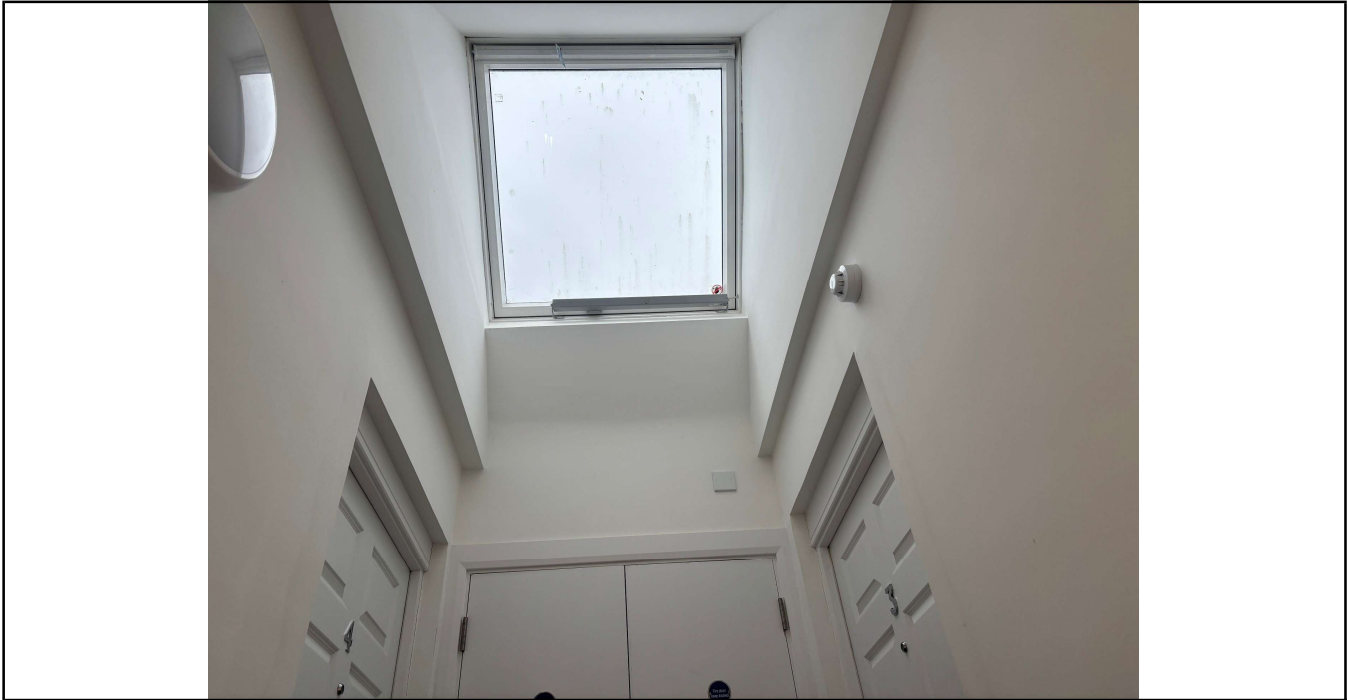
| 11.7 | Smoke Control Systems (AOV's)<br>Are records of annual testing available? | N/A | Automatic vent is fitted at this scheme head of stairs, LD 5 system installed detector and control panel. Testing certification checked. | . | | |

| Photo No. 5 | AOV and smoke detection. |

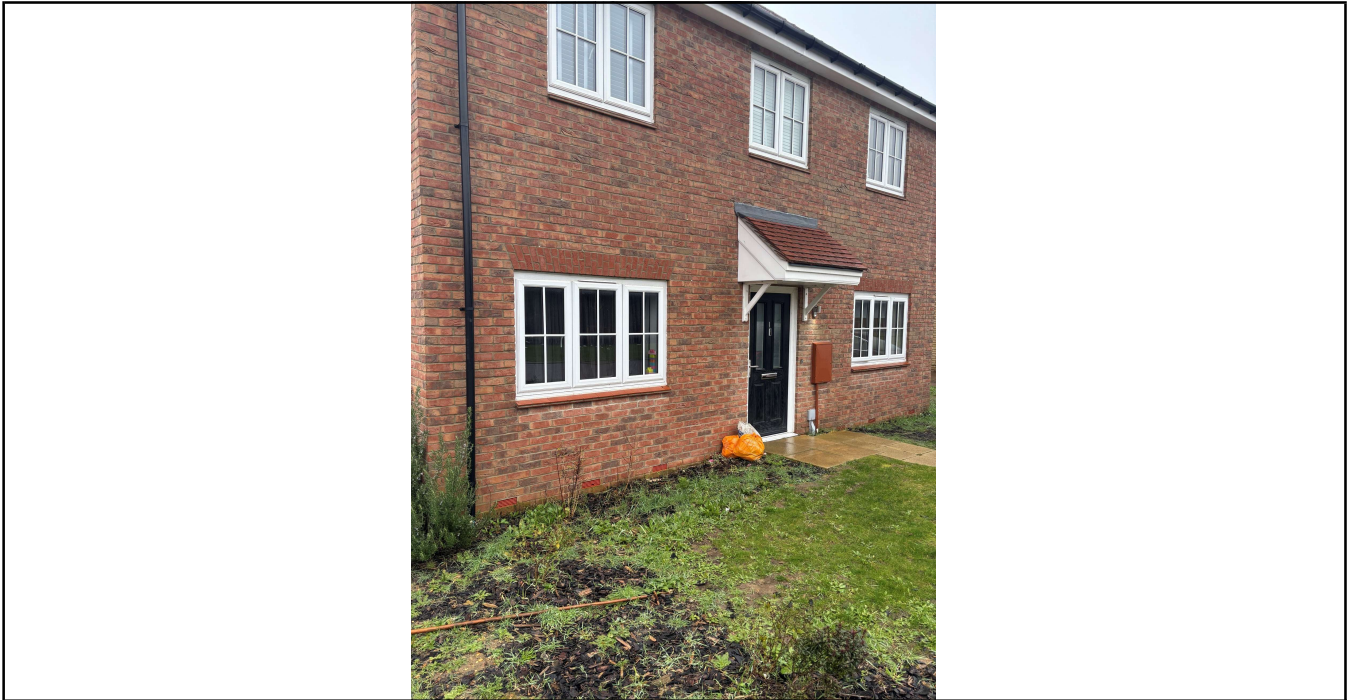
| 10.1 | Is it considered that the building is provided with reasonable means of escape in case of fire? | Yes | First Floor Flats 3 and 4 lead to protected stairway, Flats 1 and 2 Have own access to safe air. | . | | |

| Photo No. 6 | Location of Flat 1 to the side of building own access. |
