## **ACCENT HOUSING - FIRE RISK ASSESSMENT**

| <b>Scheme Name :</b> | <b>127-132 The Martindales</b> |
| <b>Date of Assessment:</b> | <b>9th Sept 26</b> |

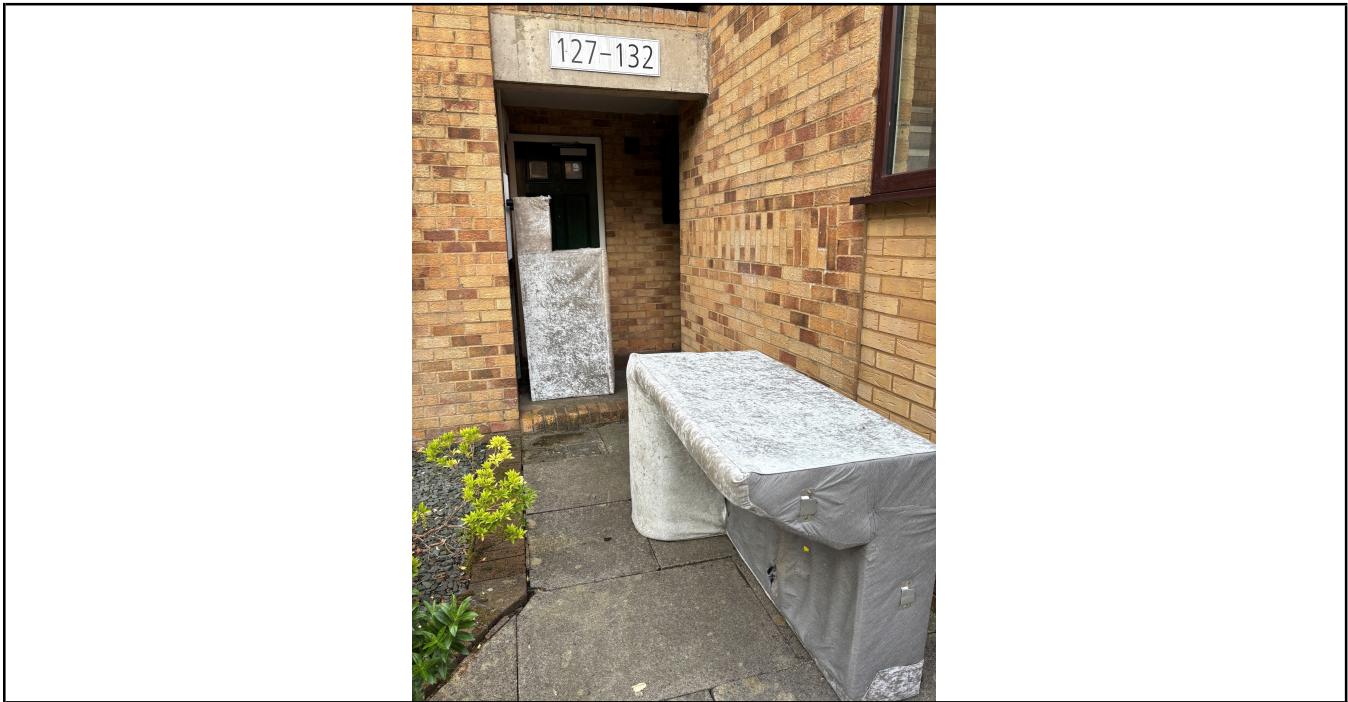
| Photo No. 1 | Personal items outside Flat 127 |

| 7.1 | Is the standard of housekeeping adequate? | No | Flammable personal items were found outside Flats 127,129 & 132. HP tasked to arrange removal. | Low | 30/9/26 |

| Action Plan - Fire | | | | | |
|---|---|---|---|---|---|
| Is the standard of housekeeping adequate? | Flammable personal items were found outside Flats 127,129 & 132. HP tasked to arrange removal. | Low | 30/09/26 | Housing Partner | 2181413 |

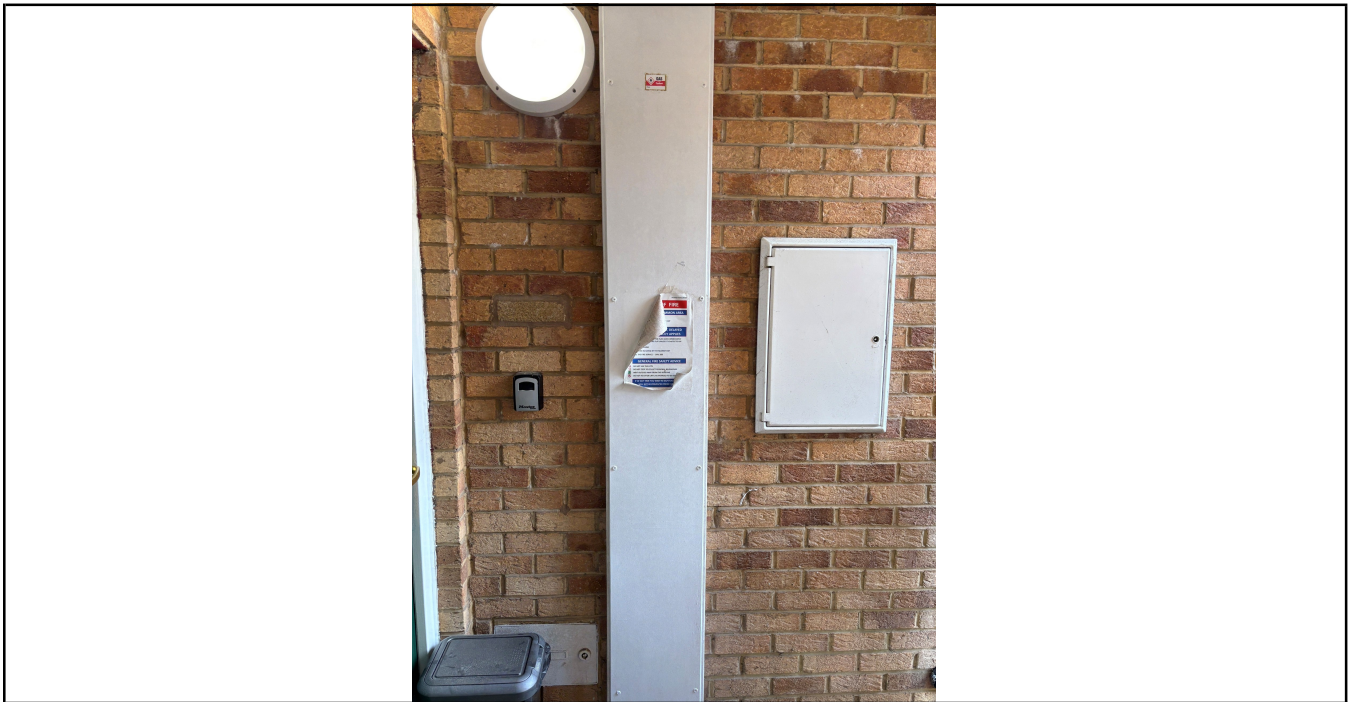
| Photo No. 4 | Evacuation notice damaged - Replaced |

| 16.1 | Are the correct Fire Action/Advice notices displayed in prominent locations within the common areas? | Yes | The correct Notices are displayed throughout the scheme. The evacuation notice on the middle floor was peeling off and was replaced at the time of inspection. | . | | |
