This report shows all the responses to the Fire Risk Assessment survey, including raised tasks.

Asset ID: 107 **Plckett Close, Nottingham**

Date of Fire Risk Assessment	11 Jan 2023
Date of Next Fire Risk Assessment	11 Jan 2026
FRA Frequency (Months)	36
Purpose of Fire Risk Assessment	3 year Re-Assessment
Type of Fire Risk Assessment	Type 3 (Common Parts and Flats - Non Destructive)
Fire & Safety Assessor	Lynn.betteridge@accentgroup.org

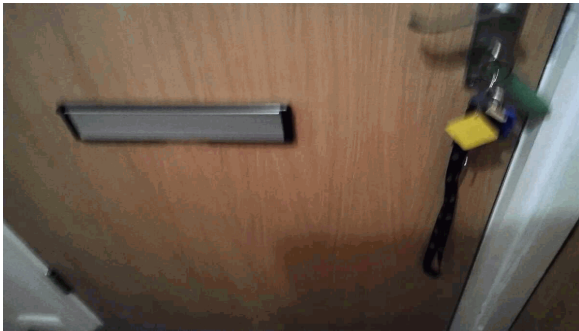
Observation	Priority	Referred To	Required By:	Task ID
2 doors you are required to have works completed to enable them to close correctly when entering the property will be booked on a repairs portal by myself	Internal - Medium	Fire & Safety Manager	03/04/2023	1608488
